**FIELD APPLICATION OF Z-SPIKE REJUVENATION
TO SALVAGE TIMBER RAILROAD BRIDGES**

Richard M. Gutkowski, Ph.D., P.E.
Nathan J. Miller, M.S.
Dept. of Civil and Environmental Engineering
Colorado State University
Fort Collins, Colorado

December 2011

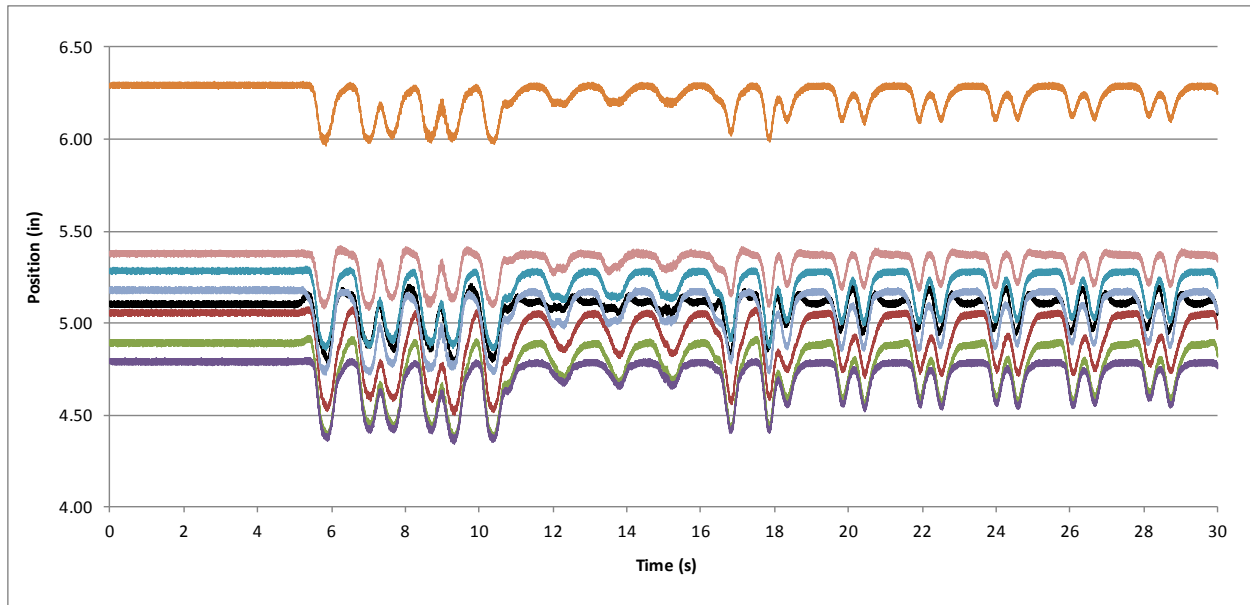
Figure 5.2 Data Record providing position of all at stringers during load test.

The stringer displacement data consisted of a 30-second graphical (and digital) record of the changing position of the members as the train crossed the bridge. Figure 5.2 provides the position data for all eight stringers of the center span of the bridge from a single load test. The start of the plot shows the unloaded position of the bridge. Then as the locomotive of the train comes onto span 1 of the bridge, the center span experiences some uplift; then as the first set of axles come onto the center span, the first valley of the data occurs. The minimum value in the valley corresponds to the condition that the first set of axles is centered on the center span (Figure C.51). At this point there are no other loads on any span of the bridge. Then as the train continues to cross the bridge (Figures C.52 and C.53), each subsequent valley in the data corresponds to each later truck of axles being centered on the center span.

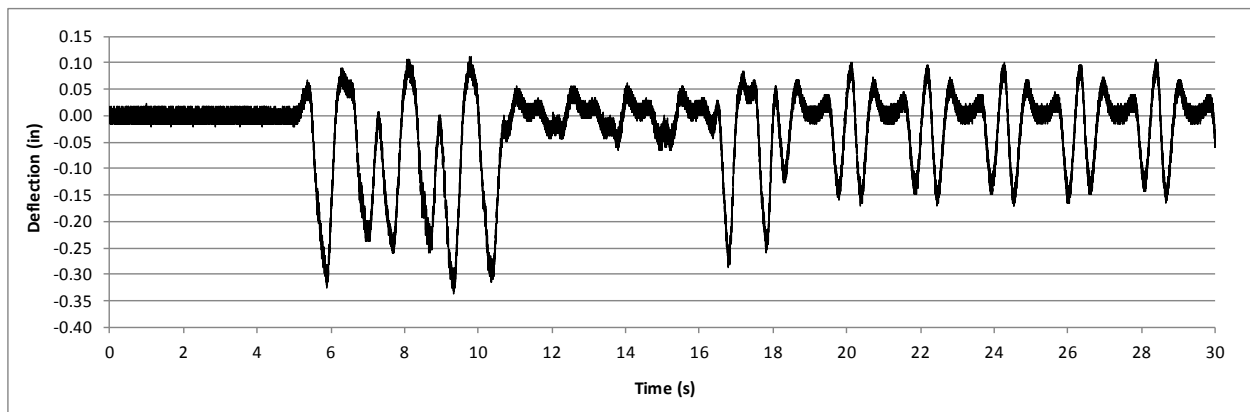
Figure 5.3 Position record for Stringer 1 under load of Train #1.

Figure 5.3 provides the deflection data from Stringer 1 in the bridge for Train #1 listed in Table 5.3. In this figure, there are six valleys at the beginning of the data that show deflection of the bridge under the load of the three locomotives that were on the train (three locomotives equal six sets of axles). The locomotives were followed by four unloaded cars and then seven loaded cars. The variation in deflection that occurs before the train arrives is an indicator of the electronic noise and perhaps other sources of inaccuracy (e.g., possible slight vibration of the bridge as the train approaches as well as vibration of the string potentiometer hanger set-up). Once the front truck of the locomotive moves on to the first span, the stringer deflects upward approximately 0.06 inch in span 2. That would be expected. Then, when the front truck moves on to span 2, that span begins to deflect downward, to a maximum deflection of 0.32 inches. Subsequent peaks in deflection constitute the effects of subsequent trucks of train axles moving on to, along, and then off the bridge.

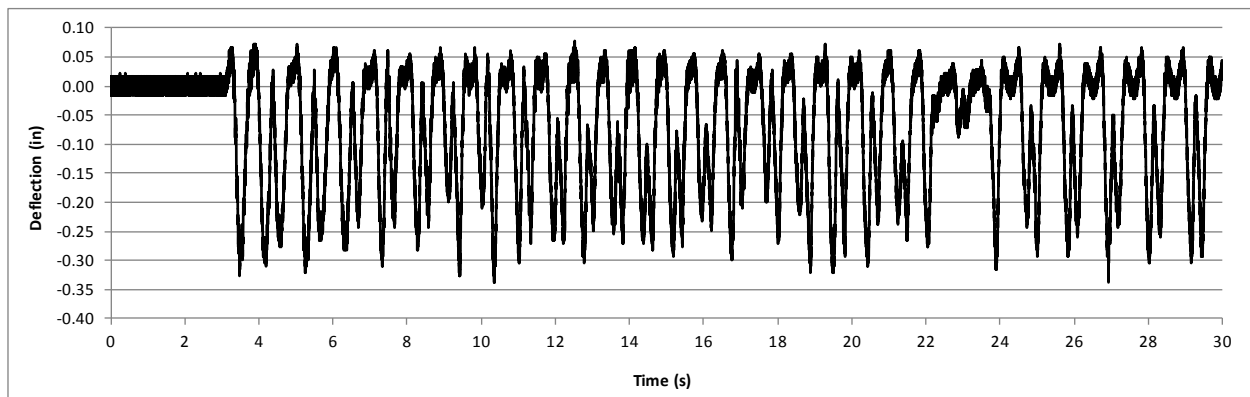
Figure 5.4 Position record for Stringer 1 under load of Train #17.

Figure 5.4 shows another example of the data collected from a train. In this case, the data are for Stringer 1 from Train #17 in Table 5.3. This train was traveling significantly faster and had many more heavily loaded cars.

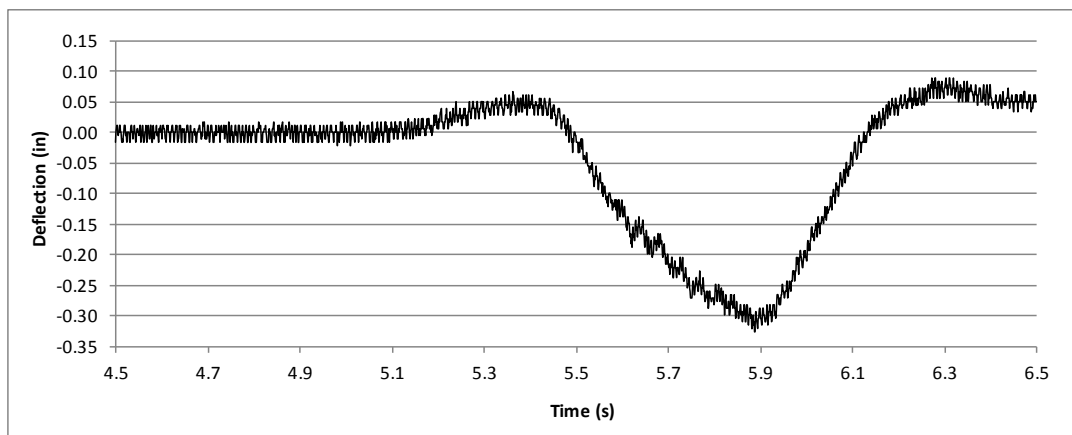
Figure 5.5 Position record of single stringer under the load of first truck of first locomotive for Train #1.

The intent of the research study was to monitor the changes in flexural measured stiffness that resulted from the spiking process. Thus, it was necessary to determine the vertical displacement of the stringers under the load of the train. It was determined that the measured stiffness would be measured under the loading of the front truck (set of axles) of the lead (first) locomotive (some trains had additional locomotives being pulled at the front and/or back ends of the stream of cars) in the train. This was deemed to be the most convenient loading for measuring the stiffness, as it was at this time that there were no other loads acting on any point along the bridge that could affect the deflection. The deflection of the bridge stringers under this load was determined from the data collected. However, before the deflection could be determined, the issue of noise in the data needed to be addressed. Figure 5.5 shows the plot of deflection versus time for the stringer exemplified in Figure 5.3 but with it zoomed in to show the deflection under the first truck of the locomotive. Clearly, from the plot there is significant noise in the data.

There are two primary sources of noise that could exist in the system. First, there is the electrical noise that may exist in the string potentiometer and data acquisition puck. There is also potential noise from the vibration of the test set-up. This would likely include the longitudinal and transverse vibration of the string potentiometer hangers. A Mathcad program was used to remove the effect of the noise from the data by using a Fourier Transform. Noise with frequencies between 10-499 Hz was removed from the data. It was determined that this range was sufficient as increasing it (above 499 Hz) did not remove any additional noise, and decreasing the range (below 10 Hz) began to remove some of the desired position measurement.

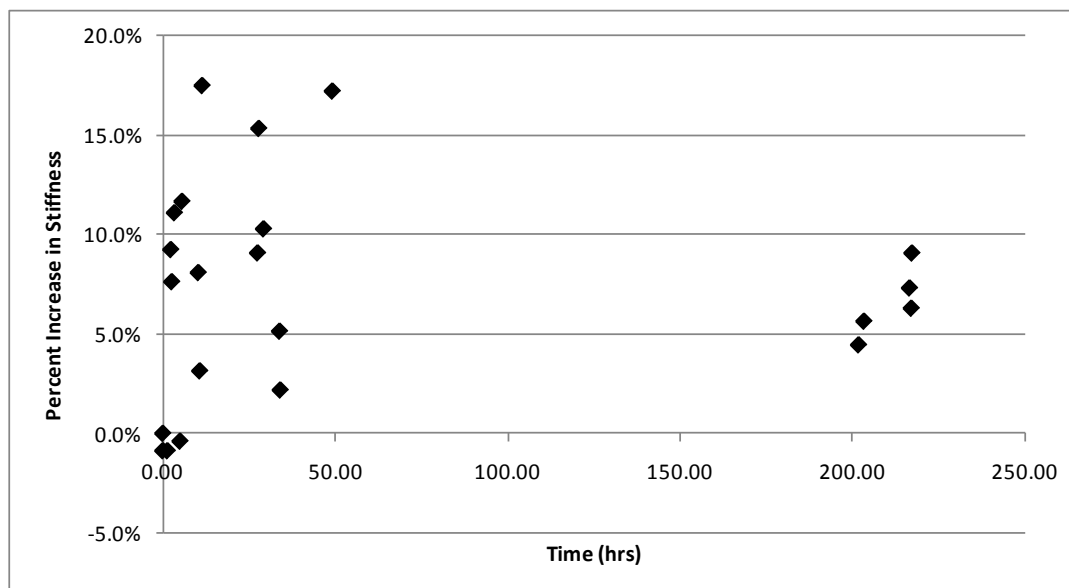
Figure 5.7 Percent increase in Measured Bridge stiffness vs. Time for all trains.

Figure 5.7 shows a plot of percent increase in bridge measured bridge stiffness versus time. There is noticeable variability in the plotted results; however, possible contributing factors need to be considered. First, there were different types of locomotives on the trains that crossed the bridge. The various types of locomotives encountered likely have different axle spacing in their trucks. As stated above, to quantify a measured bridge stiffness, it was assumed that there was only one axle at mid-span of the center span and the front and rear axles of the front truck were very close to or directly above the supports of the bridge. For shorter spacing of the truck axles, the outer axles could be far enough into the center span to add a non-negligible measurable contribution to the mid-span displacement. Another factor is the direction in which the train was traveling. This manifests itself in two ways. First, there may be dynamic effects associated with the train crossing the bridge. As the condition of each end span was different, the dynamic effects would differ depending on which end span was in play as the locomotive came on to the bridge. Consequently, the observed deflection of the center span could be affected by the direction of movement of the locomotive. The direction of train travel could also affect the weight of the train. The provided weights were measured at some unknown location. It is possible that the fueling locations on each side of the bridge were significantly different distances from the bridge, which would have an effect on the actual weight of the locomotive when it reached the bridge. Another variable that could affect the measured bridge stiffness is the speed of the train. Some materials exhibit a dynamic impact effect, whereby larger deflections occur in beams for moving loads than for static loads of the same magnitude. In such cases, as a train moves across a bridge, the observed displacements are higher for any position of the train axles than would be observed if the train was standing still in that position. The dynamic impact effect is quantified by an “impact factor,” which is used to magnify the static loads used in ordinary bridge design computations. Typically, as the rate of speed of a moving load is increased, so is the impact factor. It is generally accepted that wood has a negligible impact factor, meaning the speed should not affect the results of this study. However, it is possible that the impact factor of the steel rail affects the transmission of axle wheel loads down to the cross ties and, thus, to chords in some way.

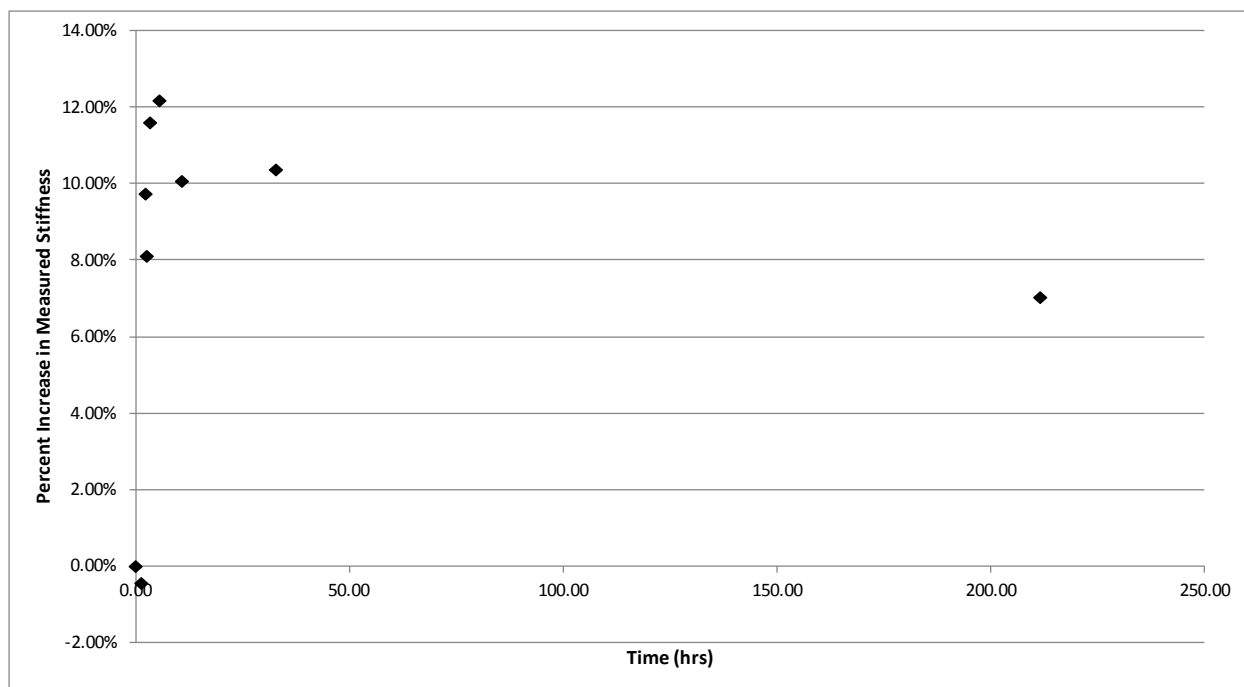
Figure 5. 8 Averaged percent increase in measured stiffness vs. time.

Due to the large amount of variability in the locomotive loading and the limited number of trains available for data collection, it was determined that averaging the data over limited time intervals would provide the most meaningful description of the results. Table 5.4 below provides a listing of the
