### Long Term Monitoring of Mechanical Properties of FRP Repair Materials

Rebecca A. Atadero, Assistant Professor Douglas G. Allen, Graduate Research Assistant Oscar R. Mata, Graduate Research Assistant Department of Civil & Environmental Engineering Colorado State University Fort Collins, CO

Mountain-Plains Consortium and Colorado Department of Transportation DTD Applied Research and Innovation Branch Denver, CO

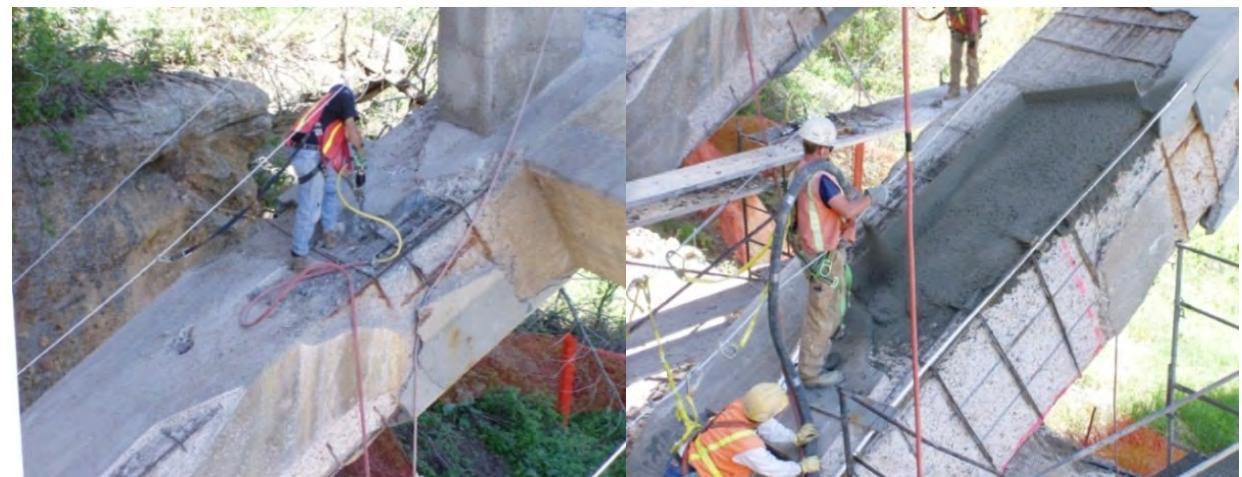
Loose concrete, typically no more than the few inches of concrete cover, was removed with 6.8 kg (15 lb.) jack hammers and the exposed steel reinforcement was sandblasted free of rust. As seen below, the cross-section was restored with shotcrete, which included a corrosion inhibitor, Sika FerroGard 903, to prevent further corrosion of the steel reinforcement.

Figure 2.9 Removal of loose concrete using 6.8 kg (15 lbs.) jackhammer and restoring the cross section with shotcrete (Mohseni, CDOT)

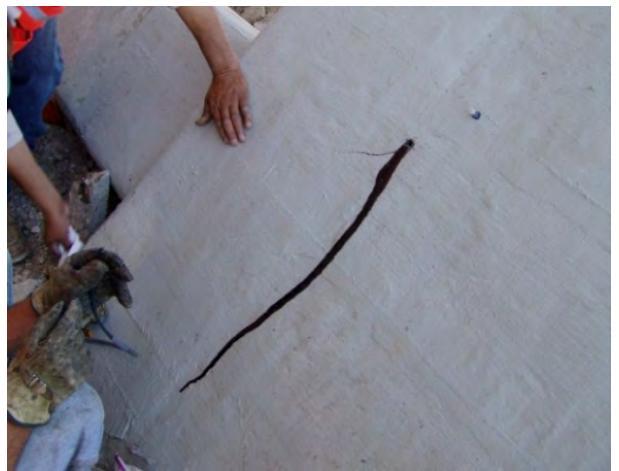
In addition, the contractor, accompanied by the engineer and manufacturer's representative, was required to examine all surfaces 24 hours after application of FRP sheets and initial resin cure to check for voids, delaminations, and air bubbles. The inspection was accomplished by visual observation and acoustic tapping tests to locate voids or defects. Areas of voids or delaminations can be detected due to the different sound emitted when tapped or when a solid object is slid over the area. Minor areas of voids of less than 38.7 cm<sup>2</sup> (6 in<sup>2</sup>) were injected with resin to fill the void and provide a bond between the FRP and the substrate. Voids larger than 38.7 cm<sup>2</sup> (6 in<sup>2</sup>) were repaired by removing and re-applying the required number of layers of CFRP. A void that had been injected with resin directly following the CFRP application can be seen below in Figure 2.12. There was no documentation of this procedure or any information regarding the areas repaired or filled with resin, but it is assumed that this process was satisfactory.

Figure 2.12 Void injected with resin during 2003 renovation (Mohseni, CDOT)

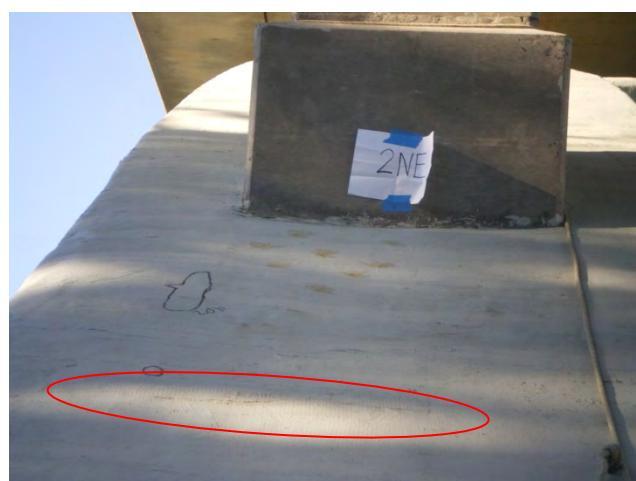
Markings made with a permanent marker on the bridge from the 2007 bridge inspection were barely visible at the time of the 2011 field assessment. Depending on the exposure from moisture and sun, markings on the bridge can exist for only a relatively short time with respect to the life span of the bridge. Below are three photographs of the areas identified from June 2007, two of which were barely visible at the time of the July 2011 visit. There were no markings found on the east arch from the inspections in 2005 and 2009. In addition to the three voids, three cracks in the CFRP were also identified in 2007, one of which can be seen below.

Figure 2.16 Crack identified in 2007

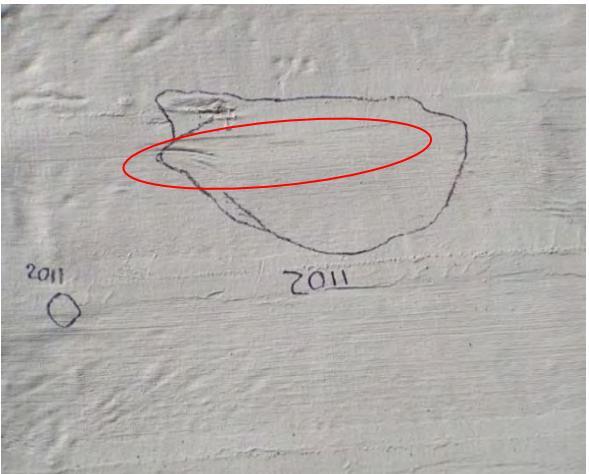
The images above are of two voids found in the first bay on the north end of the east arch. The area of the larger void was one of two areas eventually removed from the arch and is referred to as the "smaller" patch removed from the arch. Note the horizontal or transverse cracks enclosed in the red oval near the top of the void in Figure 3.2.

Figure 3.2 Two identified voids during the 2011 inspection, visible cracks in CFRP

All three voids identified during the biannual inspection in 2007 had grown in size, and all voids found in the 2011 field assessment that were not previously identified presumably developed in the time between the 2007 bridge inspection and the 2011 field assessment. It was not possible to determine whether the

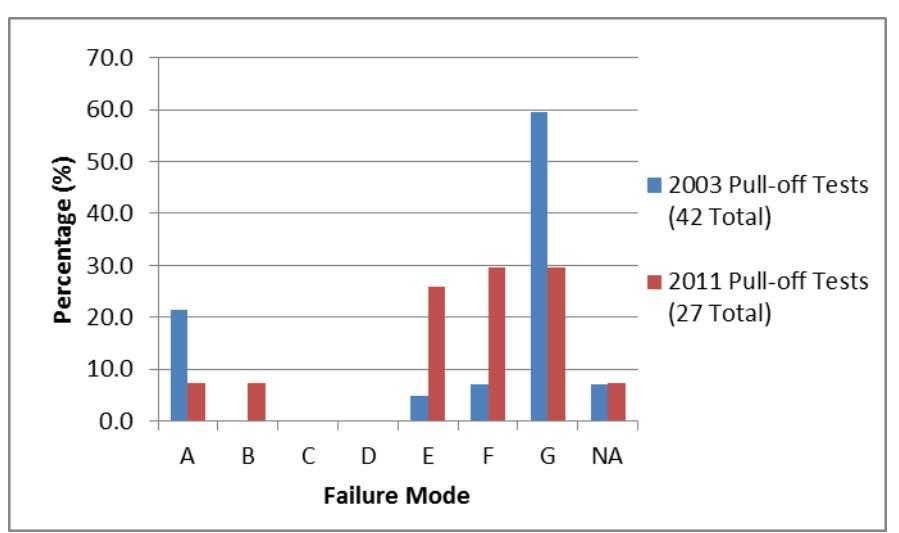
Figure 3.16 Failure Modes of Pull-off Tests from 2003 and 2011

The number of failure modes E, F, and G are roughly equal in number with only approximately 7% of the specimens failing in each of the A, B, and NA failure modes for the tests conducted in 2011. From Figure 3.16, it is apparent that the high percentage of failure mode G from 2003 significantly decreased to the evenly distributed modes E, F, and G of the 2011 test results. Mode B was a failure mode that did not occur in 2003, but did in 2011 twice out of 27 tests. An increase in percentage of failure modes B, E, and F indicates that other interfaces, other than within the substrate, are weaker and controlling. Failure Mode B is, according to ASTM D7522, "an indication of poor through-thickness properties of the FRP. Such failures may be due to incomplete wet-out of the fibers or plies comprising the laminate. Such failures may also result from environmental degradation of the FRP material itself." The term "wet-out" is referring to the quality of the CFRP composite material and whether the fibers were fully saturated in epoxy during the wet lay-up process. Failure Mode E is an indication of poor adhesion properties and Failure Mode F is a commonly observed mixed failure mode that is believed to initially fail in the cohesion in the substrate, followed by propagation to the adhesive interface. Different substrates at the location of the pull-off tests of 2003 and 2011 could have influenced both the failure mode and results of the pull-off tests. It is reasonable to consider that the tensile strength of concrete could have improved marginally since 2003 due to continued curing, especially if the substrate was shotcrete rather than the original concrete. However, even in the case of shotcrete as the substrate, this improvement or increase in strength would be fairly marginal. Comparing bond strengths of the 2003 and 2011 tests of only failure mode G tests would be a reasonable evaluation of this possible strength gain of the substrate if the testing

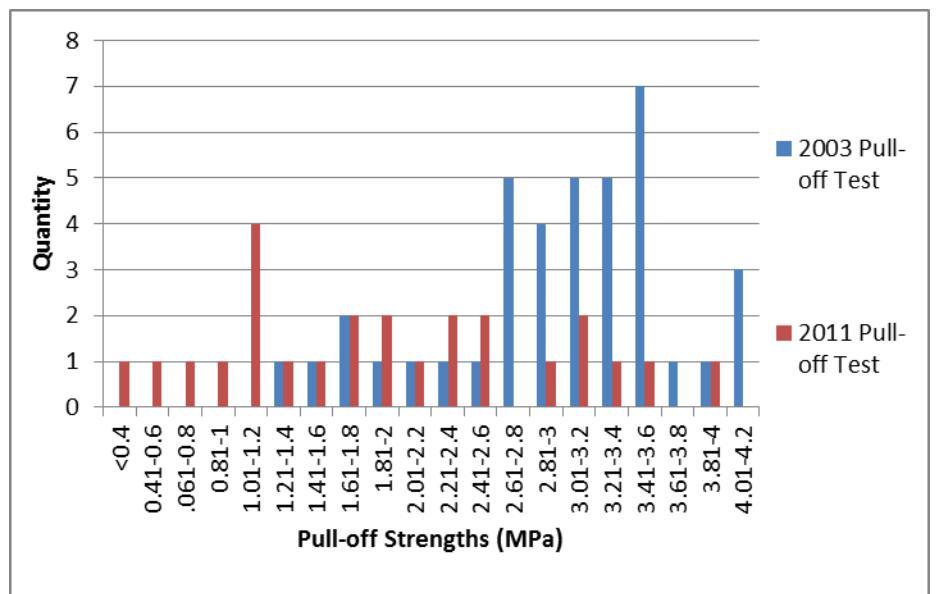
Of the 27 pull-off tests conducted in 2011, nine tests, two of which were failure mode G, failed to meet the 200 psi minimum requirement of CDOT's construction specifications (Revision of Section 602). Six of the nine tests that had strengths less than 200 psi had failure mode E. This failure mode is a failure at the interface between the CFRP and the substrate. A relatively thick layer of resin was used to smooth the surface of the substrate at the time of the CFRP repair. The thick "filler" resin varied in thickness and in color. These pull-off tests with low values all appeared to have very similar failure modes and strengths as well as appearance of the failure plane. Only one of the 42 tests conducted in 2003 failed to exceed 200 psi. Below are two figures displaying the distribution of pull-off strengths and probability density functions based on a normal distribution of pull-off strengths.

Figure 3.17 Histogram of Pull-off test strength

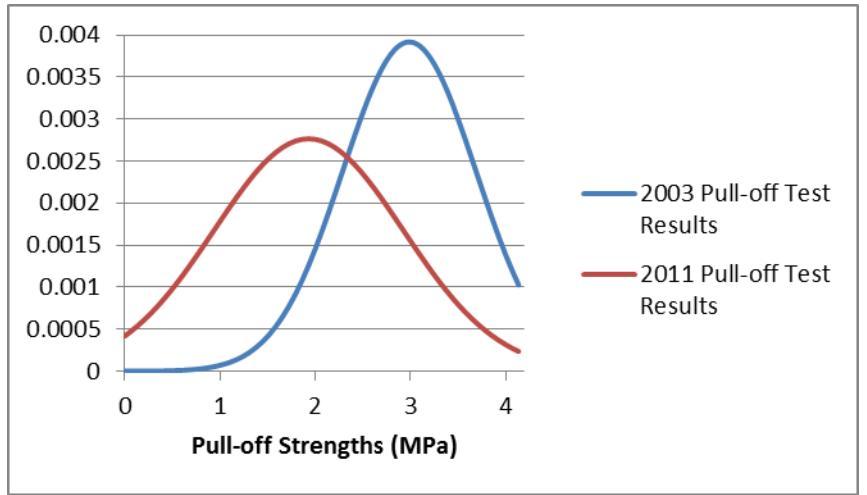
Figure 3.18 PDF of Pull-off test results

The lower, wider, curve of the 2011 PDF in Figure 3.18 gives evidence that the standard deviation increased from 2003 to 2011. The data were fit with a normal distribution for the creation of the PDF and statistical analysis. In addition, from 2003 to 2011, the mean lowered, shifting to the left. If the influence of the testing procedure could be disregarded, the larger variance of the 2011 results would likely represent the varying conditions in which the CFRP was exposed. The decrease in the mean from 2.98 to 1.93 from 2003 to 2011 gives indication of an overall decrease in the bond strength of the CFRP to the concrete. This indicates a possible durability concern for long-term applications.

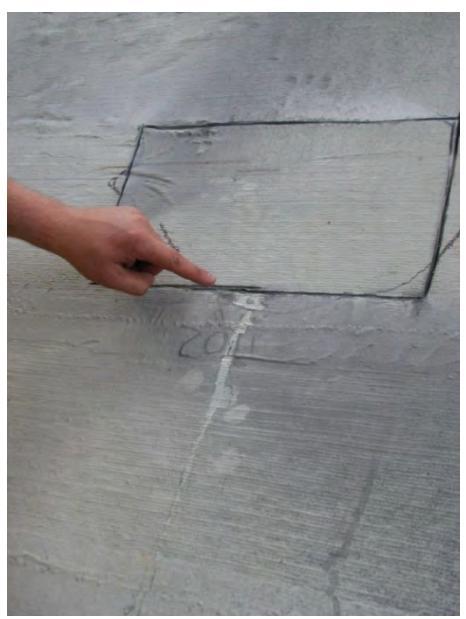
Upon cutting the lower edge of the CFRP rectangle, water exited the cut at the bottom of the void, revealing standing water at the interface between the CFRP and substrate. Photographs of the void and the removal of the CFRP layer are shown in Figures 3.20, 3.21, and 3.22.

Figure 3.21 Water exiting the void area directly after the lower cut through the CFRP was completed

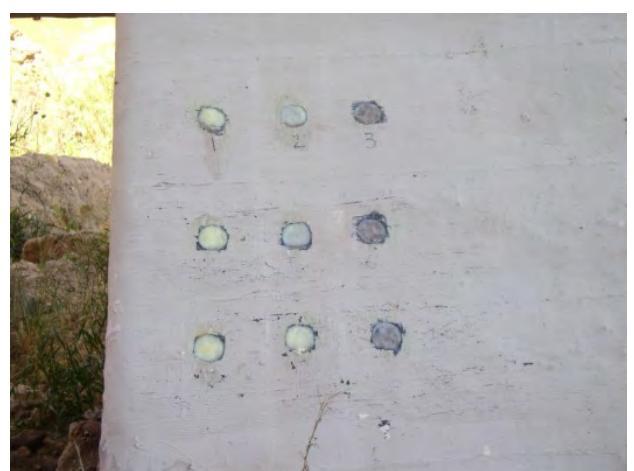
Due to the pull-off tests, a total of  $27 - 57.15 \text{ mm} (2 \frac{1}{4}^{\circ})$  diameter holes of varying depths, depending on the failure mode, were created on the arch. These areas were filled with epoxy to replace the cross-sectional area. Initially, the same epoxy used to adhere the aluminum pucks to the CFRP was used to fill the holes created from the pull-off tests. Due to the inclined angle, this epoxy, which is less viscous before curing, would slump and run down slope on the locations near the base of the arches. This was undesirable and a more viscous epoxy, 3000 psi Loctite epoxy gel, was used to fill the holes created from the pull-off tests. These filled holes of varying depths can be seen below.

Figure 3.24 Epoxy filled holes following the pull-off tests

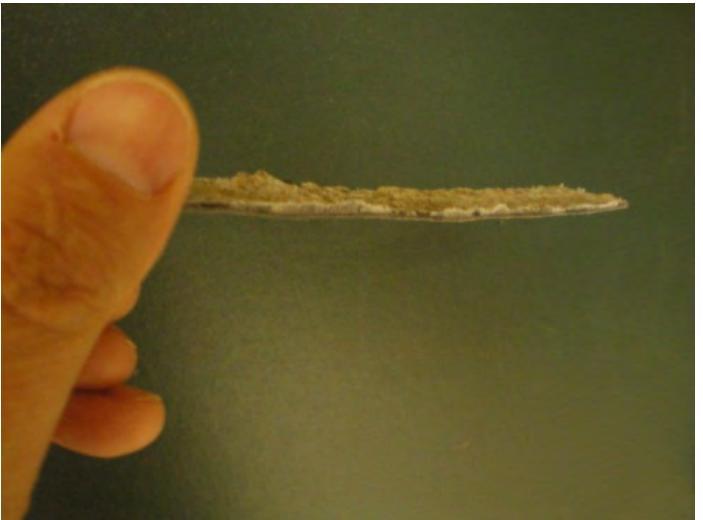
The thickness of the CFRP strips varied significantly due to the rough contour of the adhered side of the CFRP. As previously discussed in sections 3.2.4 and 3.2.5, a thick filler resin was applied to smooth the surface of the substrate prior to adhering the CFRP fabric to the arches. A photograph of the rough texture is shown in Figure 4.1.

Figure 4.1 The rough contour of a tensile test strip of CFRP

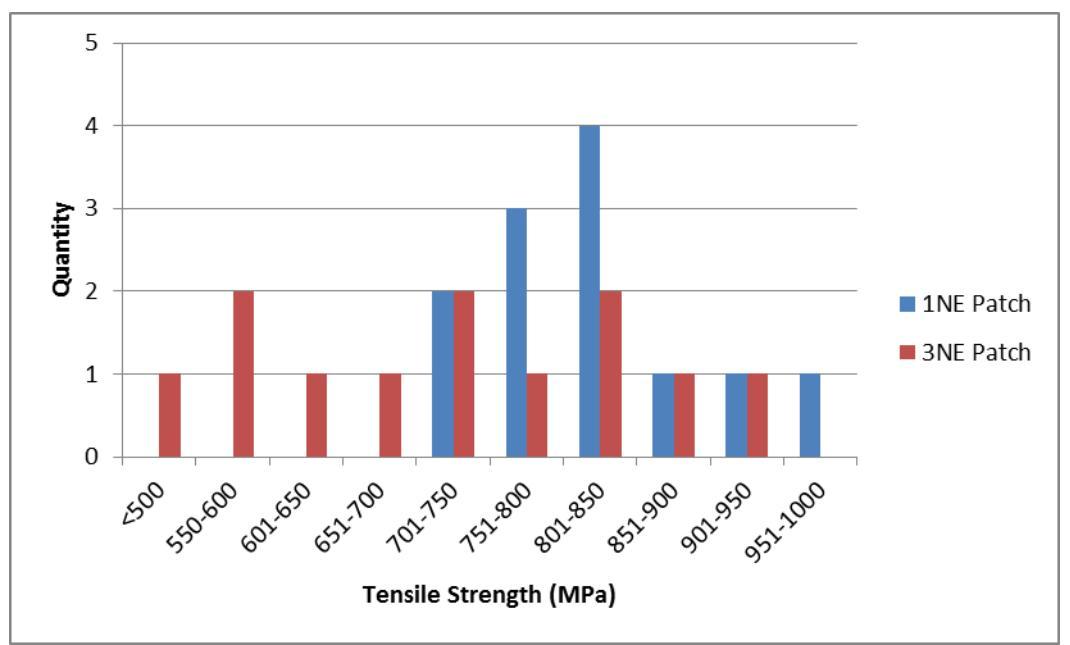
Figure 4.4 Distribution of tensile strength results

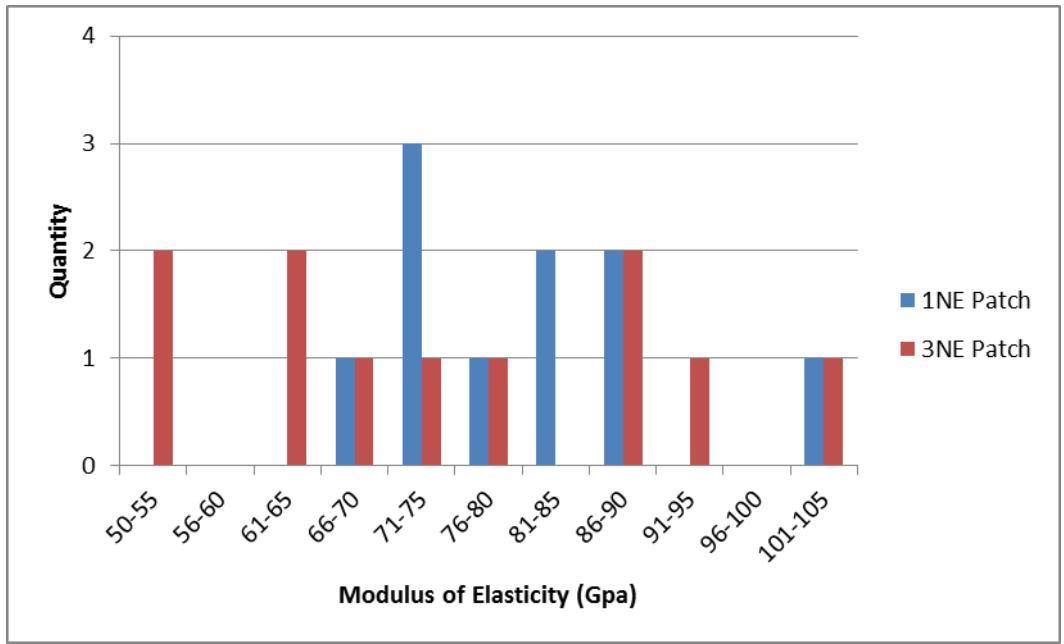
Figure 4.5 Distribution of modulus of elasticity results

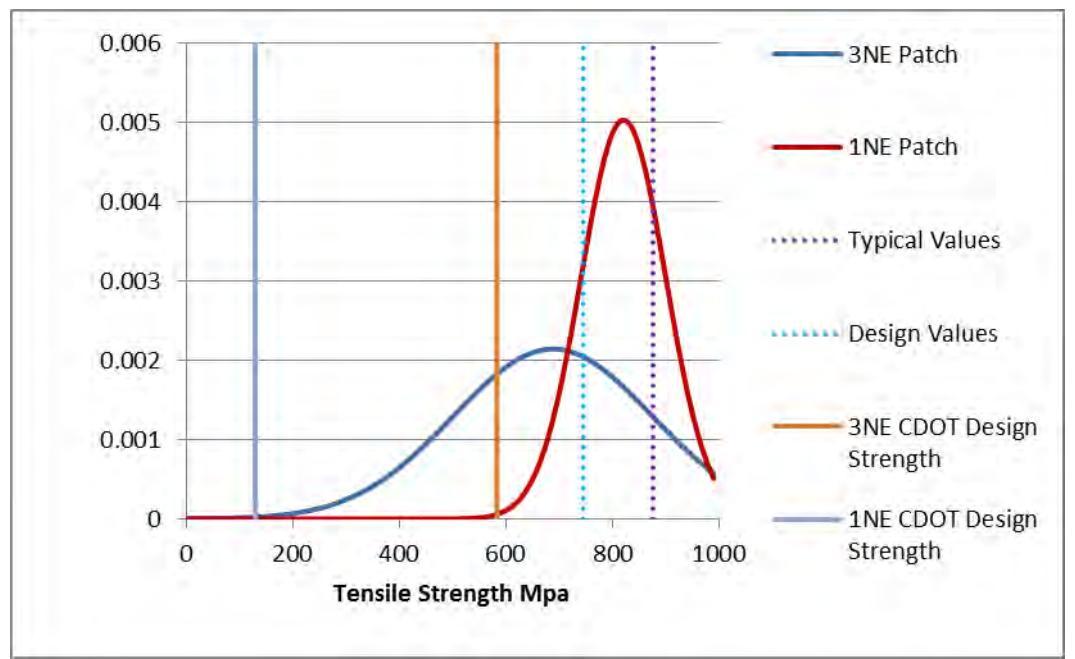
**Figure 4.6** Probability density function of the two samples, tensile strengths

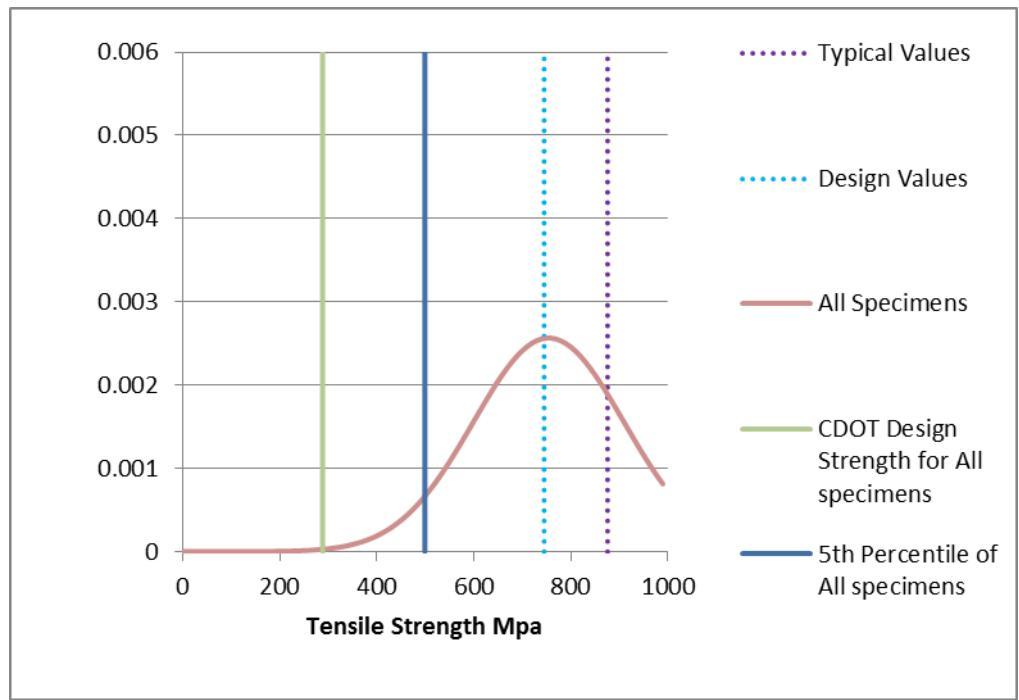
Figure 4.7 Probability density function of all tensile tests

Looking at the location of these values in Figure 4.7, there is a very concerning discrepancy between the values of tensile strength provided by the manufacturer and the values generated from the tensile tests. The values of modulus of elasticity are fairly representative of the values provided by the manufacturer. By assuming the stress versus strain response of the CFRP was linear until failure, the rupture strain was found by dividing the ultimate tensile strength by the modulus of elasticity, which was the chord modulus of 0.0043 strain or less. CDOT's construction specifications (Revision of Section 602) required a minimum rupture strain of 0.006 cm/cm. The rupture strain of the material at the time of repair was identified in the CDOT report as being 0.012 cm/cm for both the typical and design value.

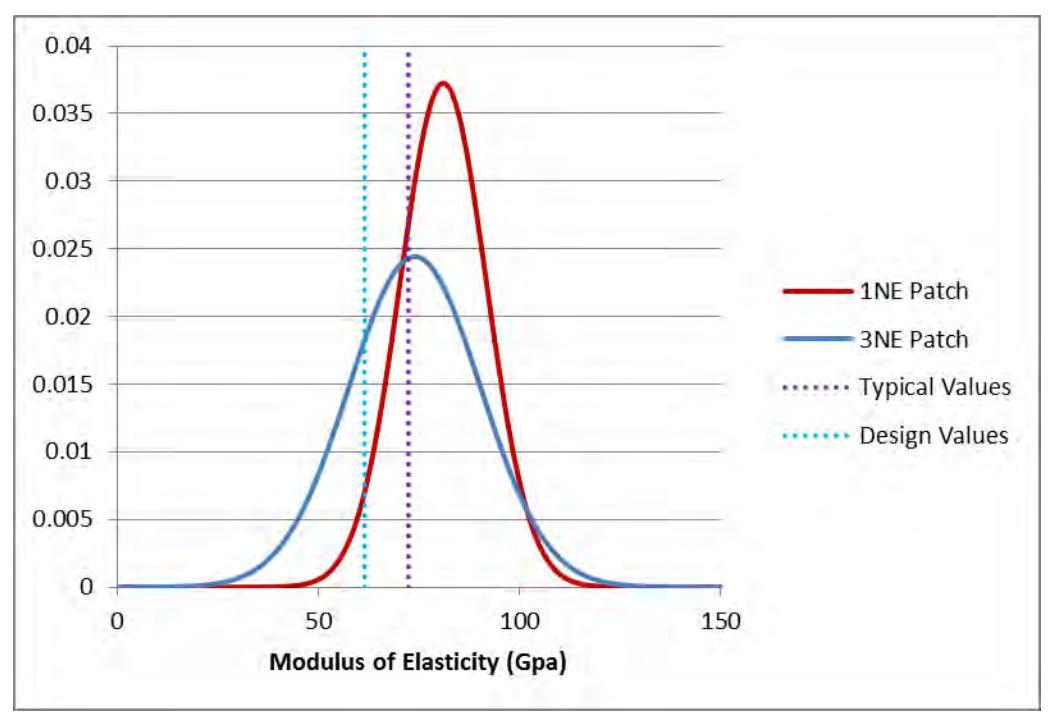
Figure 4.8 Probability density function of the two samples, modulus of elasticity

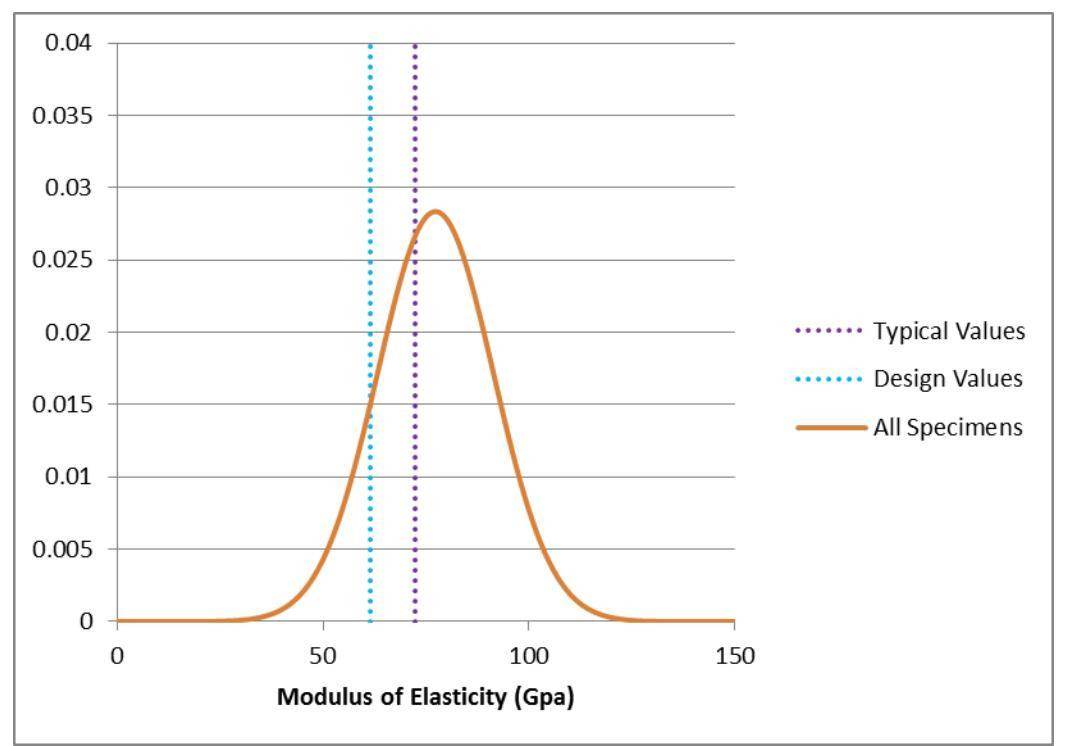
Figure 4.9 Probability density function of all modulus of elasticity samples

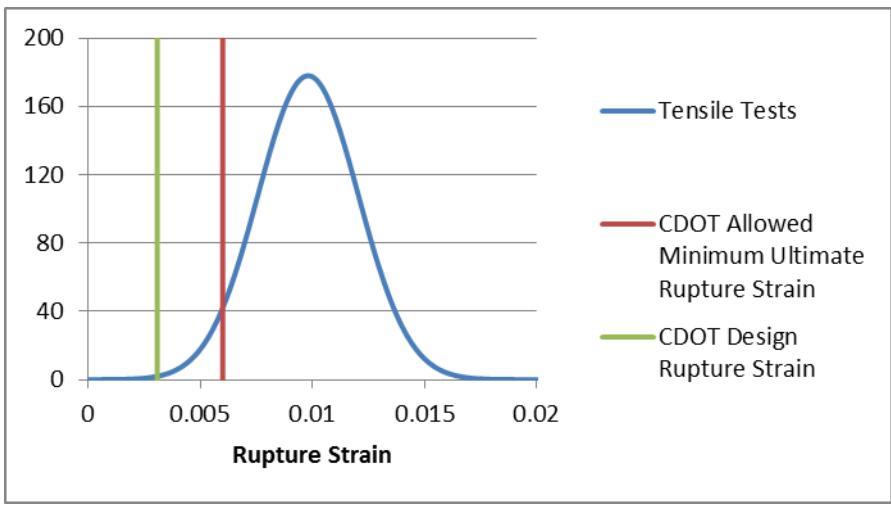
The 5<sup>th</sup> percentile value in the table above would satisfy the minimum rupture strain requirement of CDOT's construction specifications (Revision of Section 602), but the "CDOT Design rupture strain" calculated per CDOT's construction specifications (Revision of Section 602) is not adequate. A visual representation of this can be found in the probability density function in Figure 4.10.

Figure 4.10 Probability density function of the rupture strain of all tensile tests

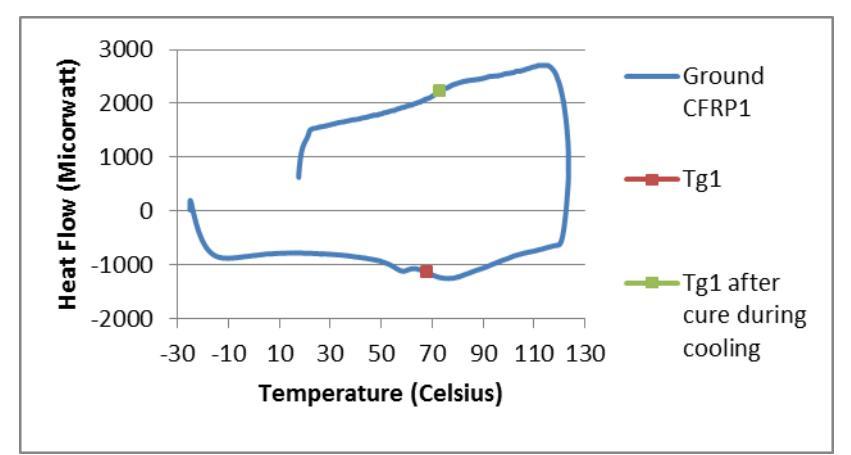
Figure 4.14 Ground CFRP specimen

During heating, the glass transition temperature, Tg, was 67.95°C, while during the cooling process, the Tg was 73.19°C. This increase in Tg is due to the curing process caused by the heating up to 130°C. The glass transition temperature of the CFRP composite was expected to be between 60°C and 82°C, as quoted by the manufacturer as being the design value and typical test value, respectively. The highest temperature of the composite's thermal history was probably not much greater than 40°C, which explains the additional curing and the upwards shift in the Tg during the heating process up to 130°C.

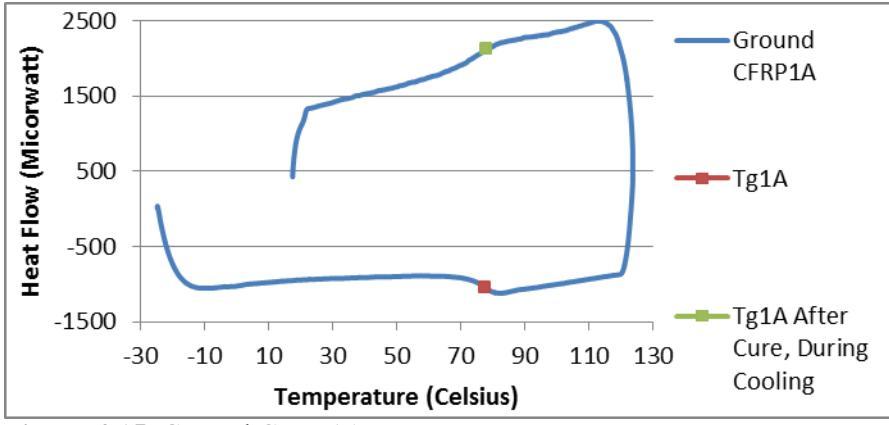
Figure 4.15 Ground CFRP1A

The erratic or irreversible behavior does not exist in the classic behavior of the DSC curve in the plot above. The behavior during heating and cooling are reversible and look identical. Subtracting the Ground CFRP1A curve from the Ground CFRP1 curve would yield an area that represents irreversible behavior.

The two glass transition temperatures were found to be 77.38°C and 78.02°C for the heating and cooling processes, respectively. The second time the specimen was heated to 130°C the  $T_g$  increased by a much smaller amount due to the post-curing that occurred during the first test. The closer a specimen gets to being fully cured, the smaller the influence additional heat will have on  $T_g$ . Additionally, there is a relatively small shift in the  $T_g$  that is due to the different processes of heating and cooling that should be considered when comparing the  $T_{gs}$  found during the heating and cooling processes. During the heating the  $T_g$  is shifted to the right and during the cooling the  $T_g$  is shifted to the left; the glass transition temperature should be taken as the average of the two values found during the heating and cooling processes if no significant curing occurred during the heating process. A plot of the heat-cool-reheat-cool process is in the figure below.

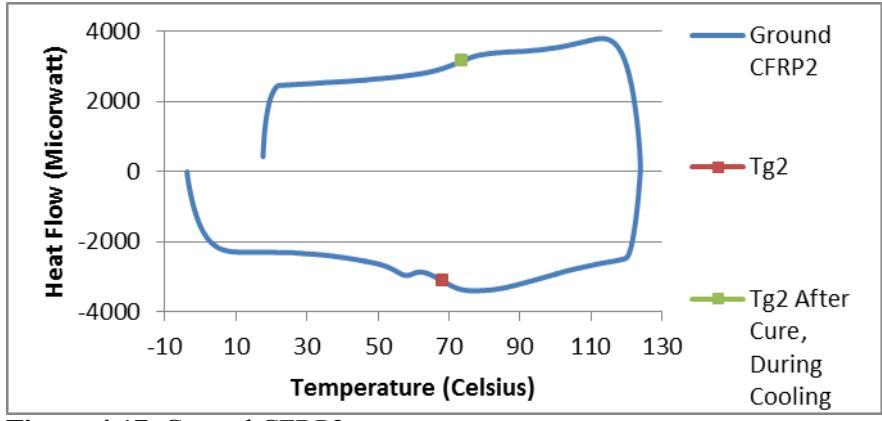
Figure 4.17 Ground CFRP2

The  $T_{gs}$  were very close to that of Ground CFRP1, 68.13°C and 73.56°C, respectively, as was the general response and presence of the irreversible behavior. Diced CFRP was also analyzed as opposed to the ground CFRP. The diced CFRP had slightly lower values of  $T_g$ , possibly due to the heat added to the ground specimens but the difference was fairly marginal. All three plots are combined in the figure below. To reduce the test time and conserve liquid nitrogen, the start temperature was changed from -30°C to -10°C for the Ground CFRP2 test.

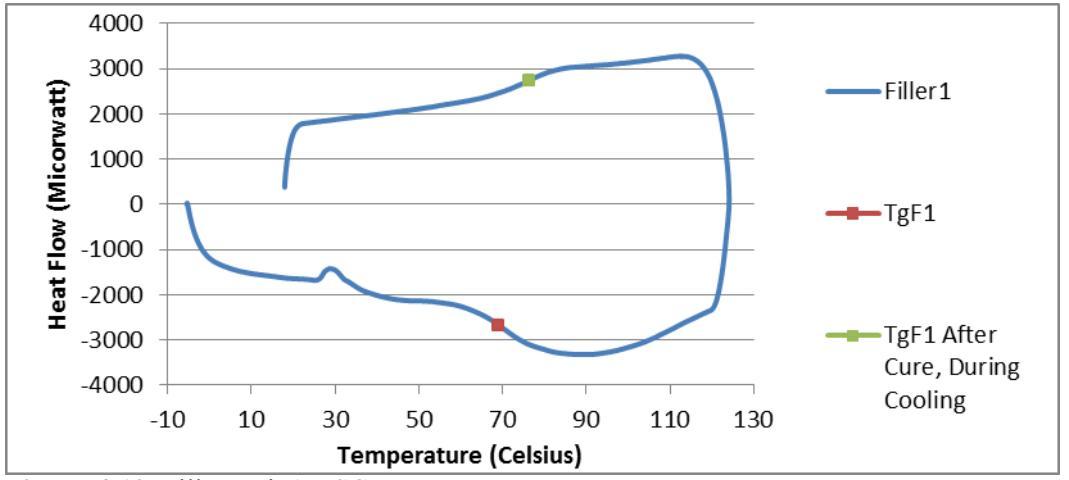
The first filler resin tested was Filler Resin1, which resulted in a DSC curve that had erratic behavior early in the test that was presumed to be irreversible behavior. The plot of this curve is in Figure 4.19.

Figure 4.19 Filler resin1 DSC curve

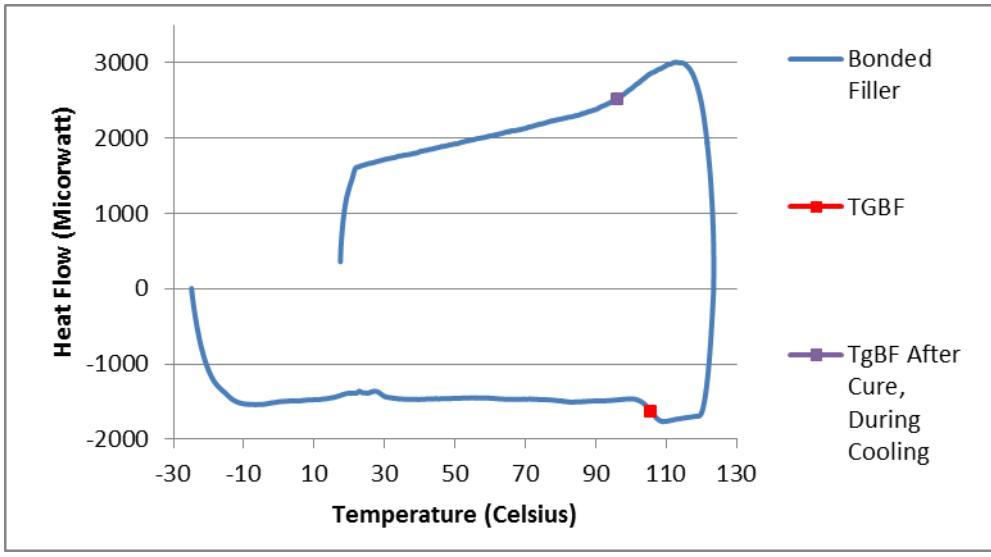
The Bonded Filler Resin specimen was prepared similar to the other Filler Resin Specimens, but resulted in significantly different behavior and a higher  $T_g$  value. The  $T_g$  values are tabulated below the plots of the Bonded Filler Resin and the plot of all three Filler Resins.

Figure 4.21 Bonded filler resin DSC curve

The response of the Bonded Filler Resin is somewhat peculiar. It is possible that the milky white filler resin had higher water content, acting as a plasticizer reducing the  $T_g$  of the Filler Resin1 and Filler Resin2 specimens. As previously mentioned, even though there was water in direct contact with the CFRP patch of Filler Resin1 and Filler Resin2, by the time the material was tested, the moisture content was likely the same for all the specimens and very similar to that of the environment. All filler resins likely had similar if not the same curing conditions, also making the higher  $T_g$  of the Bonded Filler Resin somewhat surprising.

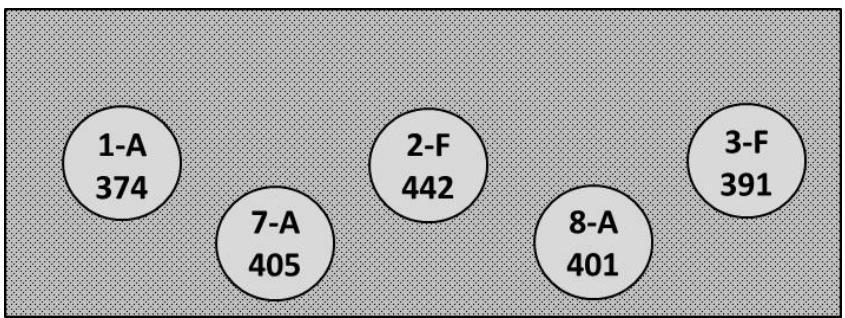
Figure 6.20 Block #1 Results

Out of the six pull-off tests performed, four showed a fully adhesive failure. As a result, four additional core circles were drilled, two for each block, with the purpose of performing four more pull-off tests for statistical validation. Tests 7 and 8 were performed on block #1. The same procedure was followed in the adhesion, including the sanding and cleaning of the surface and dollies. The Devcon high strength epoxy was applied on the dollies for adhesion and allowed to cure for 24 hours before testing. Even though strength was shown to be 405 psi (2.79 MPa) and 401 psi (2.76 MPa), failure still occurred in the adhesive layer.

The persistence of the adhesive failure modes was attributed to two main reasons. Twisting of the dolly during adhesion could have caused minor air voids in the dolly-CFRP interface, which decreased the suitability of the bond. The second possibility for adhesive failure could be the curing time of the Devcon epoxy. For all previous tests, the epoxy was allowed to cure for 24 hours, and failure Mode A was still showing. Therefore, tests 9 and 10 on block #2 were allowed to cure for five days to ensure that the epoxy was fully cured. For these last two tests, the dollies were not twisted, they were slowly placed on the surface as uniform pressure was applied for 30-90 seconds to avoid slippage. As a result, tests 9 and 10 showed strengths of 433 psi (2.98 MPa) and 439 psi (3.03 MPa), respectively, with acceptable Mode F failures. Figures 6.20 and 6.21 illustrate the strengths and failure modes of all the pull-off tests performed during stage zero. The notations on Figures 6.20 and 6.21 represent the test number, the ASTM D7522/D7522M failure mode letter, and the strength in psi. These results are also summarized in Table 6.6.

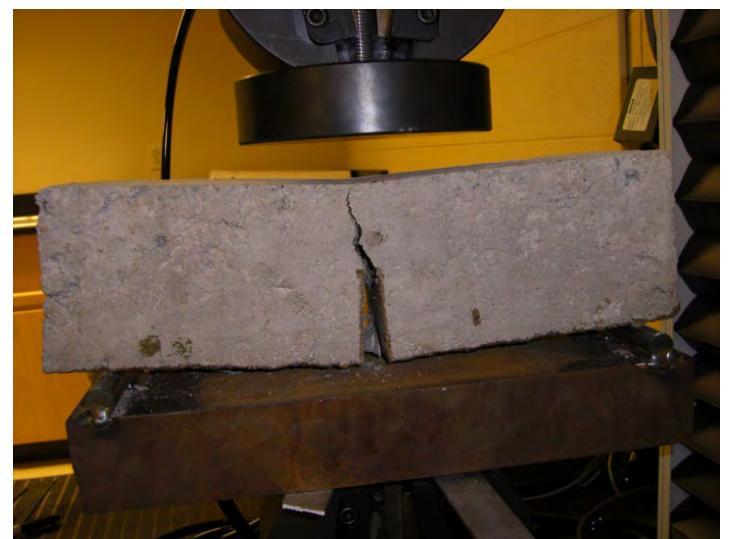
Stage 0 contained three small beams to be tested under three-point flexure. Due to an error with the testing machine, one specimen was prematurely damaged so the remaining two were used as the control specimens. As previously mentioned, a United Testing Machine Model SFM- 300 kN was used and the parameters recorded were time, force, and deflection as measured by the crosshead position. Figure 6.22 shows failure of one of the beams and how a single flexural crack was developed at the top of the saw cut, as desired.

Figure 6.22 Beam following crack failure

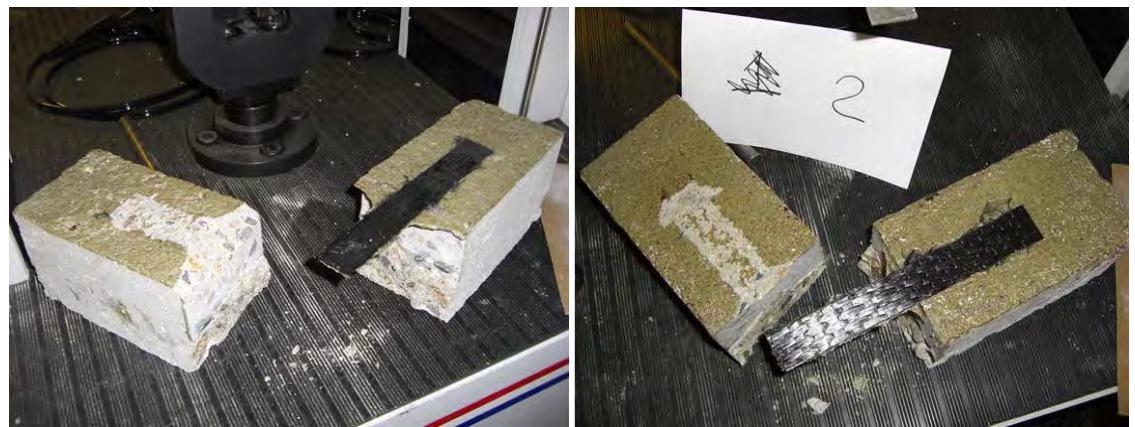
Both beams from this stage showed a fairly similar failure behavior, in which one side of the beam debonded before the other. However, the peak force witnessed on Beam 1 was considerably higher, 0.563 kips (2.50 kN) greater than for Beam 2. The larger force resisted by Beam 1 also resulted in a displacement of 0.029 in (0.74 mm) greater than for Beam 2. One possible reason for Beam 2 having a lower peak force is a weaker CFRP-concrete bond coming from the CFRP application. The darker spots on the failure surface for Beam 2 show that the CFRP did not completely adhere to the concrete substrate during application. Beam 1 contained little to no adhesive layer on top of the concrete surface after failure, which indicates that the CFRP was fully bonded to the concrete. Figure 6.23 shows the failure surfaces for both specimens, and it is noticeable how Beam 2 contained a significantly higher amount of adhesive on the concrete.

Figure 6.23 Beam 1 (left) and Beam 2 (right) following testing

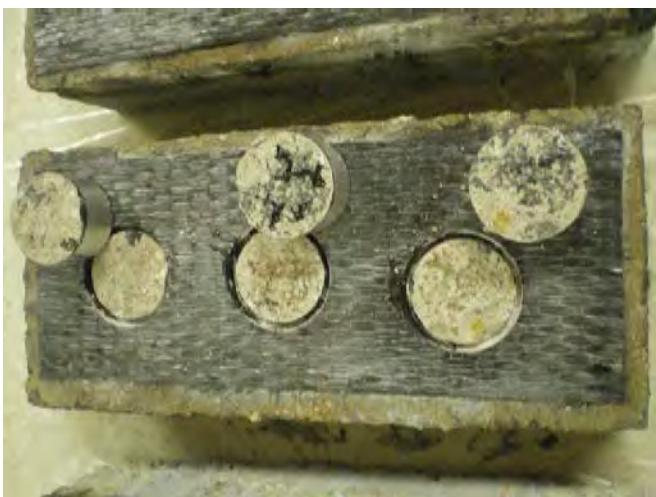
The most common failure was identified by Mode F, as labeled by ASTM D7522. Thirty-three of the 45 dollies tested showed this type of failure, in which a partial adhesive failure of the FRP-concrete interface, combined with a partial concrete failure, is seen. Figure 6.25 shows a typical failure Mode F encountered during testing. The figure illustrates how the CFRP did not fully adhere to the concrete, and it is noticeable by the black spots of CFRP that are still visible, especially on the middle dolly.

Figure 6.25 Mode F failures (ASTM D7522) during Stage 1 testing

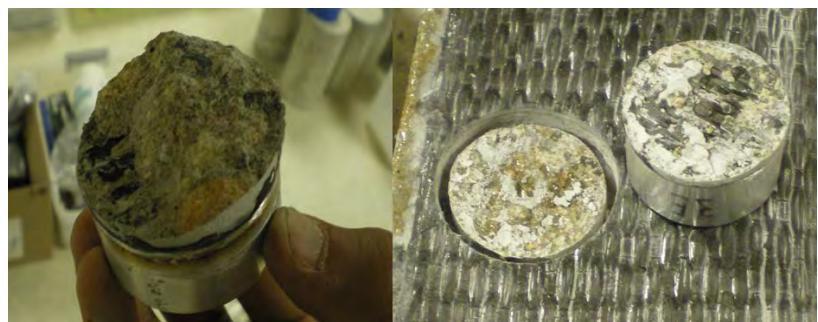
This particular pull-off was characterized as an ideal concrete failure, Mode G in ASTM D7522. It is believed that the reasons for the extremely large discrepancies among the specimens that underwent the

exact same conditioning is due to the large aggregate present on test 35, as well as the presence of moisture within the concrete-FRP interface on test 38. This moisture was noticed because of the lighter color of the concrete, as well as a softer and more clayey feel to the touch. Notice in Figure 6.26 the large aggregate on Test 35, as well as the lighter color and thinner layer of concrete on test 38.

Figure 6.26 Test 35 (left) vs. Test 38 (right)

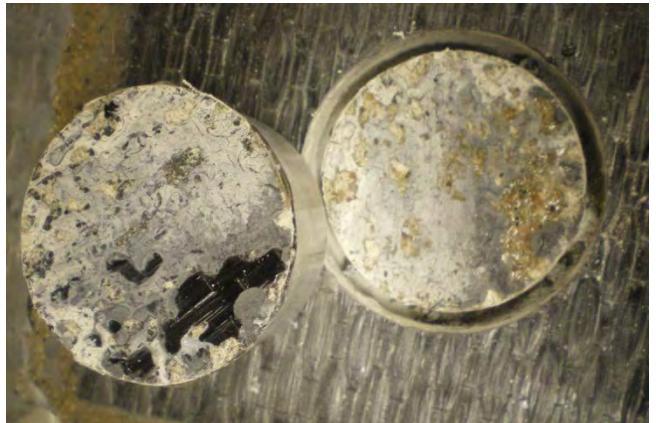
The second special case encountered during testing has some relation to test 38 above: the presence of moisture in the CFRP-concrete interface on Blocks #4, #9, and #13. This moisture was not present at the time of fabrication of specimens. Therefore, the deicing solution that these blocks were exposed to actually infiltrated into the bond either through the FRP or the concrete. This moisture was noticed in the specimens with different tonalities of gray in the concrete, as well as a softer, more clayey feel to the touch. It was determined that such moisture did decrease strength considerably. In the case of block #4 corresponding to wet-dry cycles, dollies #10, #11, and #12 showed moisture and did result in the ones with weaker strengths out of the whole group. In addition, dolly #16 from the non-chloride based deicer group showed a strength of 271 psi (1.868 MPa) lower than the remaining dollies in that group, and it was the only pull-off that exhibited levels of moisture within that group.

The same moisture level – strength relationship was witnessed in dollies #25, #26, and #27 (Block 9) within the non-chloride based deicer group, as well as dollies #33 from Block 11, and dollies #37 and #38 from Block 13. With these patterns identified, one can draw the conclusion that the presence of moisture does in fact reduce the pull-off strength. However, reasons why some dollies within the same group may or may not have exhibited moisture are unknown. A characteristic example of a dolly showing signs of moisture is illustrated in Figure 6.27.

Figure 6.27 Presence of moisture at CFRP-concrete interface

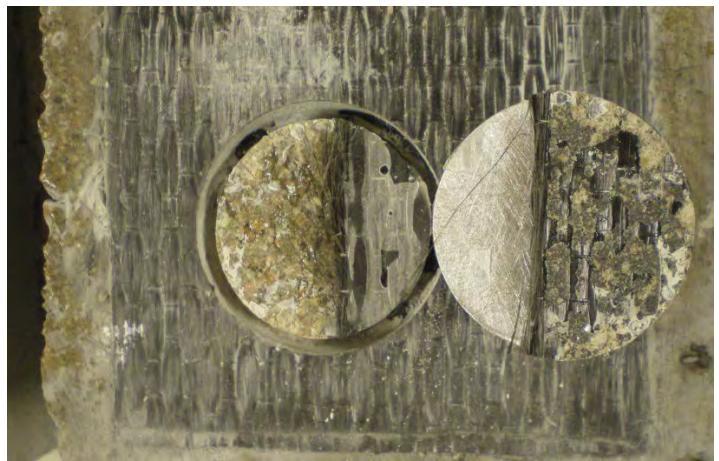
The last special case consisted of having a mixed failure mode between Mode A and Mode F. In this special case, the CFRP fibers may not have been fully saturated during application, causing separation of

the bundles. Figure 6.28 shows how half of the dolly completely detached from the concrete at an adhesive level on the dolly-FRP interface, whereas, the second half was seen as an adhesive failure on the concrete-FRP interface.

Figure 6.28 Combined Mode A and Mode F Failure

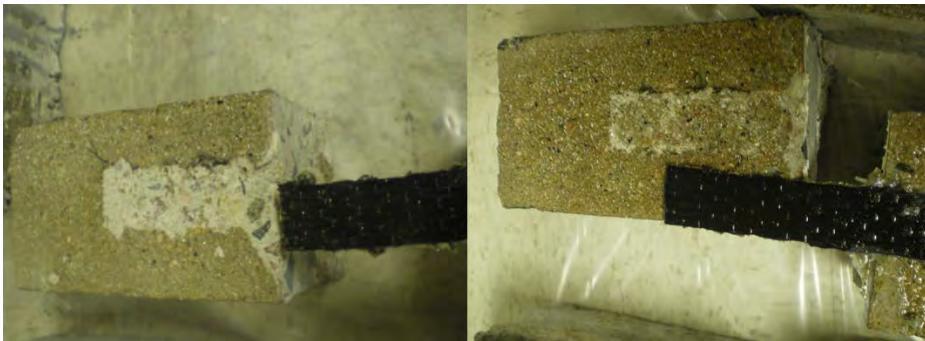
Two control specimens were kept at dry conditions and room temperature. From the 13 beams tested, these two possessed the highest peak load values at 4.242 kip (18.87 kN) and 3.843 kips (17.09 kN). The absolute lowest load experienced on the beams was identified on Beam #8, corresponding to immersion in non-chloride based deicer. Figure 6.29 below clearly demonstrates the major differences in the bond

between one of the control specimens (Beam #1) and Beam #8. The larger area of darker spots on the concrete surface where the CFRP failed was found noticeable. The dark spots correspond to the cured epoxy adhesive that did not fully bond with the CFRP strip. Although it is possible that the non-chloride deicer may have contributed to degradation of the bond, the other potential cause for this behavior is improper adhesion of the CFRP onto the concrete during preparation.

Figure 6.29 Beam #1 (left) vs. Beam #8 (right) failure

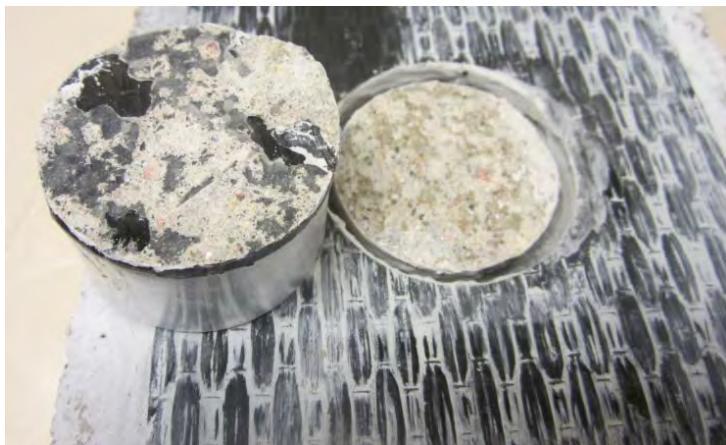
Once again, the most common failure type corresponds to Mode F. Thirty-two of the 45 pull-off tests resulted in this failure mode, equivalent to 71% of the total. Figure 6.30 shows a representative failure for these 32 dollies. The black spots on the dolly correspond to sections where the CFRP did not fully adhere to the concrete, followed by partial concrete detachment within the same dolly.

Figure 6.30 Representative Mode F failure for Stage 2

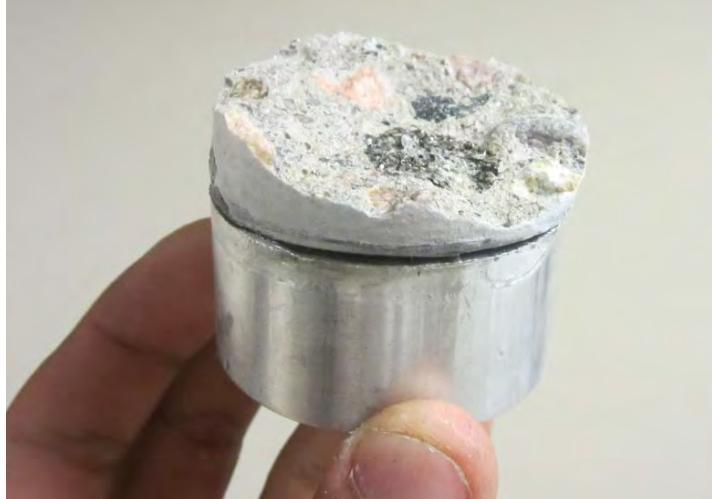
Four blocks were exposed to a non-chloride based deicer, equivalent to a total of 12 pull-off tests. Two of these blocks were reinforced with two layers of CFRP, and the remaining two blocks with three layers of CFRP. Failure modes varied from Mode A in three pull-offs, Mode F in eight dollies, and the last one corresponded to an ideal Mode G failure. Figure 6.31 shows the Mode G failure that was witnessed on dolly #20 from this stage, corresponding to one of the blocks reinforced with two layers of CFRP.

Figure 6.31 Mode G Failure in Dolly #20

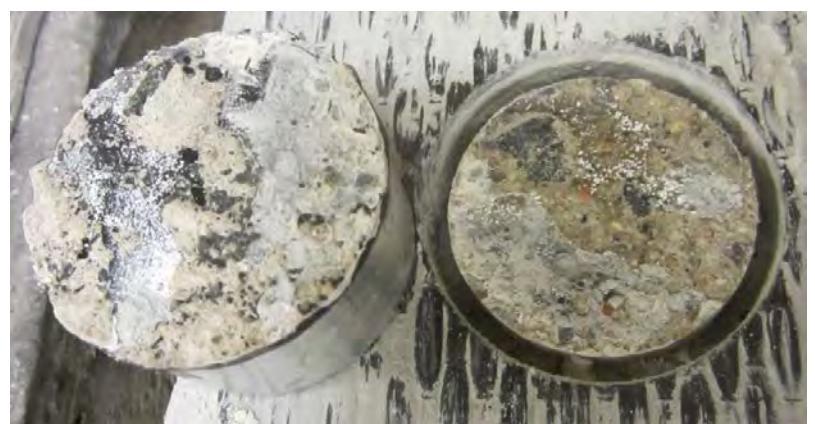
In this stage, the presence of moisture in some of the dollies was also witnessed. Two of the dollies within the water exposure group, three within the wet-dry cycle group, three within the non-chloride based deicer group, and nine within the chloride-based deicer group, were the specimens that showed moisture between the concrete and FRP. Once again, the different tonalities of gray as well as a softer more clayey feel to the touch helped identify which dollies showed levels of moisture. The amount of moisture ranged from very small spots around the edges to larger areas within the dolly. Figure 6.32 shows a characteristic image of the presence of moisture in the specimens. As far as moisture – strength relationship in the water group, no logical pattern was found. In fact, dollies #8 and #9 resulted in the highest bond strength in the group, even though these were the ones that showed some moisture within the group. However, dollies #25, #26, and #27 did turn out to be weakest ones within the non-chloride based deicer group. For the chloride-based deicer group, the moisture-strength relationship makes sense in the double-layer reinforcement ones, where dollies #28, #29, #32, and #33 showed the lowest strengths as opposed to the drier ones. These patterns, however, are difficult to interpret, as the moisture was not present within individual blocks, but rather within individual dollies.

Figure 6.32 Presence of moisture on Dollies

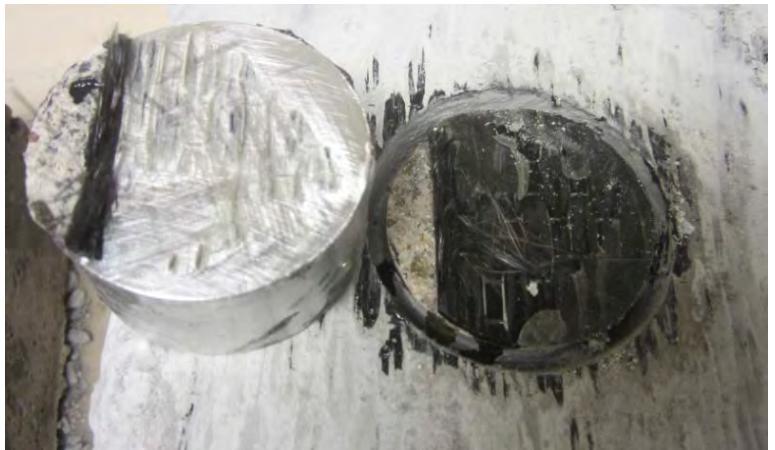
Finally, the special case in which a combined Mode A and Mode G failure was witnessed in dolly #31 from Stage 1, was also seen in Stage 2 in dolly #42. Figure 6.33 shows dolly #42 with this particular failure. The cause may have been once again due to improper adhesion of the fabric, causing separation of the bundles, or due to a weak pattern of concrete on one side.

Figure 6.33 Combined Mode A and Mode F failure in Dolly #42

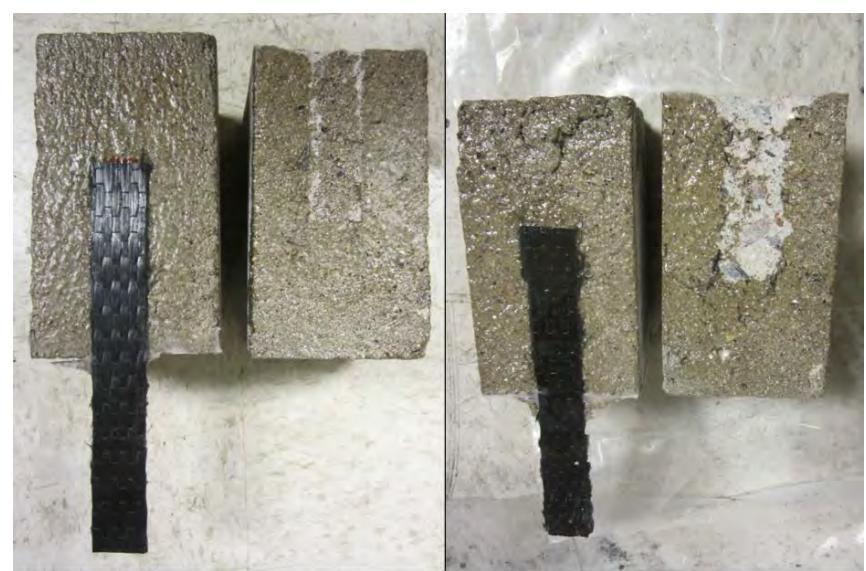
Figure 6.34 Beam #6 (left) vs. Beam #1 (right)
