### Long Term Monitoring of Mechanical Properties of FRP Repair Materials

Rebecca A. Atadero, Assistant Professor Douglas G. Allen, Graduate Research Assistant Oscar R. Mata, Graduate Research Assistant Department of Civil & Environmental Engineering Colorado State University Fort Collins, CO

Mountain-Plains Consortium and Colorado Department of Transportation DTD Applied Research and Innovation Branch Denver, CO

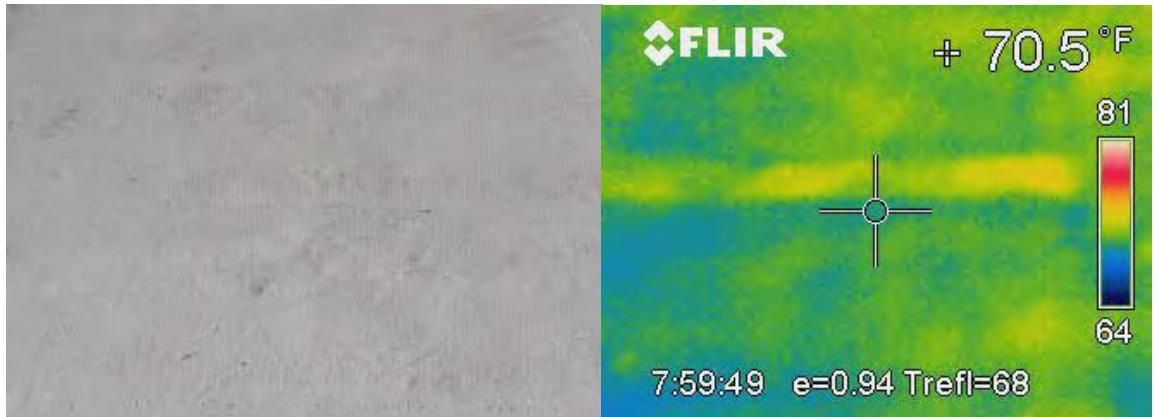
Figure A12. Photograph and thermal image of a seam in the CFRP sheets, no void present

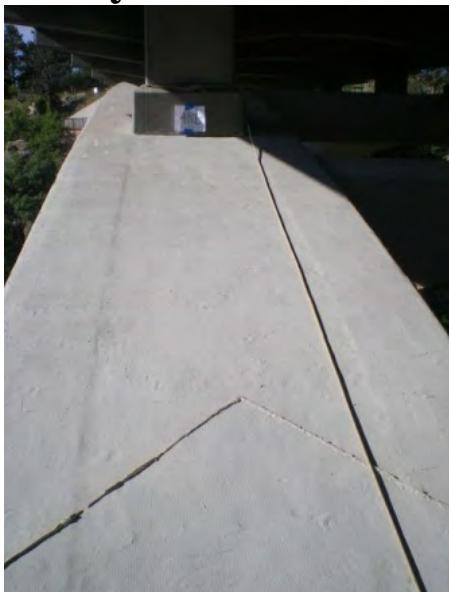
# Bay 4NE: 1 Void

Figure A13. Bay 4NE, V-shaped silicone bead water diverter

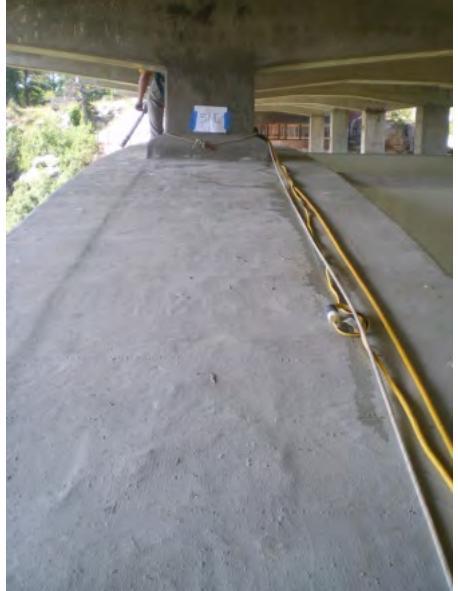
Figure A14. Bay 5NE

# **Bay 5NE: No Defects Found**

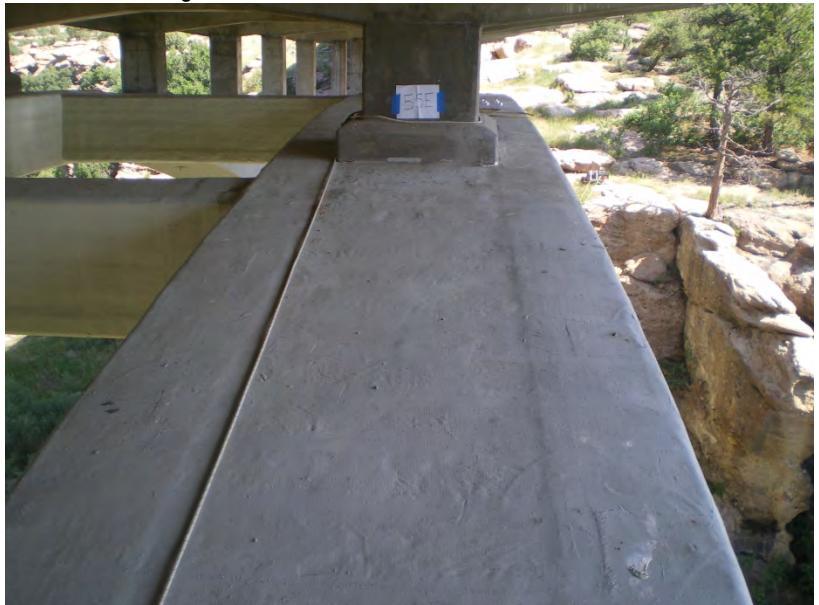
Figure A15. Bay 5SE

# **Bay 5SE: No Defects Found**

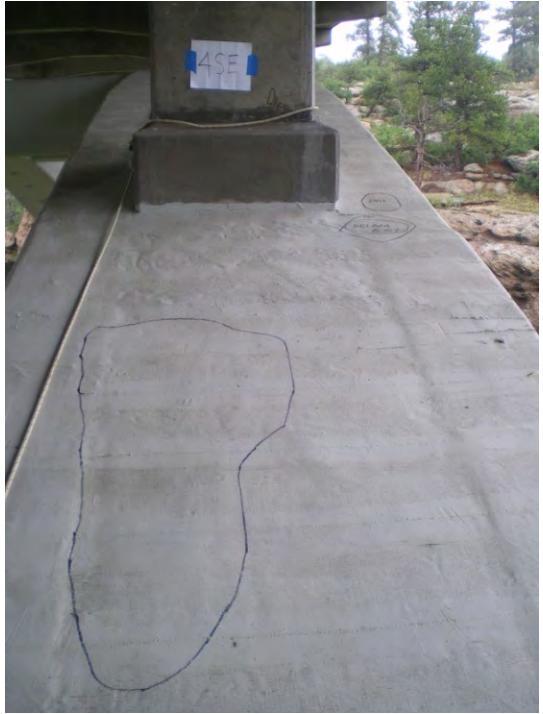
Figure A16. Bay 4SE

# Bay 4SE: 3 Voids, 1 Was Identified in 2007

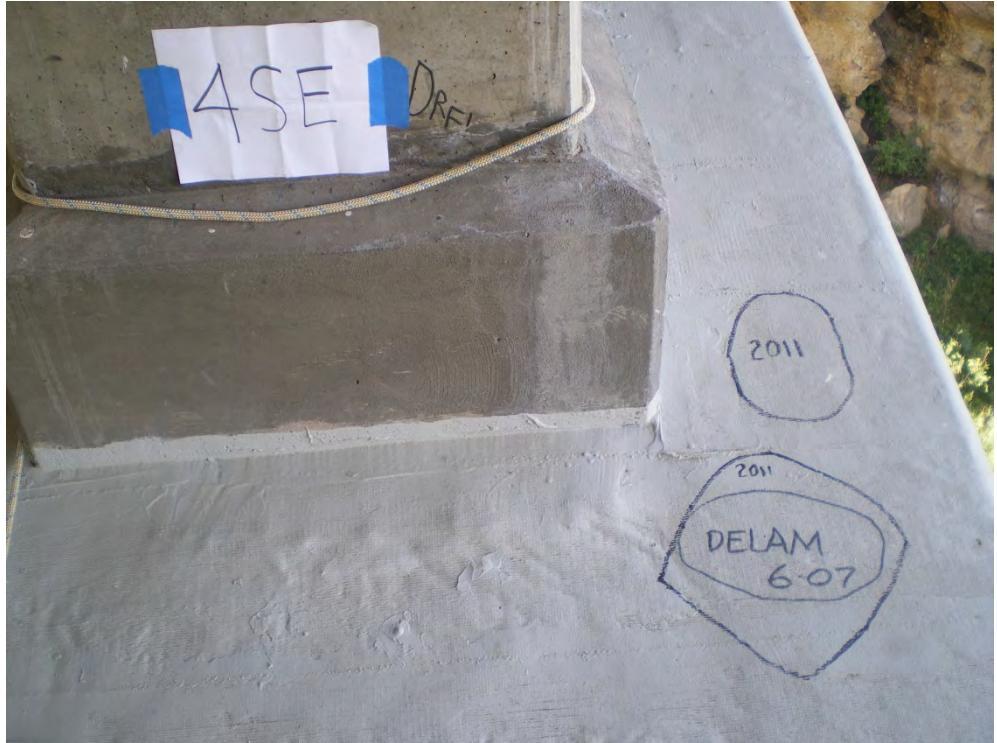
Figure A17. Void from 2007 has grown and a new void developed

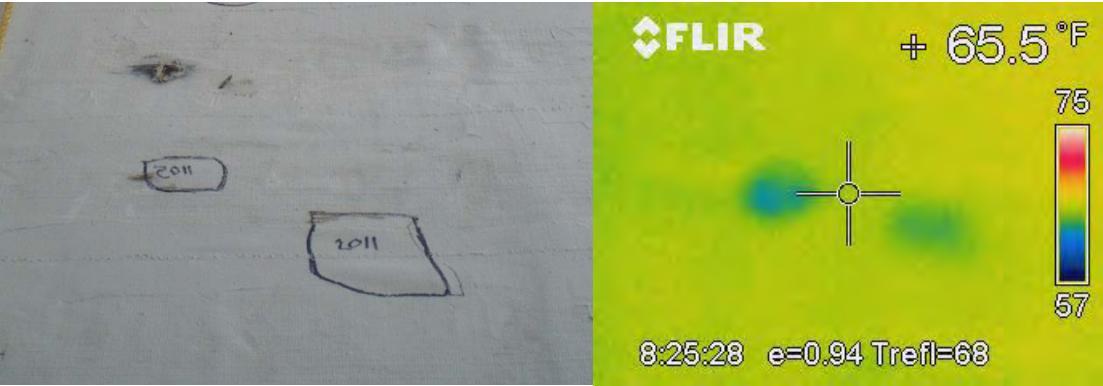
Figure A21. Photograph and thermal image of two voids

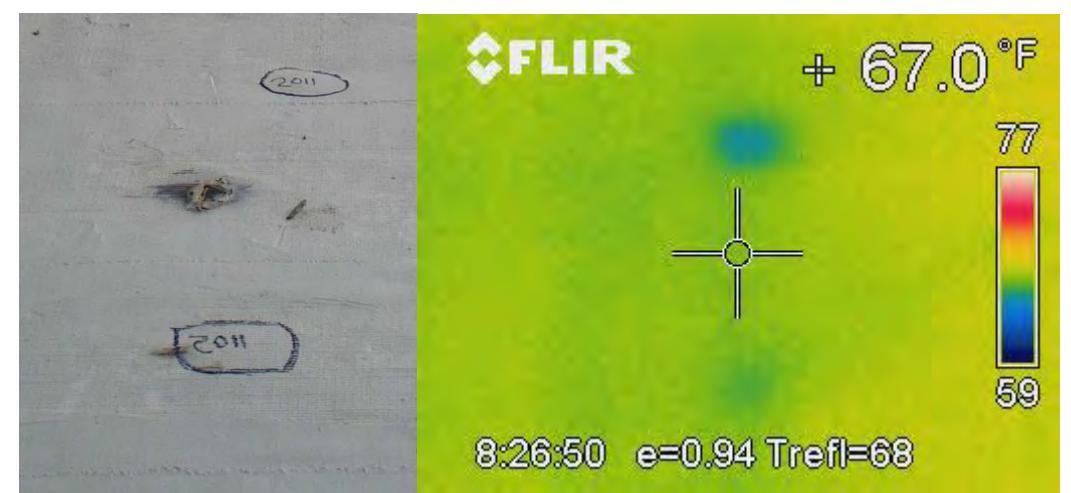
**Figure A22.** Photograph and thermal image of two voids, the black color in the photograph is left over strain gauges from the work done by Colorado University of Boulder

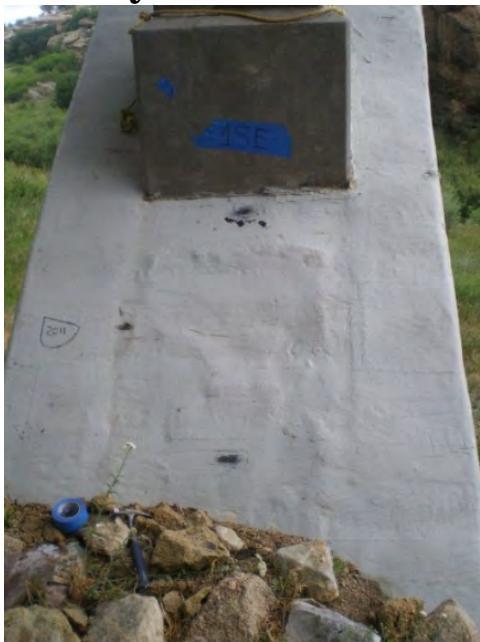
Figure A23. Bay 1SE, 1 void

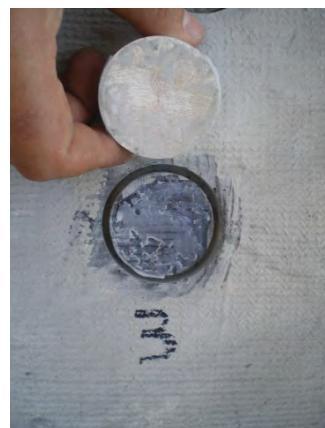
Figure B3. Test No.3, Photograph of Test No.4 is not available

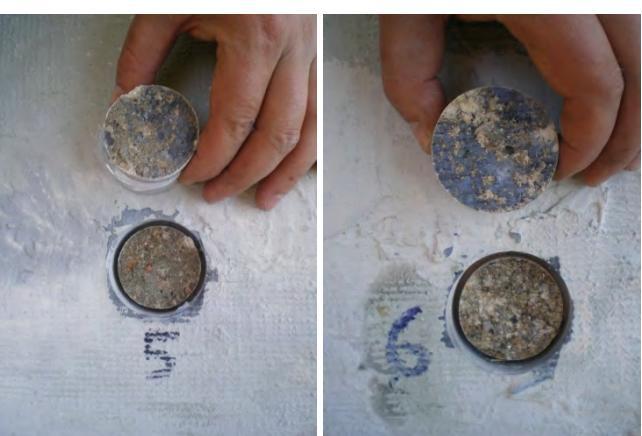
Figures B4 and B5. Test No.5, note puck slid off of center while epoxy was setting, and Test No. 6

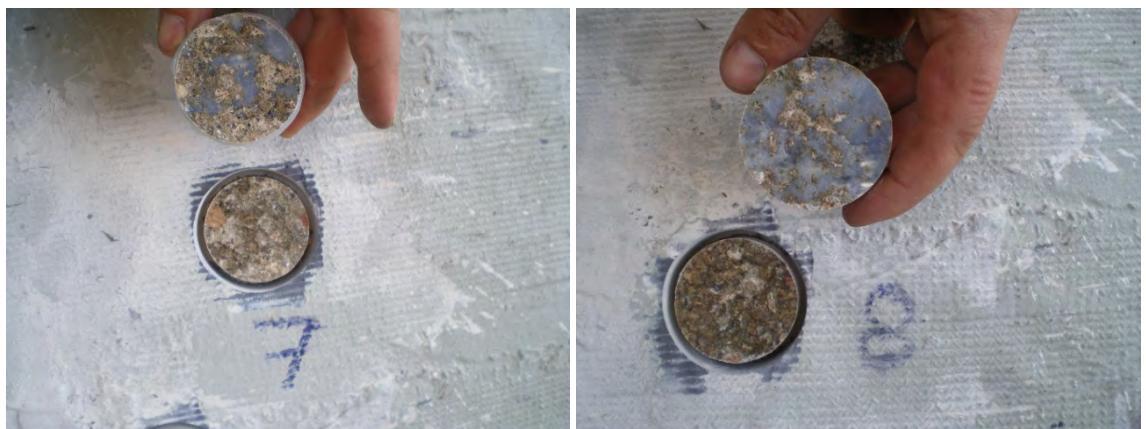
Figures B6 and B7. Test No.7 and Test No.8, weak bond strength

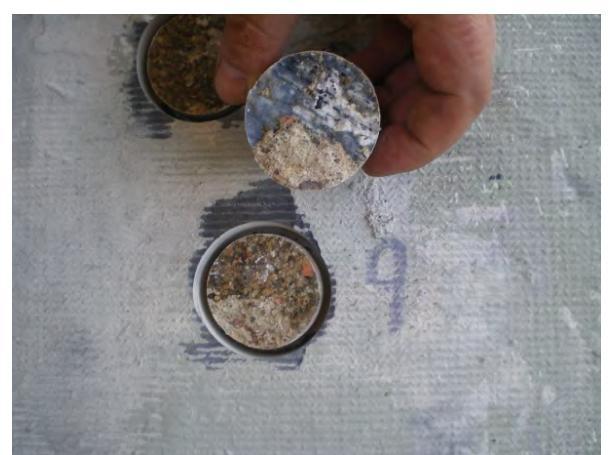
Figure B8. Test No.9, weak bond strength

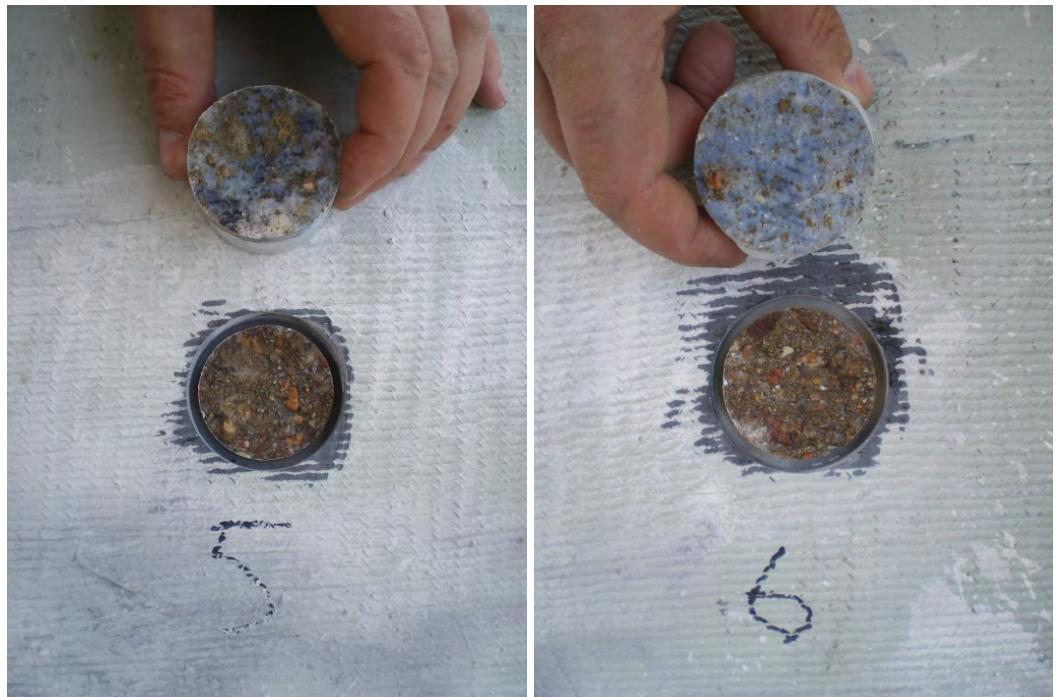
Figures B12 and B13. Test No.14, weak bond strength, and Test No.15, weak bond strength Test No.16 Not available, puck had faulty threads

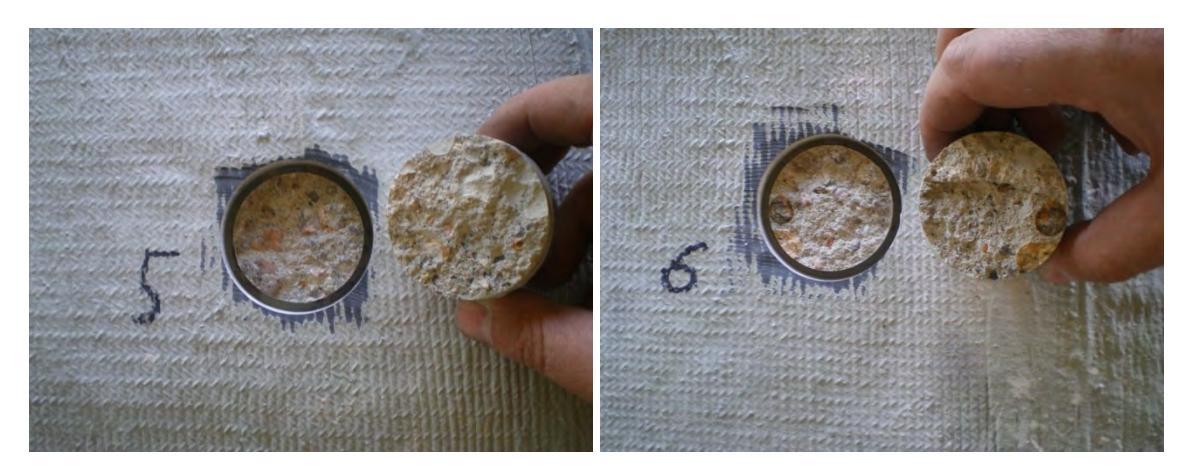
Figures B20 and B21. Test No.23, weak bond strength (poorly mixed concrete?), and Test No.24

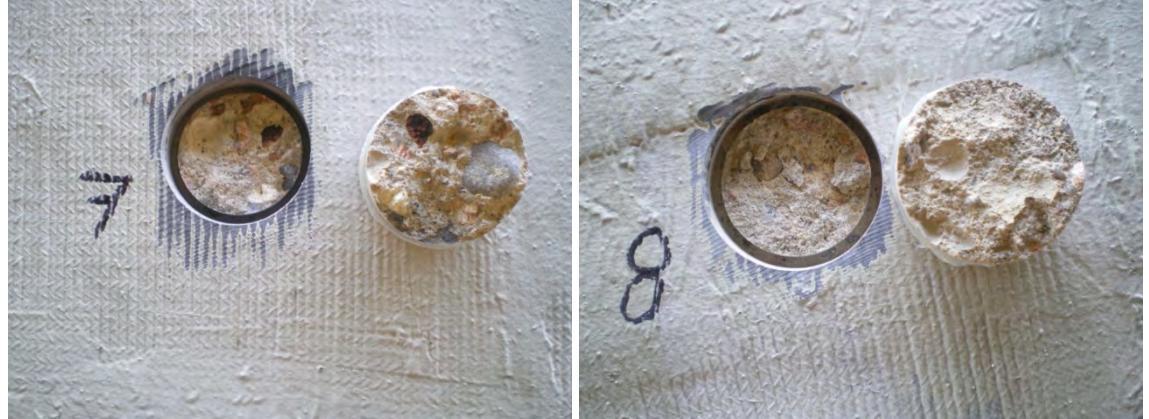
Figures B22 and B23. Test No.25 and Test No.26, note very weak bond strength (poorly mixed concrete?)
