MPC 19-404 | P. Romero, S. Bao, and D. Sudbury

Evaluation of the Durability of Thin Lift Surface Treatments

Department of Civil and Environmental Engineering The University of Utah Salt Lake City, Utah

November 2019

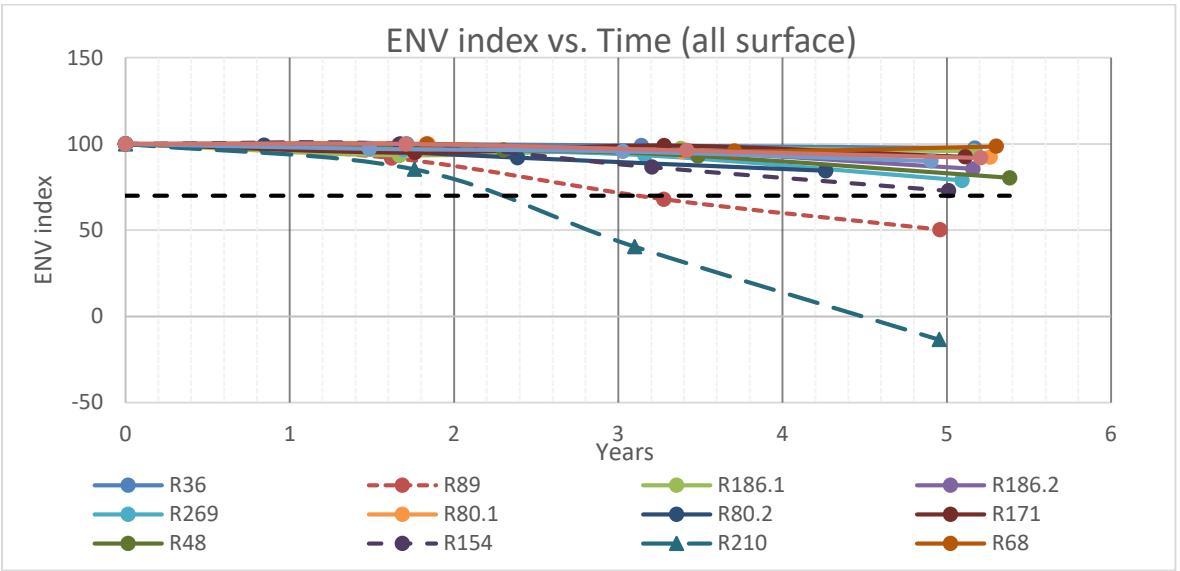
Figure 5.1 ENV Index Summary Plot

The ENV index summary plot shows the expected decreasing trend at an increasing rate for most TLT sections. SR-210 and SR-89 failed at year two and three, respectively. The remaining TLTs surfaces have an estimated life that ranges from six to 11 years. Half of the TLT sections had more LNWP cracks in comparison to other distresses; this is a common problem due to low density at the pavement surface joint. The other half of the TLT sections had significant transverse cracks caused by the low temperature environmental condition. Most of the TLT surface treatments followed the expected life predictions, with the exception of SR-210 and SR-89.

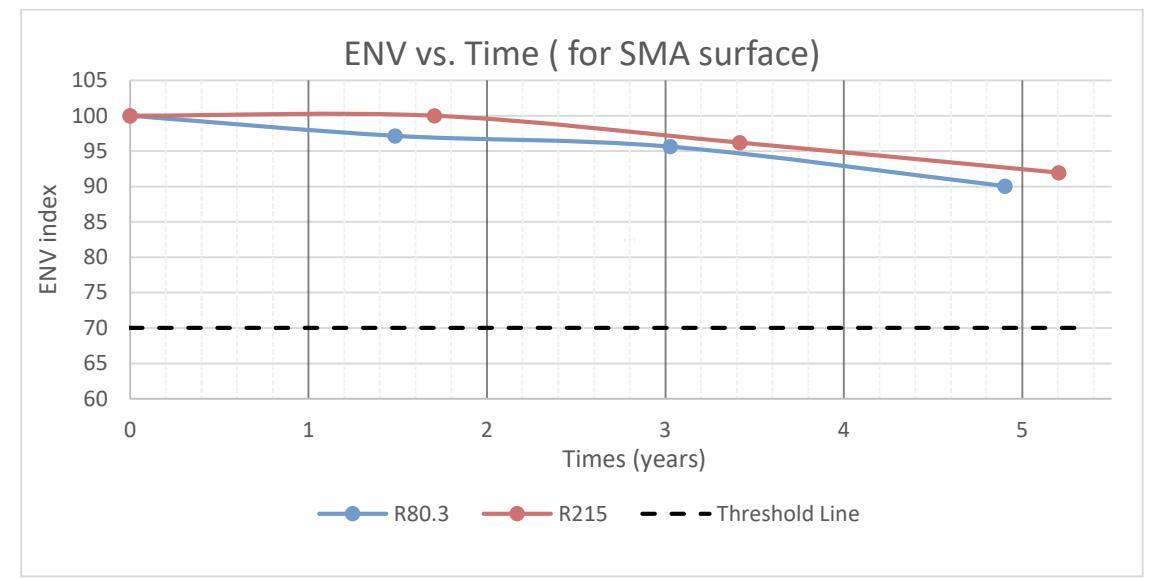
Figure 5.4 SMA TLTs ENV Plot

The SMA treatment consisted of only two sections, I-215 and I-80.3. As shown in Figure 5.4, both SMA sections have a high ENV index. After five years, both sections still have a value above 90. The extended trend line shows the estimated lifetime for I-215 as ten years and for I-80.3 as 11 years. On average, the lifetime is estimated as ten years for the SMA surface treatment.

While only based on two surface sections, the SMA shows good performance. The evaluation of SMAs resulting in higher condition indices on both ENV and WP. Since the deterioration rate of SMA is still not in the secondary stage, the life estimate is not reliable. Nevertheless, based on all the limitations cited, the estimated lifetime of the SMA thin lift treatment is shown in Table 5-4.

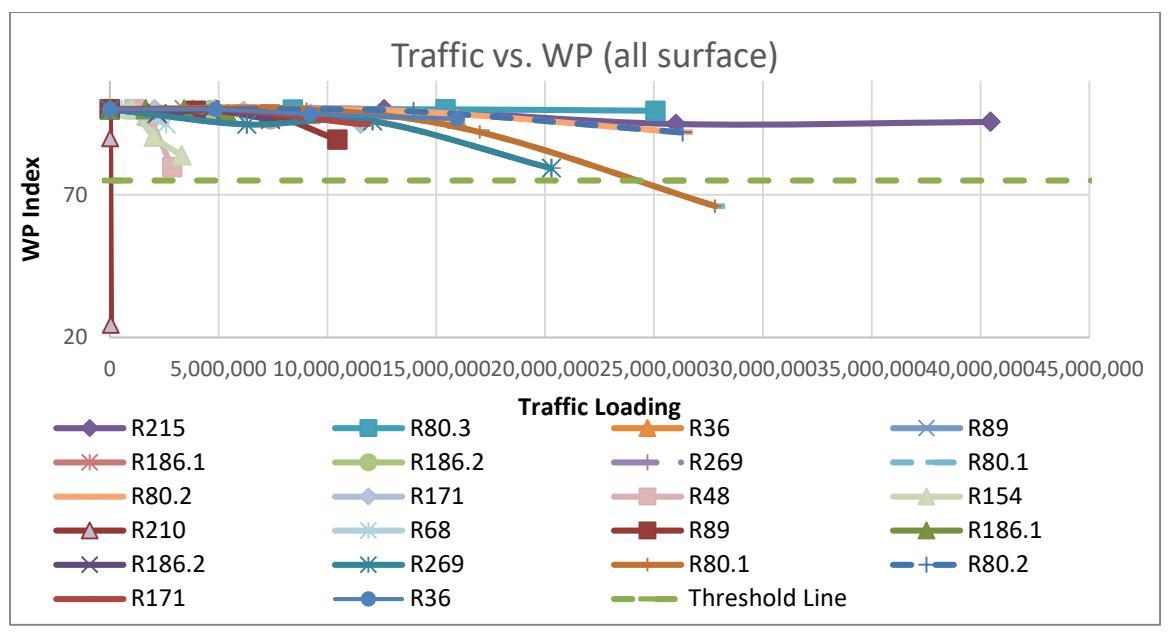
Figure 5.5 WP Index Summary Plot

The total WP index value versus traffic loading counts for all 14 TLT treatment sections in each observation year were plotted. In general, the results follow the expected curve of the pavement performance versus traffic loading. This is shown in Figure 5.5.

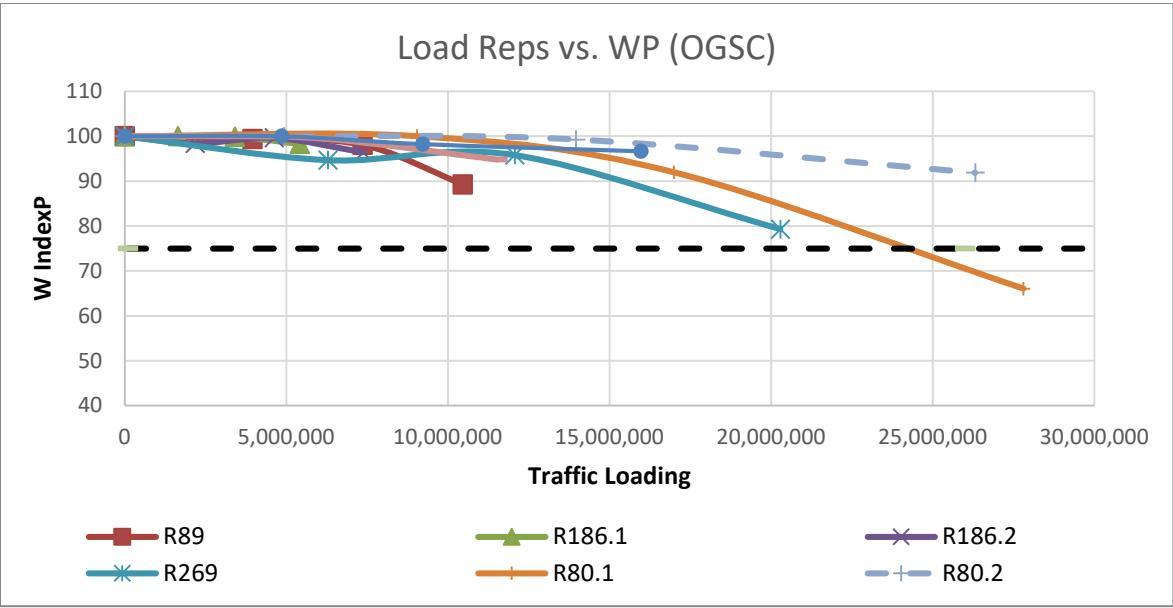
Figure 5.6 OGSC WP Index Plot

The Open Graded Surface Coarse (OGSC) treatment consisted of eight surface sections. A majority of the OGSC surface treatments followed the general trend of decreasing performance as the rate for traffic load increased. Other studies have determined that the life expectancy of an OGSC pavement under the designed condition to be between eight and 12 years. Based on the current daily traffic amount and growth rate, the estimated life for the OGSC surface treatment in Utah is about 8.5 years. Figure 5.6 shows this information.

The estimated lifetime for the OGSC thin lift treatments is shown in Table 5.5. By extending the data point line, the cross point of the threshold line and the trend line is the estimated lifetime, and the estimated traffic loading is calculated for all sections. The estimated life expectancy for the OGSC surface based on the WP evaluation analysis is about 8.5 years on average. This value is lower than the ENV index estimation result.

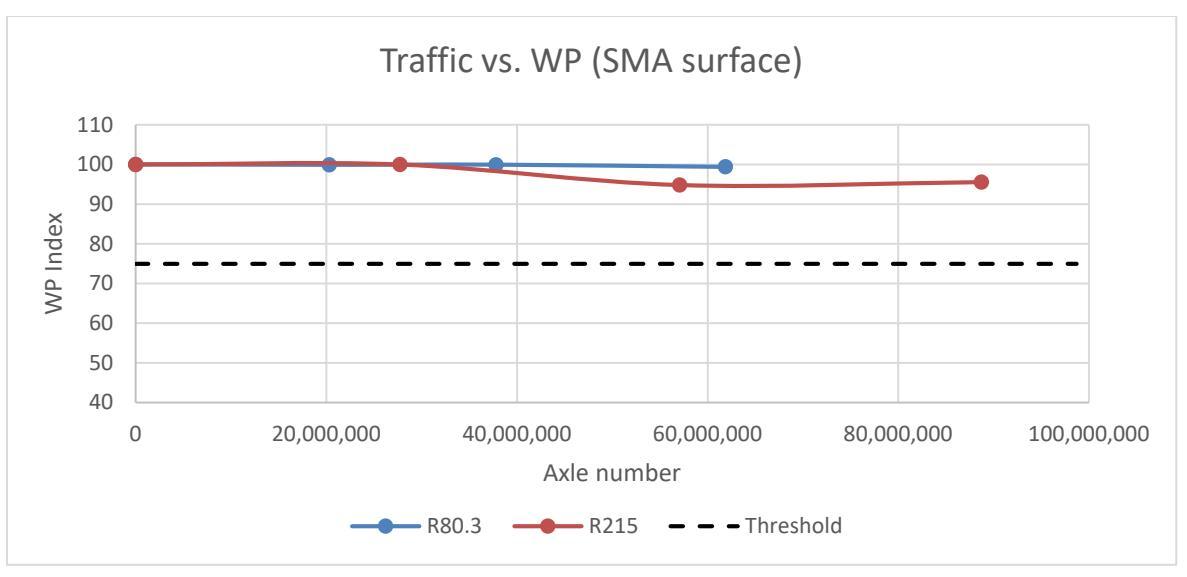
Figure 5.8 SMA WP Index Plot

The stone matrix asphalt (SMA) has the best performance among the three types of surface treatments studied. The plot shows the high quality of the SMA for the WP index evaluation after five years of use. Even though there were only two routes that were resurfaced with the SMA treatment, the data, shown in Figure 5.8, shows excellent performance results.

The SMA surface shows no WP index drop during the five years of this study. Both of the treated surfaces have a final WP index higher than 95 and no obvious decreasing trend or WP distress in spite of the high traffic volume. SR-215 has the highest traffic loading of all of 14 TLT sections, with 40 million load repetitions on it, yet the wheel path shows no serious damage. SR-80.3 has the second highest traffic load repetitions, and it has a WP index of 99, the best performance evaluation on the WP index. This results in an estimated lifetime of 13.5 years as shown on Table 5.7.

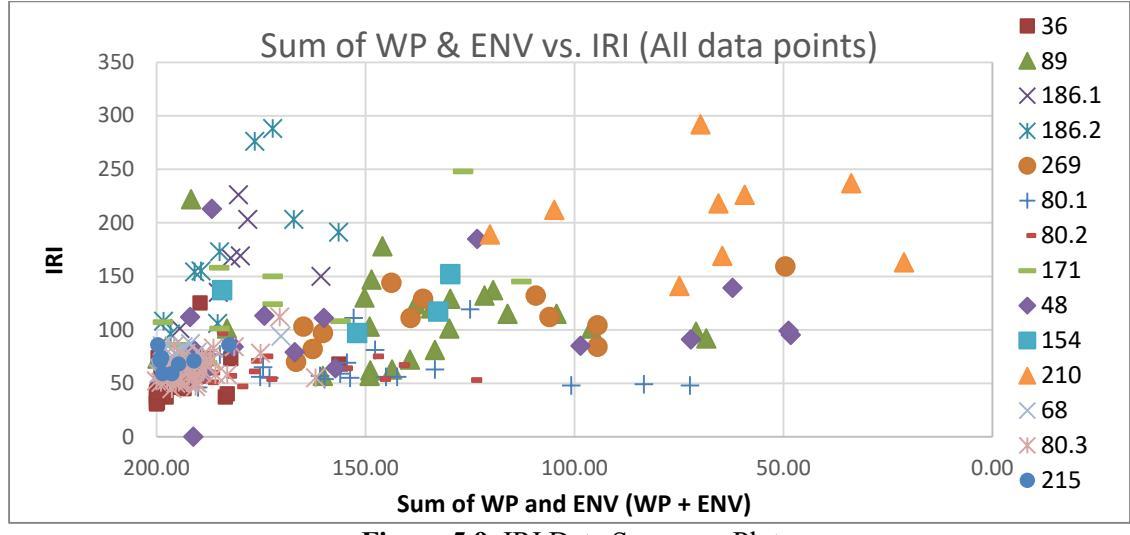
Figure 5.9 IRI Data Summary Plot

Figure 5.9 shows the relationship between the IRI and the sum of WP + ENV. The IRI value was expected to increase when the amount of distress increased, and the total distresses should be the total number of ENV and WP. However, as can be seen, there is not a clear trend. Different TLT sections behaved differently, with no obvious trend or rule that could be found from this plot.

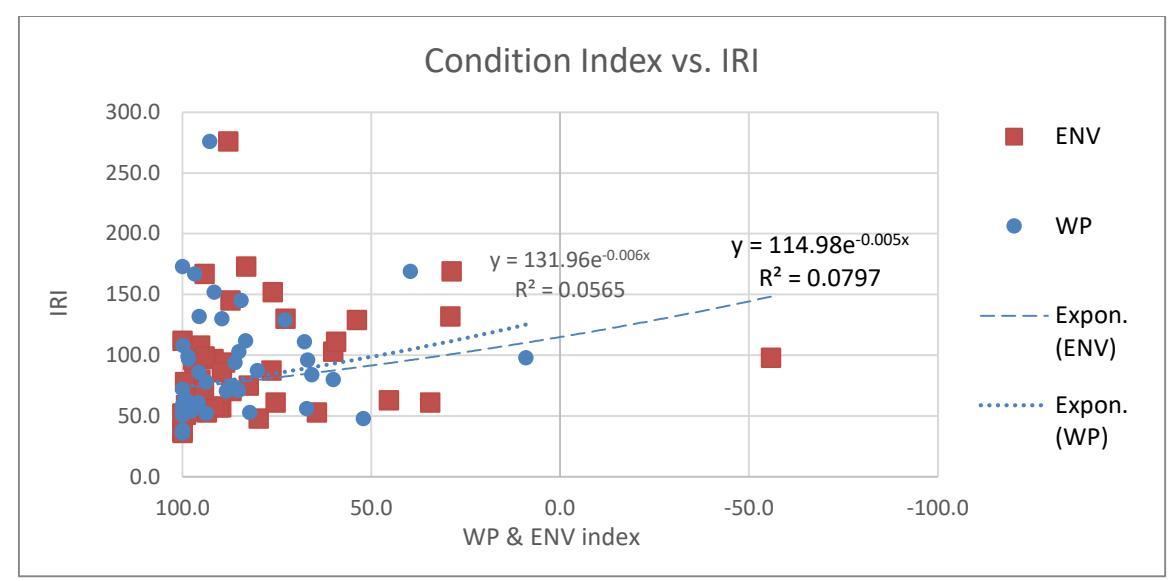
Figure 5.10 TLTs' IRI Data Plot

The correlation coefficient (R^2) between the IRI and the Surface Condition Index was determined for WP, ENV, and ENV+WP. As shown in Figure 5-10, the correlation coefficient is below 0.08, which indicates that the IRI does not account for or capture the effect of all distresses. For example, cracking is counted based on width, so unless faulting were to occur, such distresses would not make a significant difference in the IRI. The large spread area and high concentration of points on the good condition side does not establish a relationship function for the IRI and the condition index, so the surface condition indices may not relate to the IRI. In other words, contrary to what some previous research has reported, one value cannot be used as a predictor of the other or as an alternative to the other.

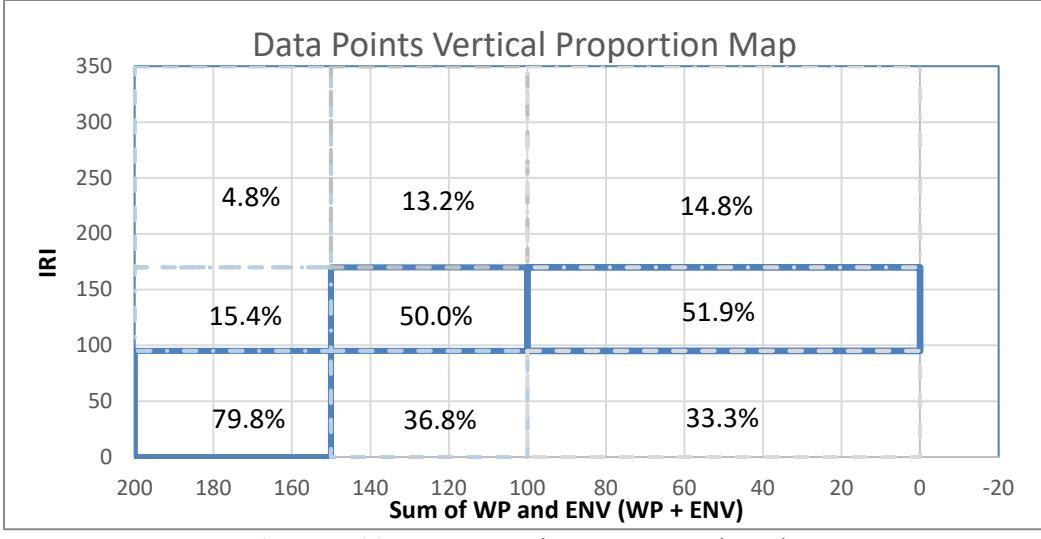
Figure 5.11 IRI Data Points Concentration Plot

The IRI data points proportion was calculated based on each condition level. In the "Good" condition WP+ENV is greater than 150, and 79.8% of the sections have an IRI less than 100; in other words, it can be said that a section with WP+ENV > 150 has an 80 percent change of being smooth (IRI < 100). When the WP+ENV is between 150 and 100, 50% of the sections have an IRI between 95 and 170, which falls into the "Failed" category; in other words, if the WP+ENV is less than 150 but greater than 100 there is a 50% probability that the IRI is between 95 and 170. Finally, if the WP+ENV is less than 100, 67% of the sections will have an IRI greater than 100 and only about 33% of the sections have the IRI less than 95. While this does not necessarily represent causation, it would be expected that those sections having a high WP+ENV index (i.e., have few distresses) will have lower roughness. This is shown graphically on Figure 5.11.

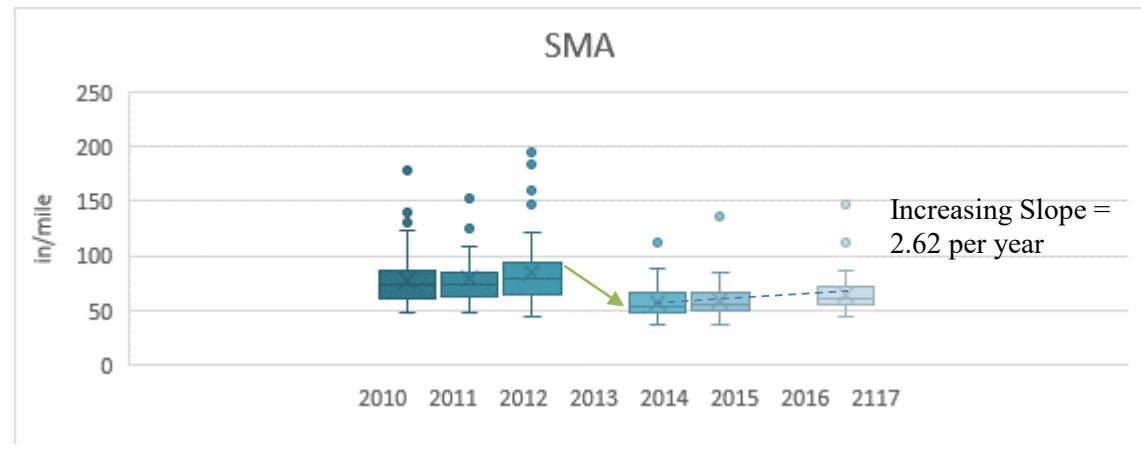
The IRI plot of the SMA treatment, Figure 5.12, shows the clearest trend. It shows an increase in IRI with time (2010-2012) then a drop after the treatment (2012-2013) followed by a small increase in the IRI of 2.62 in/mile per year with time (2014-2017). SMA TLTs were only used on two roads, which led to a small data set, so no significant conclusions can be made.

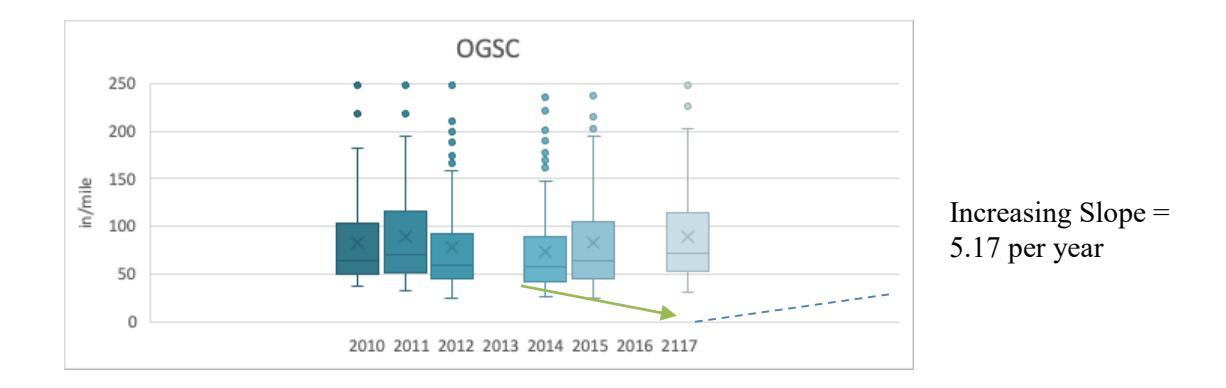
The OGSC surface has a larger data set when compared to the other two treatments. As shown in Figure 5.13, the surface conditions of all of the OGSC sections have a lower IRI on both average and data range after they received the TLT in 2012, but less concentrated data points indicate the large variability of OGSC IRI data. Also, a constantly increasing trend of OGSC roughness index of 5.17 in/mile per year is found from 2014 to 2017.

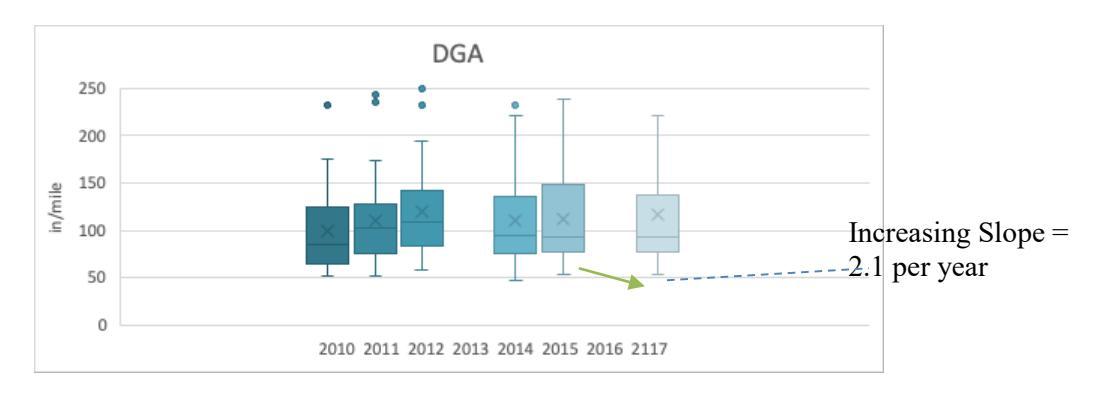
Figure 5.14 DGA IRI Box Plot

As seen in Figure 5.14, the DGA IRI has the highest value out of the three TLT results, starting above 100 after the treatment. The DGA surface also shows more improvement from the treatment as reflected by a drop in its IRI index from 2012 to 2014. The roughness number increased from 2014 to 2017 at a rate of 2.1 in/mile per year, which is less than the other treatment; however, the IRI values are, as a whole, higher than other surfaces.

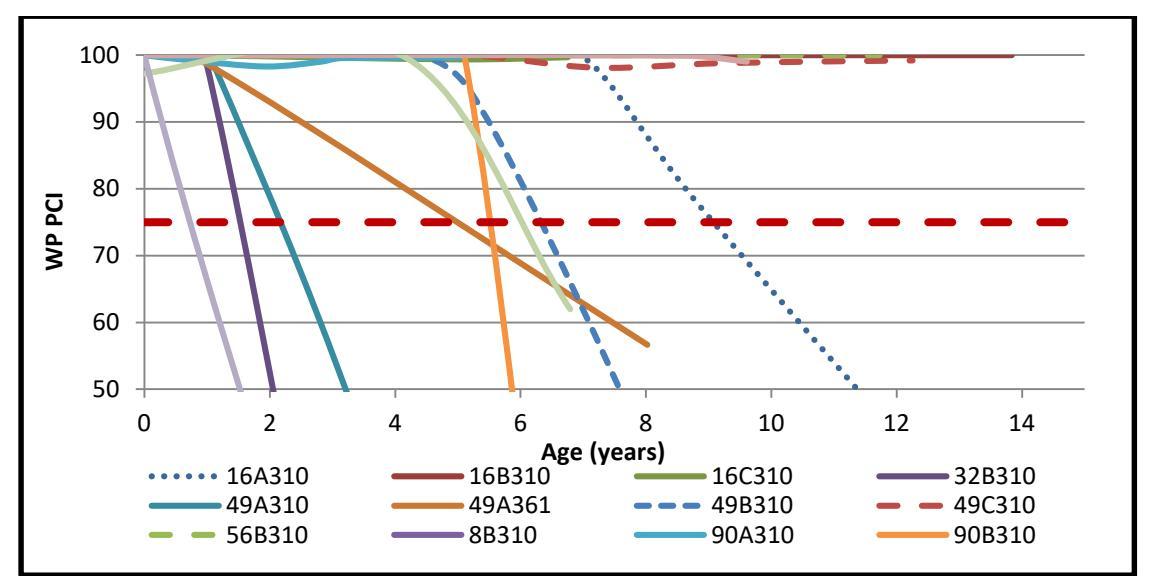
Figure 6.1 Wheel path pavement condition index with failure line

Out of the 16 sections, seven appear to be failing for WP cracking. Figure 6-2, the ENV index versus age, shows some interesting behavior in the measurement of the ENV index for the sections. For instance, on section 8B310 the ENV index dips below 70 after one year and picks back up to 76 half a year later. Other sections that experienced this same behavior were 90A310, 8A310, and 49B310. This could possibly be attributed to the evaluators rating the distress types differently over the survey time period or to the self-healing of thermal distresses. Self-healing is the closure of cracks due to the liquid behavior of asphalt, which increases at higher temperatures (Little and Bhasin 2007). Out of the 16 sections, ten appear to be failing for ENV distresses. This high number may be an indication of the Marshall Mix design method not considering temperature effects in binder selection.

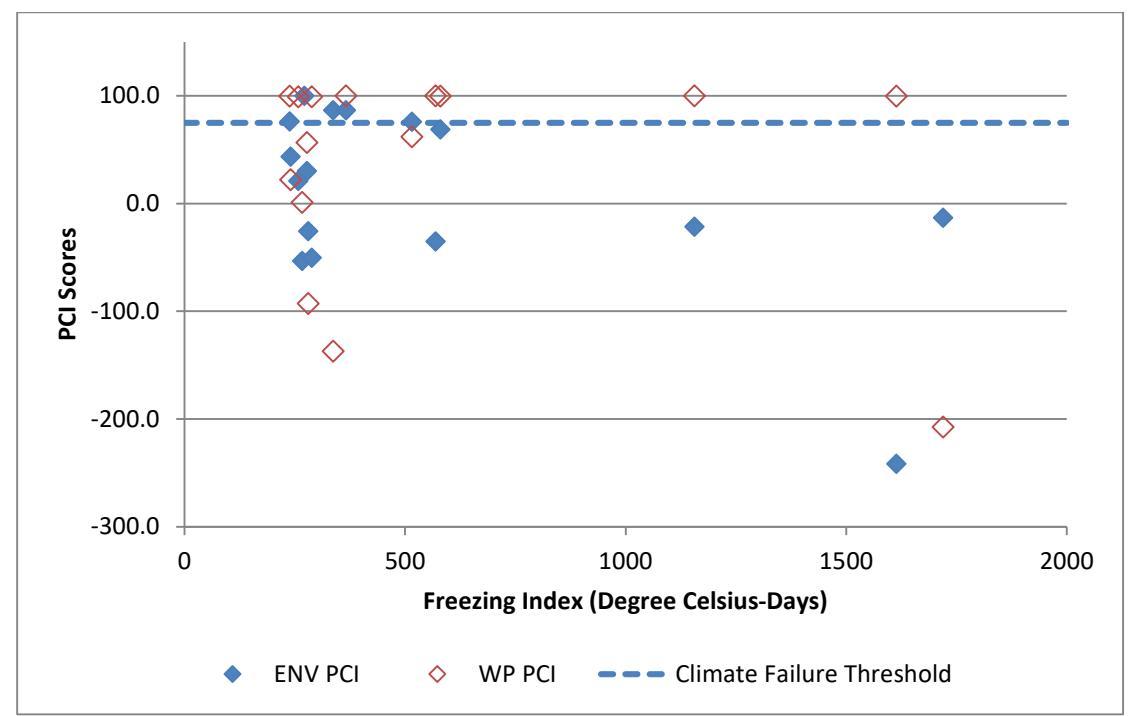
Figure 1.3 LTPP pavement condition indices and freezing index

The effect that temperate and climate had on the overlay treatments was substantial. Obviously, colder climates will exacerbate distress formation. In order to show this, the ENV and WP indices for each route were plotted in Figure 6-3 against the annual freezing index for these sections. The freezing index, as defined by the National Snow and Ice Data Center, is the total annual cumulative number of days when temperatures are below zero degrees Celsius. Figure 6-3 indicates a general downward trend in the ENV index scores as the freezing index increases. For the WP index, this trend is not indicated as the data is more scattered. However, as ENV cracking increases, it is expected that WP cracking will increase proportionately. This is primarily due to increased water ingress into the pavement and subsequent structural damage to the supporting layers.
