# NTSB TRB Truck and Bus Update

Robert Molloy, PhD

January 8, 2025

# Pittsburgh Bridge Collapse

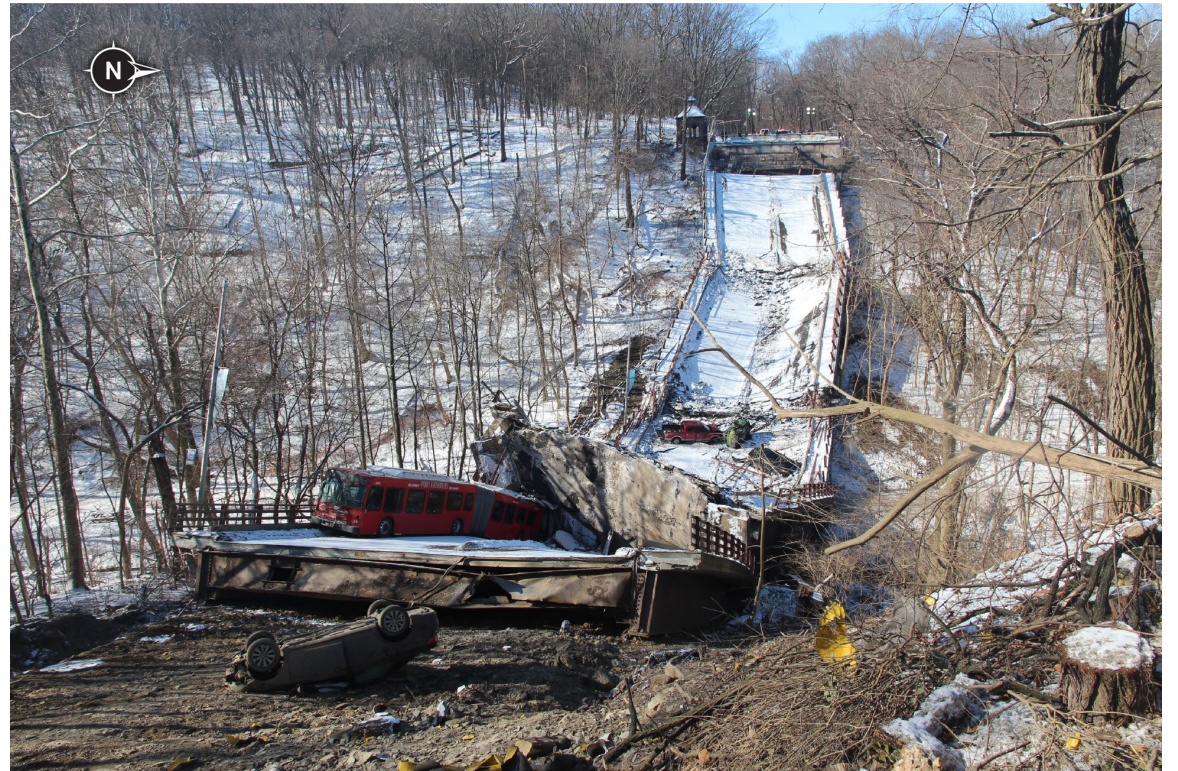
- January 28, 2022, about 6:37 a.m.
- Structural failure and collapse
- Fell into Frick Park
- Dark with light snow
- Transit bus & 4 passenger vehicles
- Fifth passenger vehicle drove off abutment
- All injured transported by 8:26 a.m.
- Precautionary evacuation but no fire or explosion
- Emergency response excluded

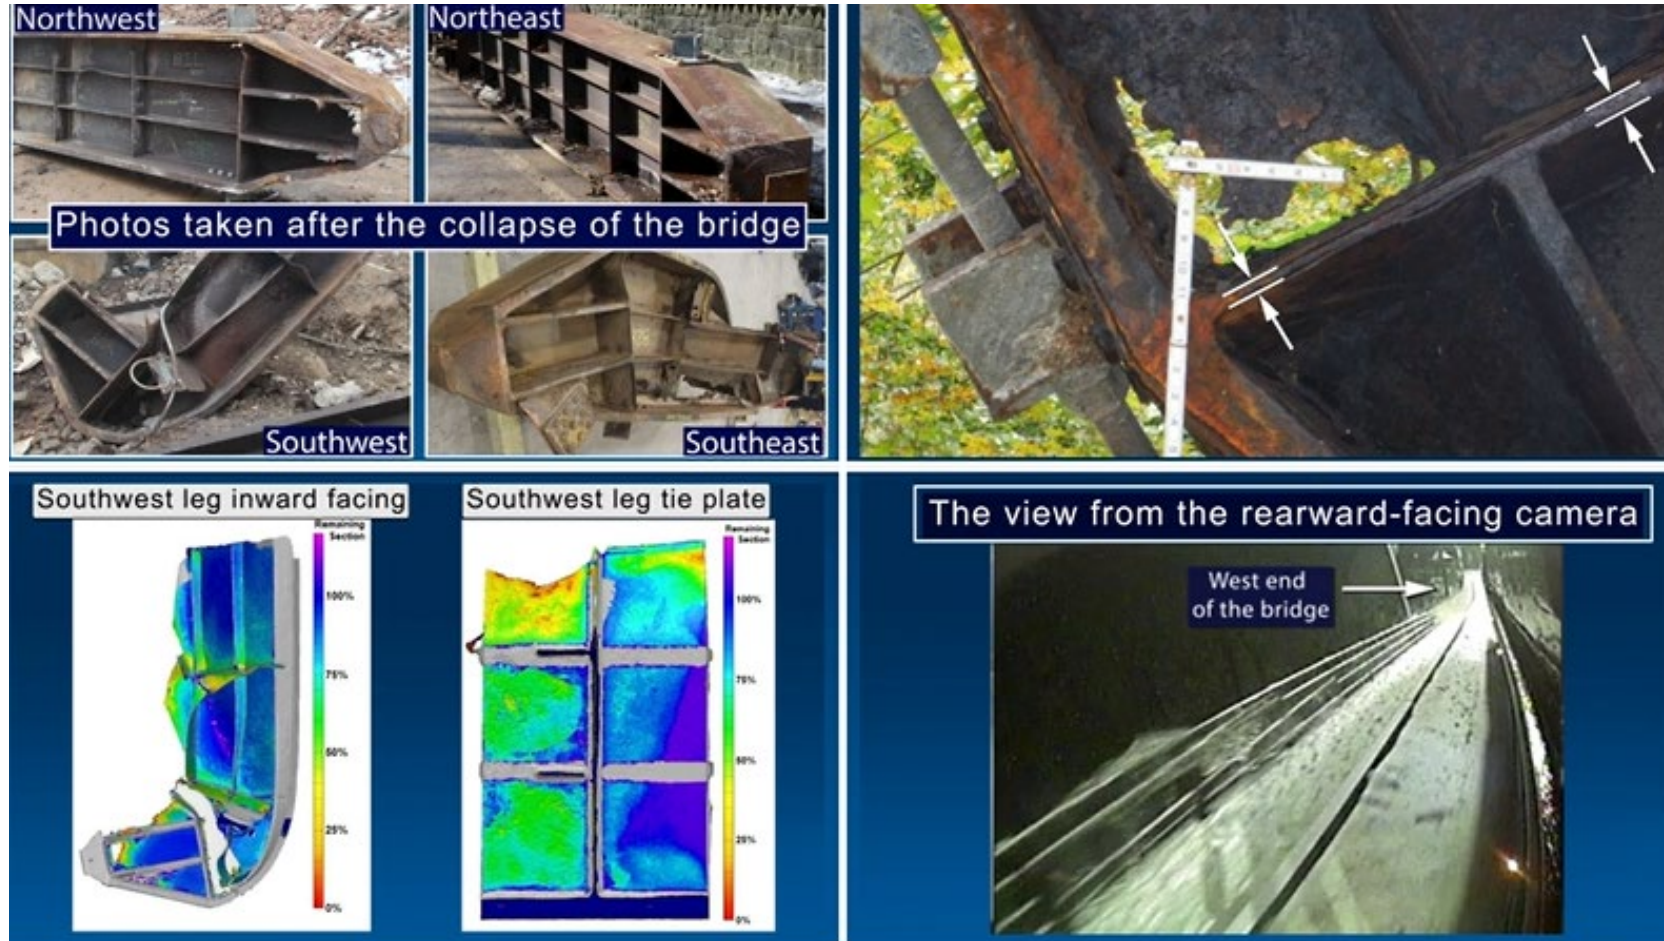
# Bridge Failure Location Evidence

1. The failure of the transverse tie plate on the southwest leg of the bridge, a fracture-critical member (nonredundant steel tension member), due to corrosion and section loss
2. Resulting from the City of Pittsburgh's failure to act on repeated maintenance and repair recommendations from inspection reports.
3. Contributing to the collapse were:
  1. the poor quality of inspections,
  2. the incomplete identification of the bridge's fracture-critical members (nonredundant steel tension members), and
  3. The incorrect load rating calculations for the bridge.
  4. Insufficient oversight by the Pennsylvania Department of Transportation of the City of Pittsburgh's bridge inspection program.

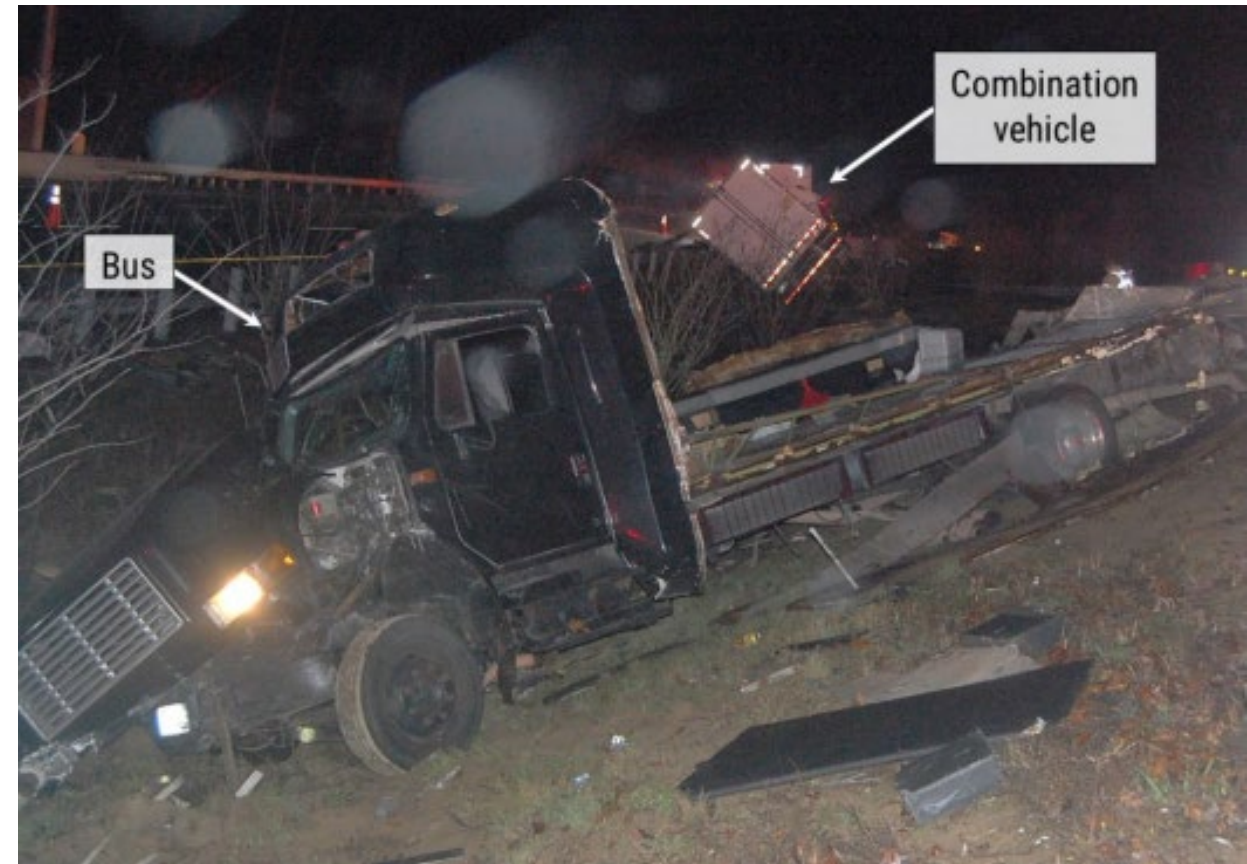
- December 16, 2022, about 1:36 a.m.
- Interstate 64 in Virginia
- Truck traveling 65 mph ran into back of a party bus traveling 25 mph
- 3 bus occupants died, 9 sustained serious injuries, and 11 sustained minor injuries.
- The truck driver also sustained serious injuries

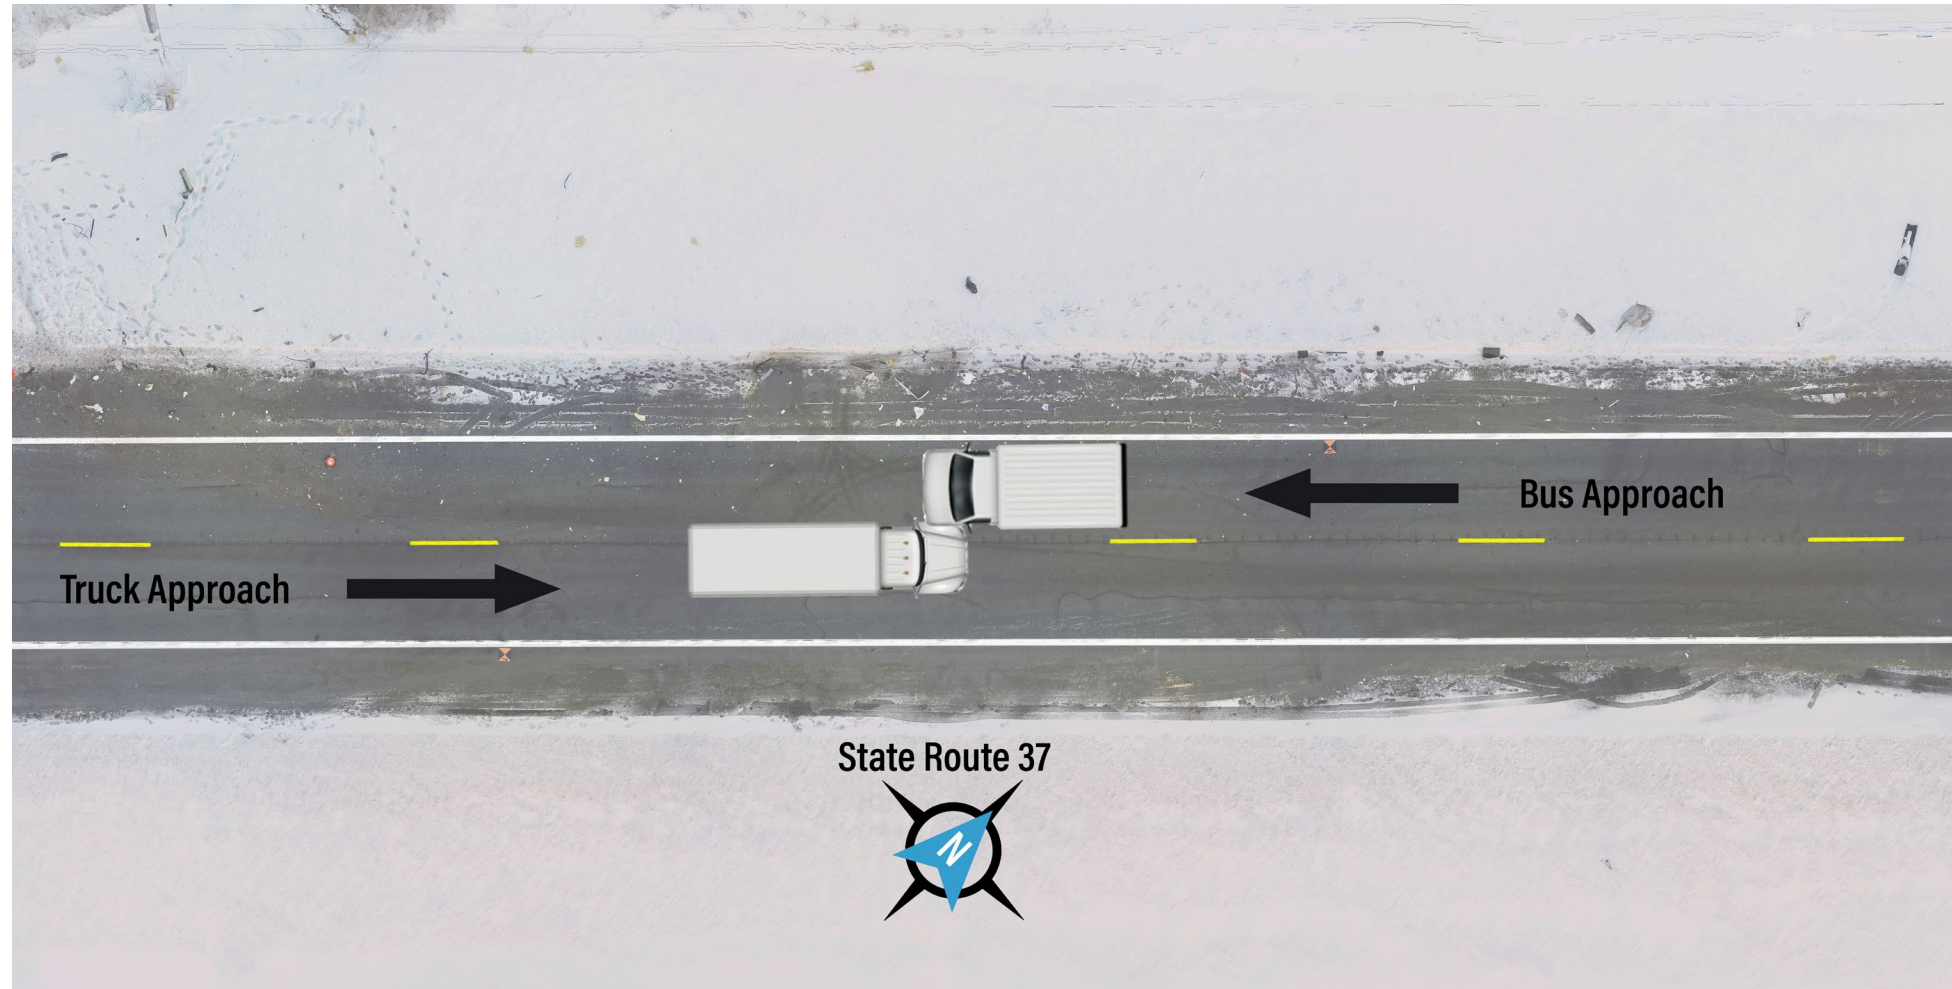
# Crash Sequence

- January 28, 2023, about 6:00 a.m.
- LBFNY company bus Westbound SR-37
  - 2013 Chevrolet Express bus
  - ~53-54 mph
- Aero Global Logistics box truck Eastbound SR-37
  - 2021 Freightliner box truck
  - ~59 mph
- Roadway was wet, lane markings visible, light snow

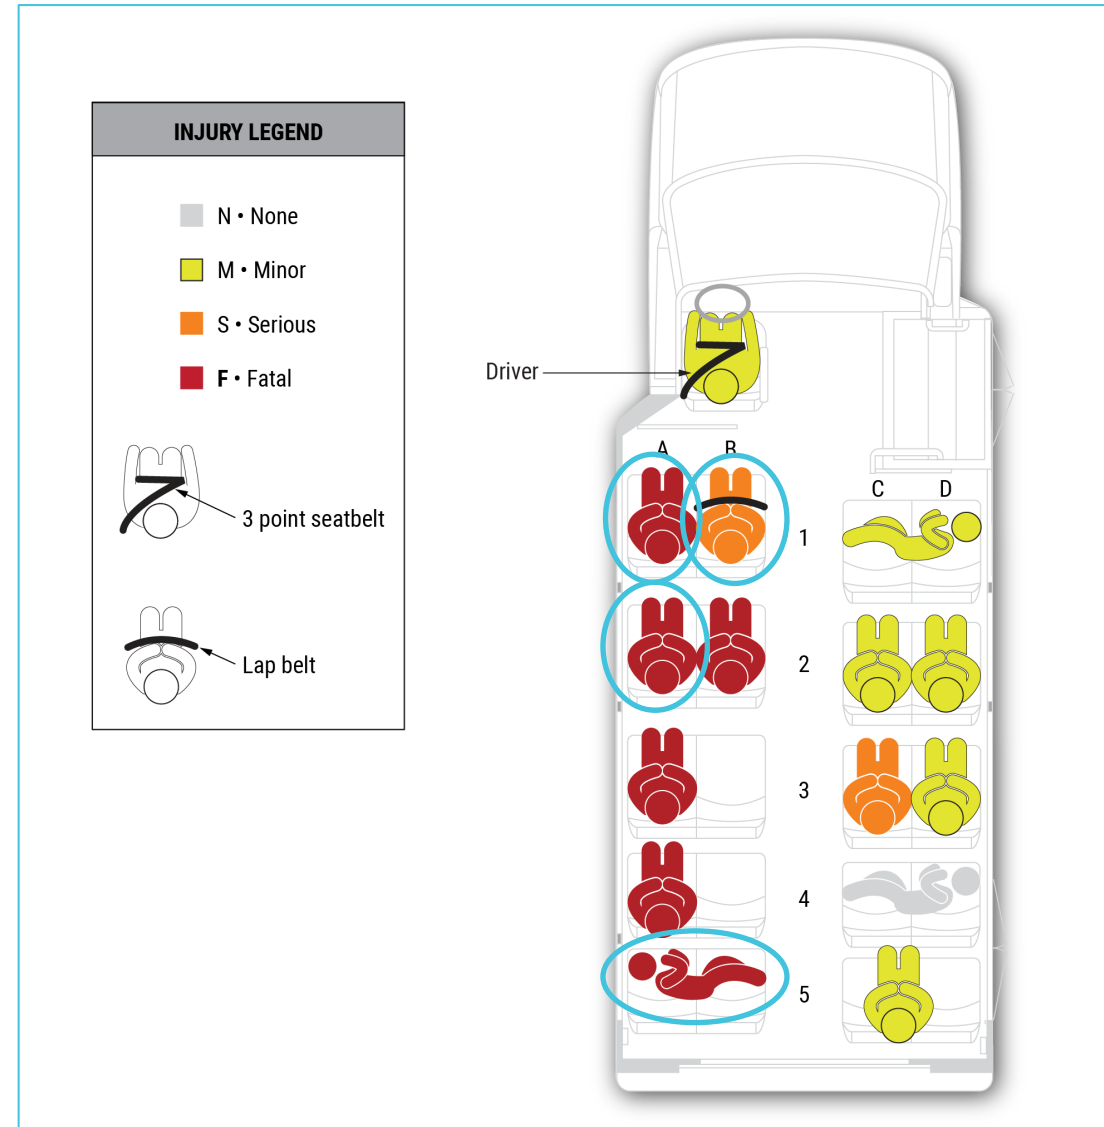
# Bus Injuries

- Restrained driver – minor injuries
- Restrained passenger – serious head trauma
- Six fatalities
- Three unbelted ejected
- Multiple unbelted bus passengers displaced from their seats
