***COMPOSITE REPAIR OF TIMBER STRUCTURES***

D.W. Radford  
M.L. Peterson  
D. VanGoethem

Department of Mechanical Engineering  
Colorado State University  
Fort Collins, Colorado

June 2000

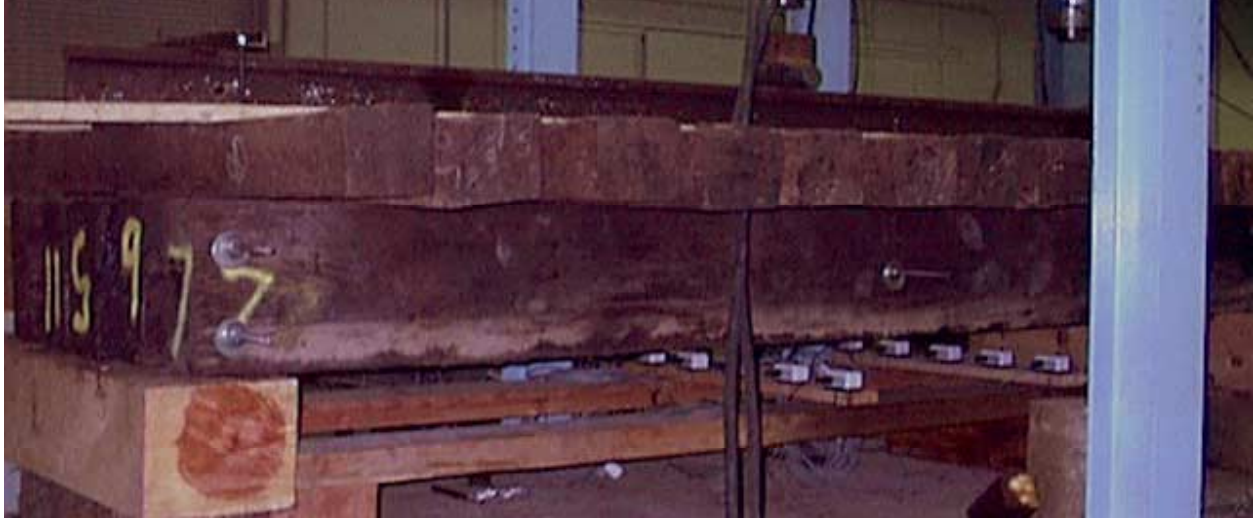
Figure 2.1 Laboratory Single Span Rail Bridge

Several approaches previously have been applied to the repair of wooden timbers. However, these approaches have not been specifically developed for in-situ application. Procedures include the replacement of severely degraded timbers, epoxy repair approaches, the addition of reinforcing plates to the sides of exposed timbers, and the addition of a fiberglass wrap (bandage) around damage locations.<sup>5,6,7,8,9</sup> Unfortunately, the reinforcing plates and the wrap can only be readily applied, in-situ, to exposed timbers which means that many of the structural timbers must be removed prior to repair. Figure 2.1 shows a laboratory single-span timber bridge. The span timbers are seen directly below the ties and are the focus of this research project. Five parallel span timbers are shown in this case, of which only the outside of the outer two timbers would be readily field assessable for the application of shear patches. This accessibility issue would negatively also effect the application of on-site applied composite wraps, and the central timbers would have to be removed for access or replacement.

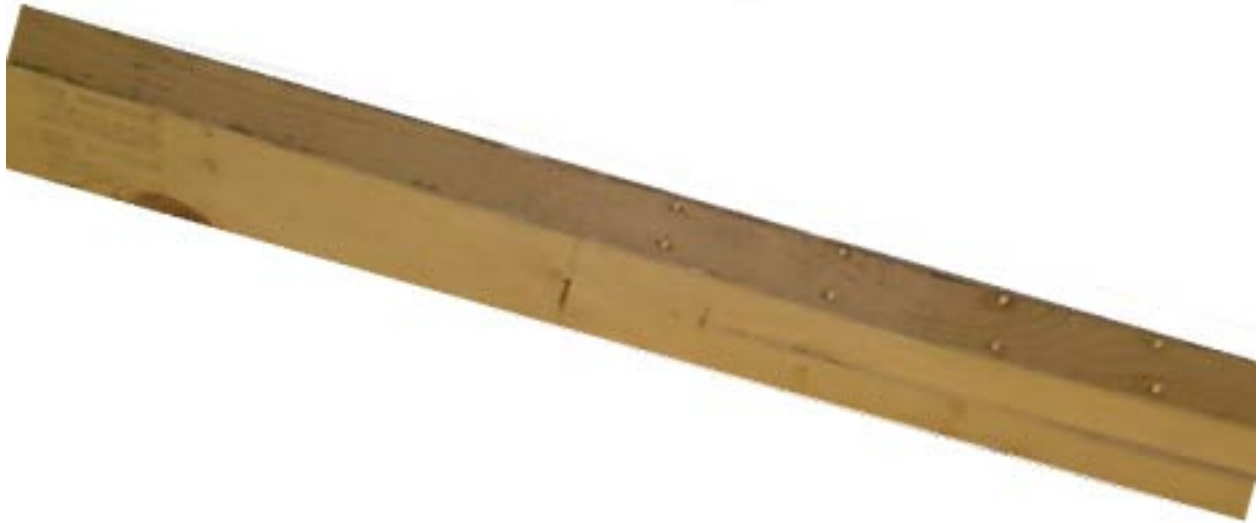
Figure 3.1 Proposed “Shear Spike” Repair Concept

*(Inverted view, showing shear spikes on right half repairing split.)*

Rather than apply an exposed “patch” to the vertical sides of the beam, which can be quite an inefficient approach to shear stiffening, this report suggests an approach that inserts composite rods from the bottom of the beam to the top. These rods or “shear spikes” are inserted in locations of damage at spacings dictated by the degree of decay, or by the amount of performance enhancement desired. The shear spikes act much as nails attaching multiple 2x4’s into a single stiff beam. The shear spikes are completely within the timber, exposed only at the bottom insertion points. This means that aesthetics are unchanged; the bond is improved, since the preservatives applied to the timber only penetrate a short distance from the surface; and the exposure to the elements is minimized.

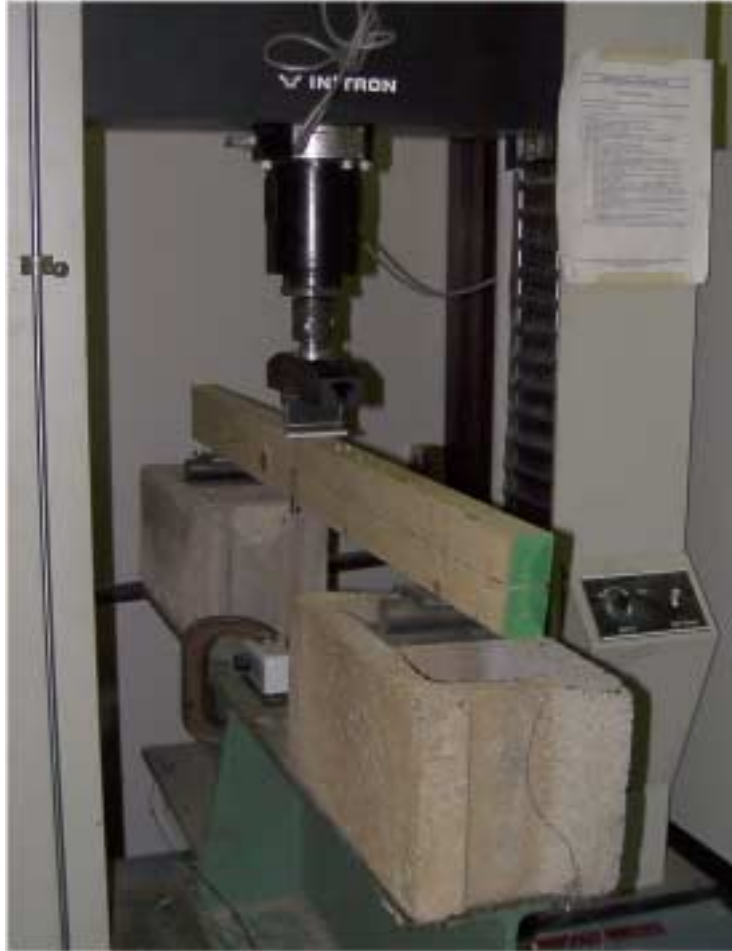
Figure 4.1 3-Point Flexure Test Setup with String Gage.

The actual test setup is shown in Figure 4.1. The test placed a stiff I-beam base frame in the Instron to support the test beams and attached the central load point directly to the load cell. The loading points also are shown in the figure, along with the stress distribution points to stop local crushing. At the mid span of each test beam a small nail was inserted to allow the connection of the strain gage string device. The strain gage device is the light-colored box shown on top of the base frame. Data was collected using a PC data acquisition system connected to the load frame and to the strain-measuring device.

Load and deflection were measured. Mid-span deflection was measured using a string potentiometer strain gage. Beam performance was computed based on ASTM D790, which uses measured mid-span load and deflection to determine the modulus, strength and strain. ASTM 790 equations follow:

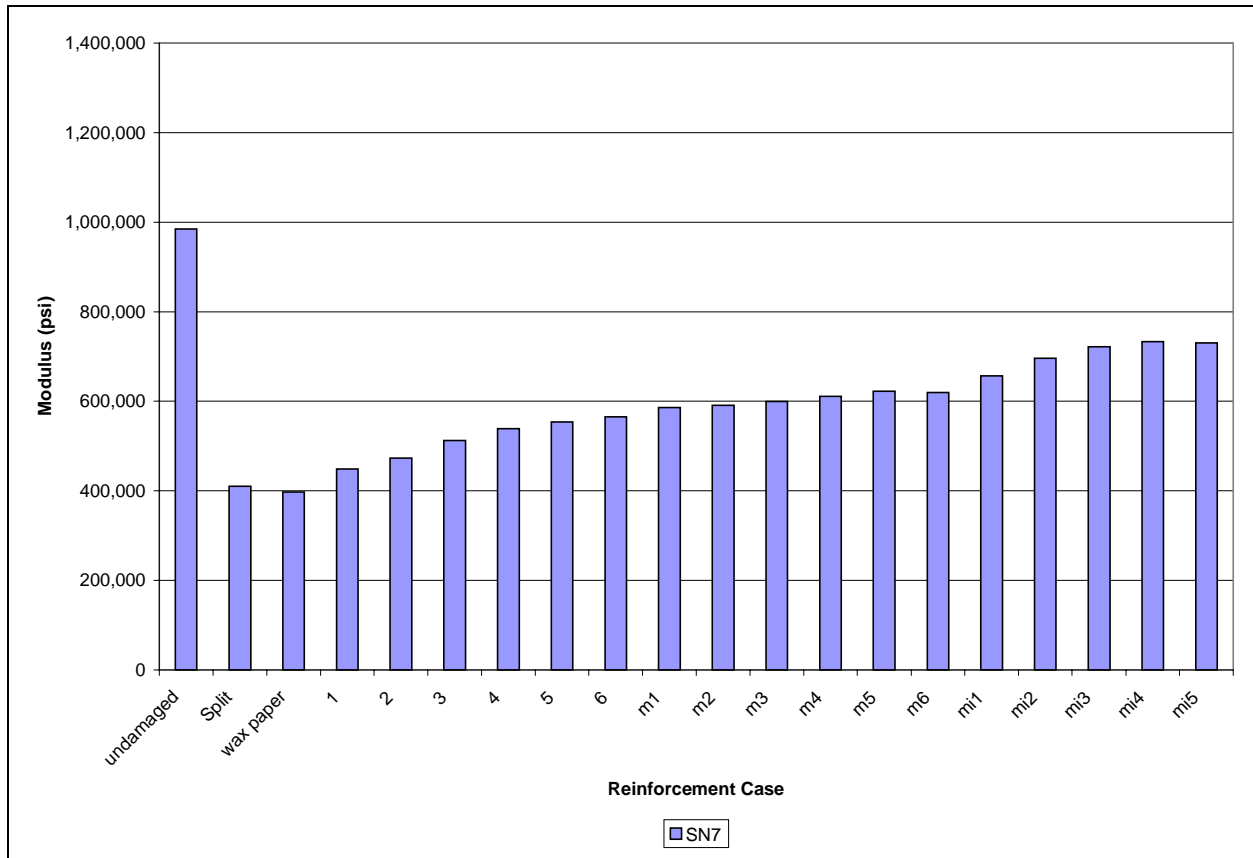
Figure 5.16 Stiffness Related to Additional Reinforcement in 2x4 Specimens (Mid, then Intermediate)

The results of stiffness testing of this modified beam, shown in Figure 5.16, indicate that the additional shear spikes do enhance the modulus of the specimen. The addition of the third pultruded rod in each row has only a limited effect, with the greatest gain (m5) being approximately 10 percent more than the final set of paired spikes. The additional intermediate rows of spikes showed a somewhat greater gain, with the final modulus showing an increase of approximately 25 percent more than the final paired shear spike case (6).

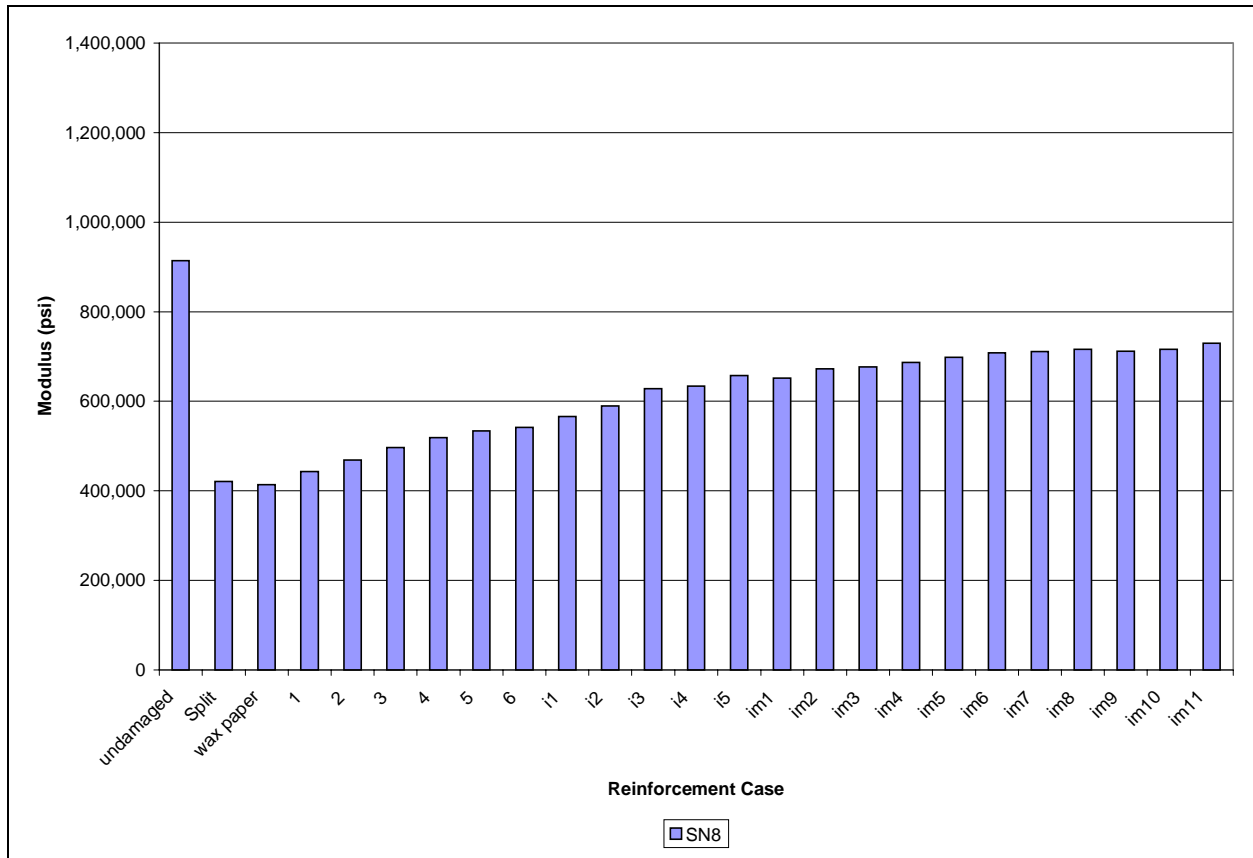
Figure 5.18 Stiffness Related to Additional Reinforcement in 2x4 Specimens (Intermediate, then Mid)

The results of stiffness testing of this modified beam (SN8), shown in Figure 5.18, indicate that the additional shear spikes do enhance modulus of the specimen. Again, the addition of the intermediate pairs of rods seems to have a somewhat greater overall effect. The additional intermediate rods (i5) yield an approximate gain in modulus of 20 percent more than the final paired shear spike case (6), while the added middle rods only generate an additional 10 percent increase. The final modulus increase is similar to the previous specimen (SN7), having an approximate gain of 30 percent over the final paired shear spike case (6).
