Evaluation of UDOT'S Video Detection Systems

System's Performance in Various Test Conditions

December 2004

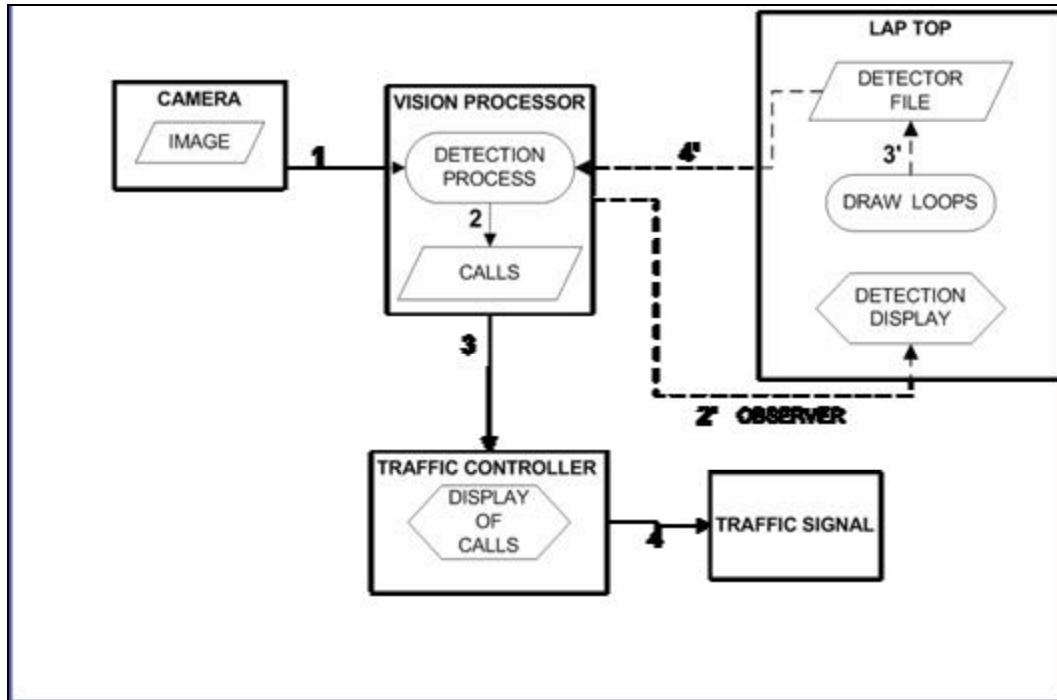
Figure 2.1: Flowchart depicting the Peek and Autoscope systems' detection process

Figure 2.1 shows the Peek, Autoscope and Traficon NV detection process. The Iteris detection process is shown in Figure 2.2. Detector files are created in the Iteris and Traficon NV systems using a monitor and a mouse instead of a computer [7]: that is, the vision processors contain the necessary software to create a virtual loop. In general, cameras installed on the mast arms or on luminaries at the intersection capture images of the vehicles. Step 1 shows this signal being sent to a central processing unit called the vision processor. In step 2, the system detects vehicles by means of application specific algorithms. Step 3 shows that a "call" is given to the controller if a vehicle is detected. A "call" is a demand for service registered in a controller. Depending on the number of actuations, the controller provides the passage time for these vehicles until "max green" is reached. The process of drawing loops and storing them in a detector file is also shown in step 3. This detector file is downloaded into the vision processor to view detection. Detection of the vehicles can be viewed on a laptop/monitor.

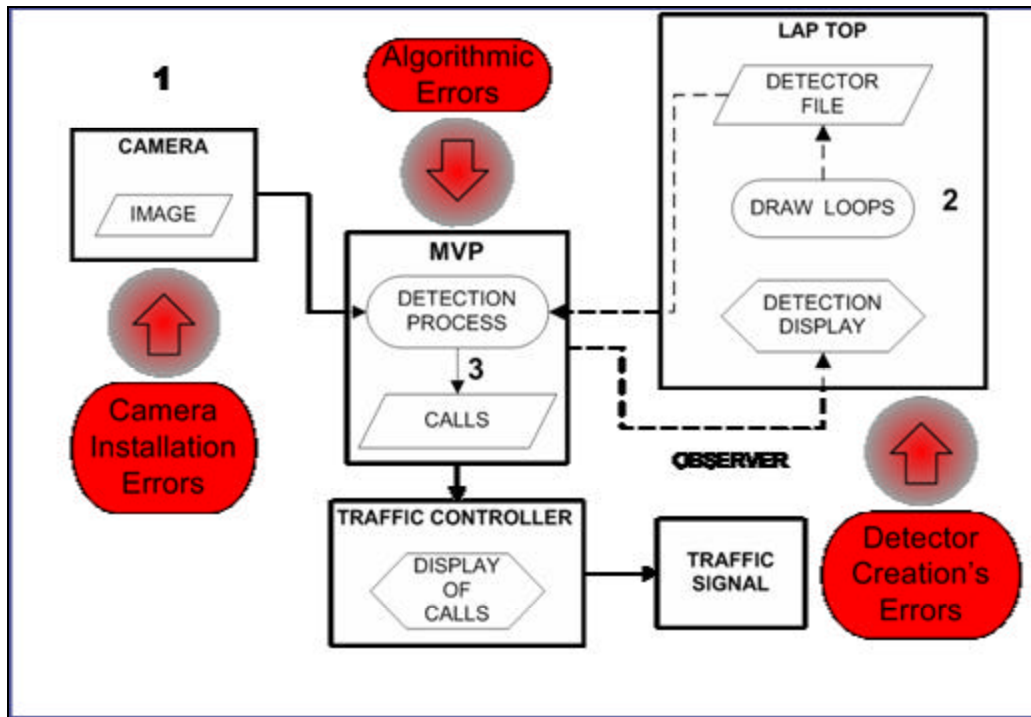
Figure 4.1: Flowchart depicting the source of errors

Figure 4.1 shows the installation errors explained in the above paragraphs.

Step 3 in Figure 4.1 shows the errors generated in the vision processor. If the algorithm used to detect the system is not accurate, it could result in discrepant calls.

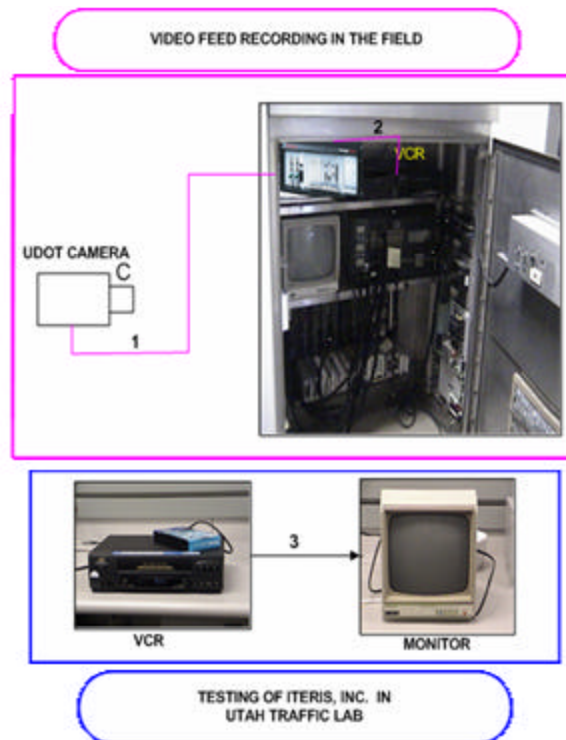
Figure 5.1: Data Collection Methodology for Iteris, Autoscope and Traficon NV Systems

The equipment required for collecting data were VCRs, a BNC to RCA/RCA to RCA adaptor and a monitor. The monitor was used to ensure that the data recorded was the information needed. The monitor was connected to the VCR using the RCA to RCA adaptor. The video feeds analyzed by the vision processor at the field were recorded on VHS video tapes. The video tapes also captured the detector overlay or configured detection zones. These video tapes were viewed at the Utah Traffic Lab (UTL) during the data reduction process to determine the detection accuracy of these systems. Figure 5.1 shows the methodology for data collection for these systems. Step 1 shows the video feeds at the intersection being analyzed by the vision processor. Step 2 portrays the system detector analysis and step 3 shows the tapes being viewed on a monitor at the UTL.

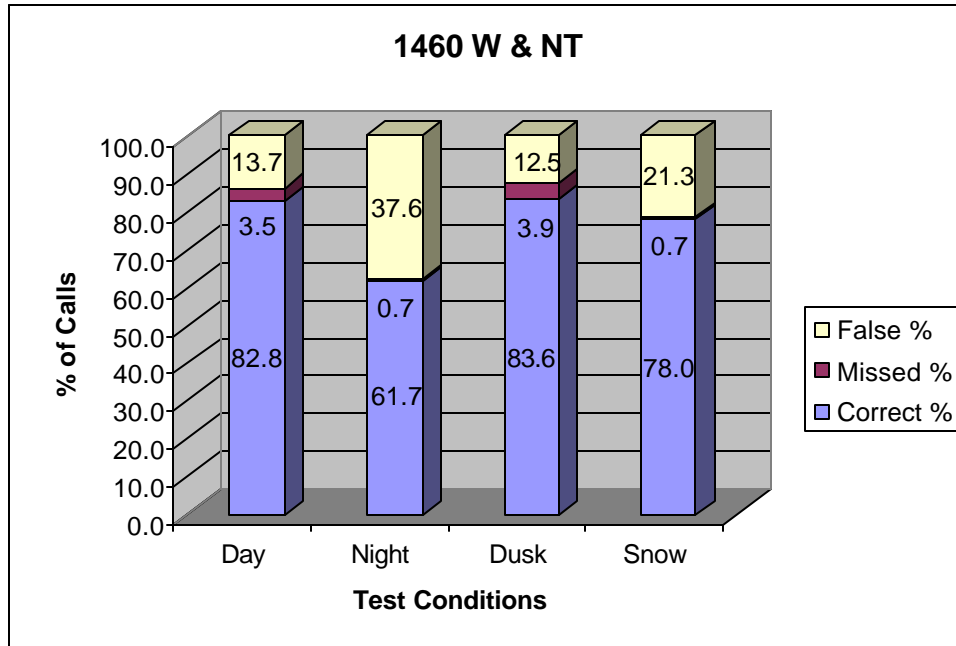
Figure 6.1: Performance at 1460 W & NT in Various Test Conditions

Overall performance in various conditions is shown in Figure 6.1. The correct call percentage produced by the system ranges from 61.7 percent to 83.6 percent. The percentage of false calls was higher than the percentage of missed calls at this location. Most of the false calls in the night condition were associated with headlights activating the detectors (class H). Other test conditions also recorded high percentages of false calls, due to vehicles activating detectors in the adjacent lanes (class I) and extended detection (class J). The system seemed to perform well in the day and dusk conditions, with over 80 percent correct calls. But the night performance of the system deteriorated due to the high number of false calls caused by headlights activating the detectors (class H).

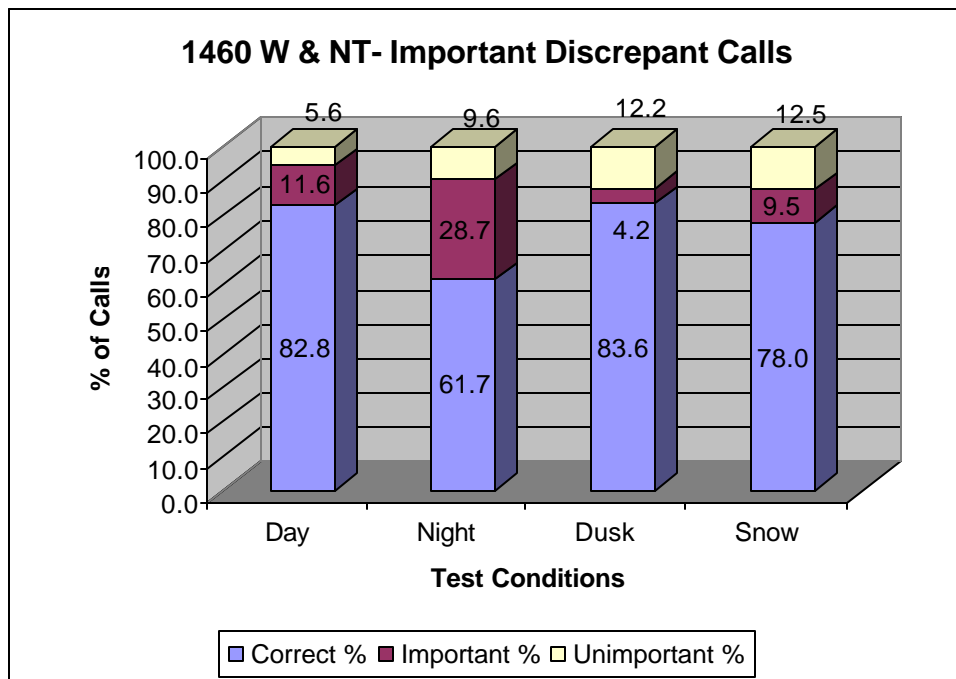
Figure 6.2: Important Discrepant Calls at 1460 W & NT in Various Test Conditions

Figure 6.2 shows the effects of these discrepant calls on the signals. Among the 17.2 percent discrepant calls recorded during the day condition, only 11.8 percent of these calls could have an affect on the signal timings. Similarly, the night condition produced about 28.7 percent important discrepant calls. Most of these calls were false calls and could have resulted in max out of the signal timings on the major approaches. For the inclement weather condition, this system produced only 9.5 percent of the important calls among the 30 percent overall false and missed calls observed for this condition.

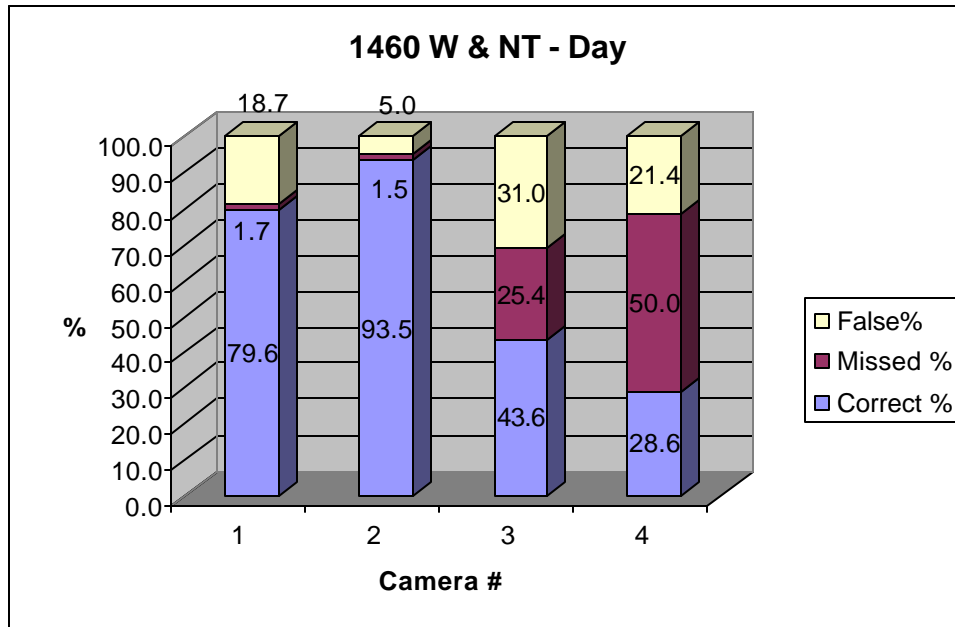
Figure 6.3: Performance of 1460 W & NT in the Day Condition

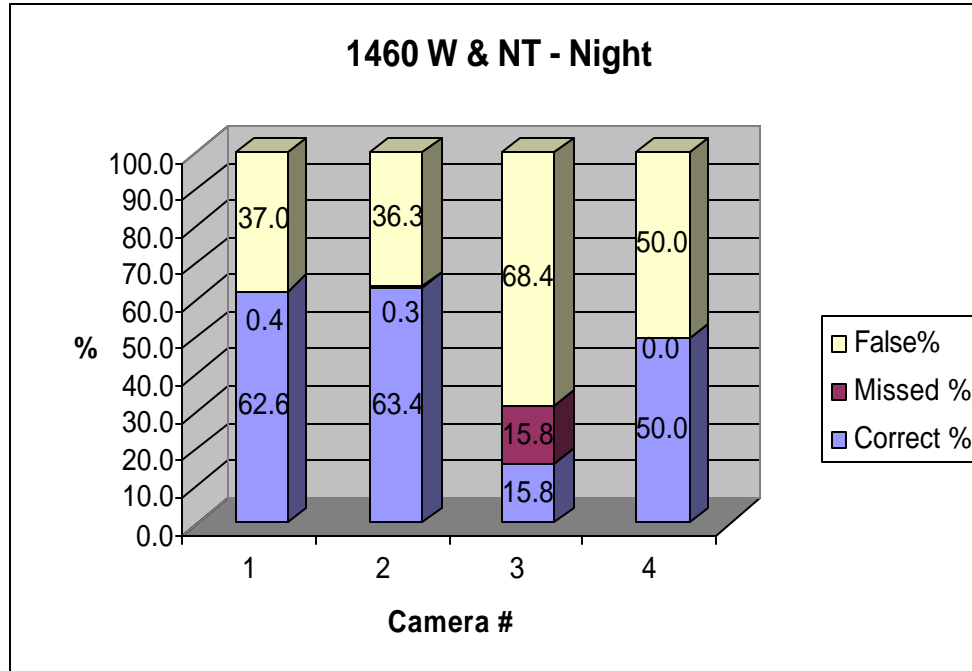
Figure 6.4: Performance 1460 W & NT in the Night Condition

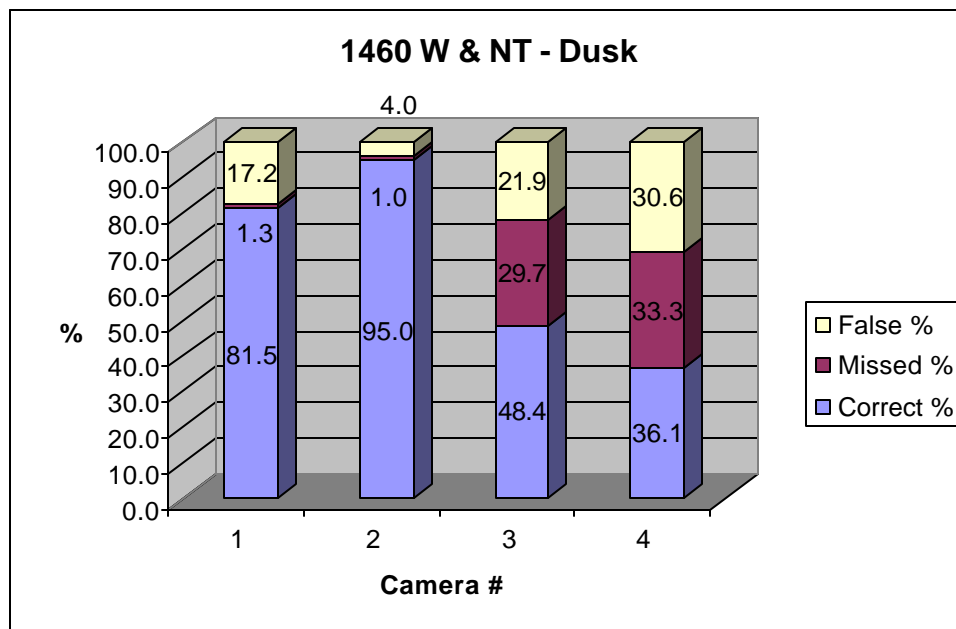
Figure 6.5: Performance of 1460 W & NT in the Dusk Condition

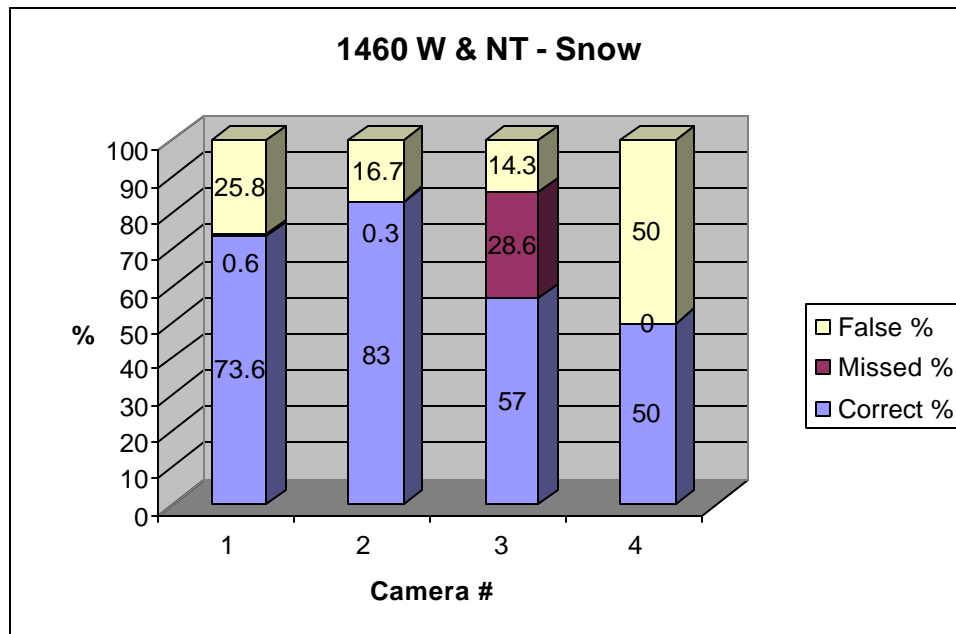
Figure 6.6: Performance of 1460 W & NT in the Snow Condition

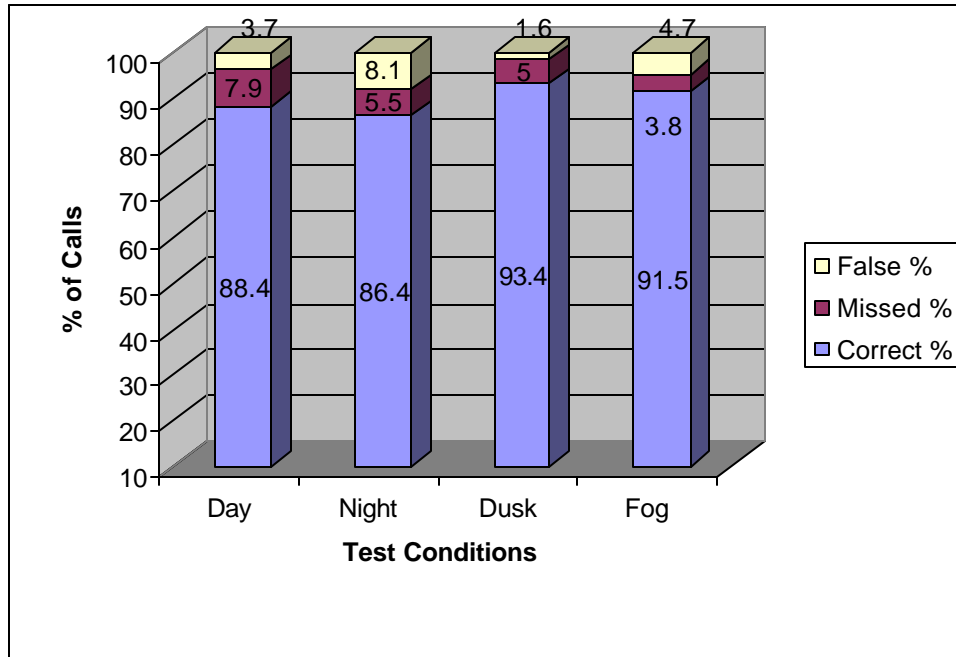
Figure 6.7: Performance at 5150 S and State St. in Various Test Conditions

The majority of false calls at this location were associated with extended detection and headlight activation of detectors (class H) during the night and during bad weather conditions. Overall, the system performed well during all the test conditions with a correct call percentage of over 85 percent.

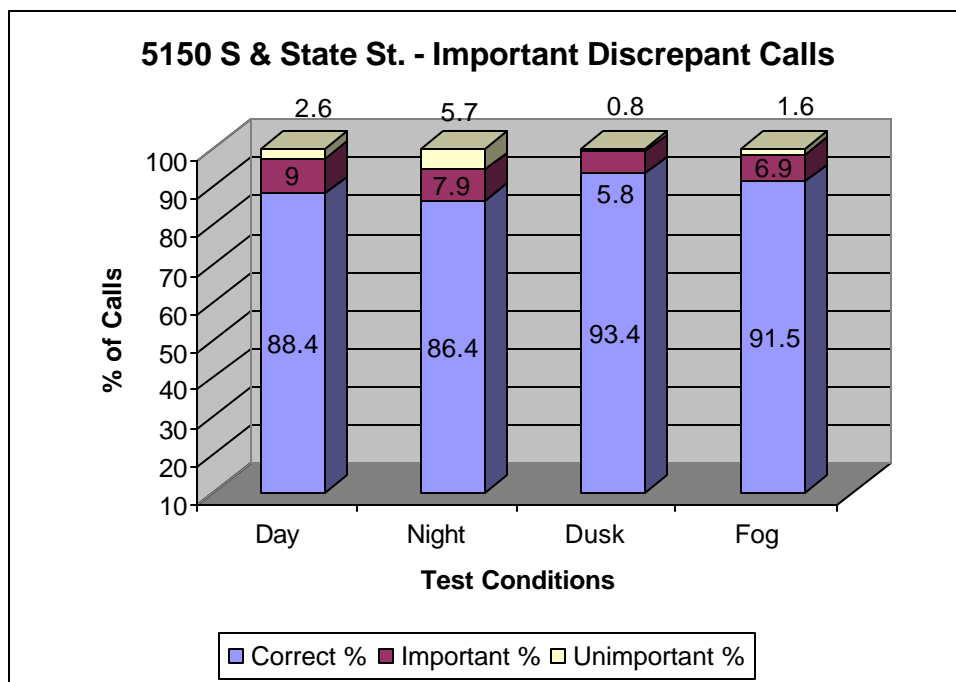
Figure 6.8: Important Discrepant Calls at 5150 S and State St. in Various Test Conditions

The effects of important discrepant calls on the signal timings are shown in Figure 6.8. Among the 11.6 percent discrepant calls produced during the day condition, about 9 percent of these calls were noted to be important. This was the highest percentage recorded among all the test conditions. Extended detection (class J) and headlight activation (class H) during the green phase and dropping of detection (class E) in the red phase constituted these important discrepant calls.

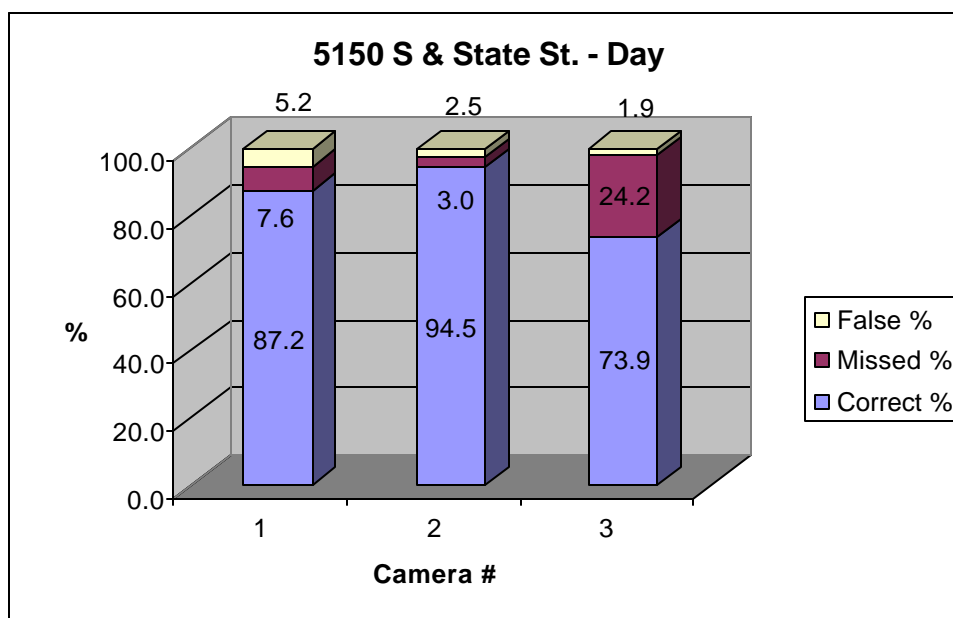
Figure 6.9: Performance of 5150 S & State Street in Day Condition

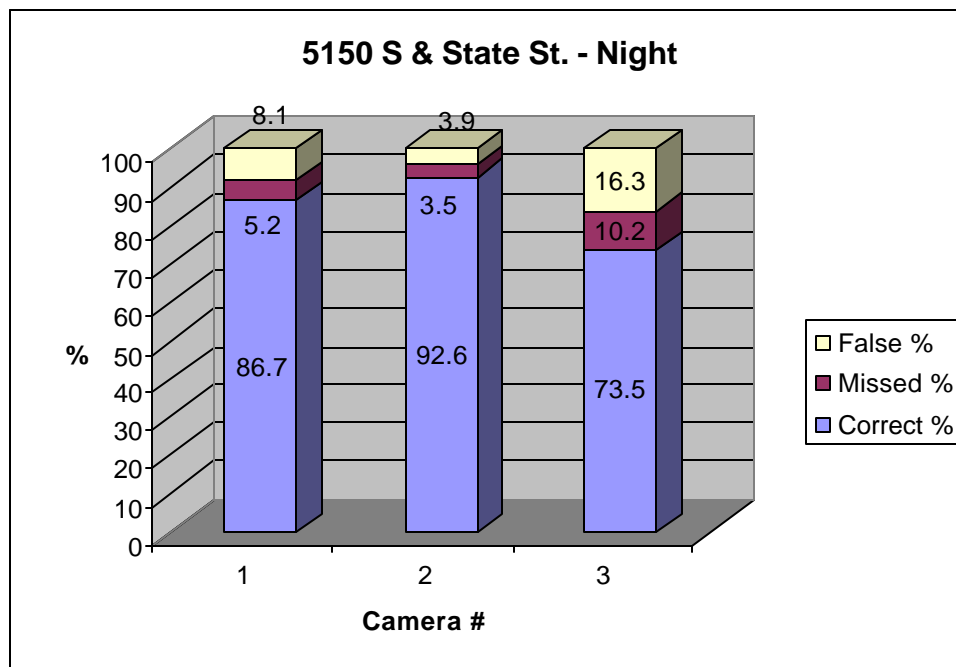
Figure 6.10: Performance of 5150 S & State Street in the Night Condition

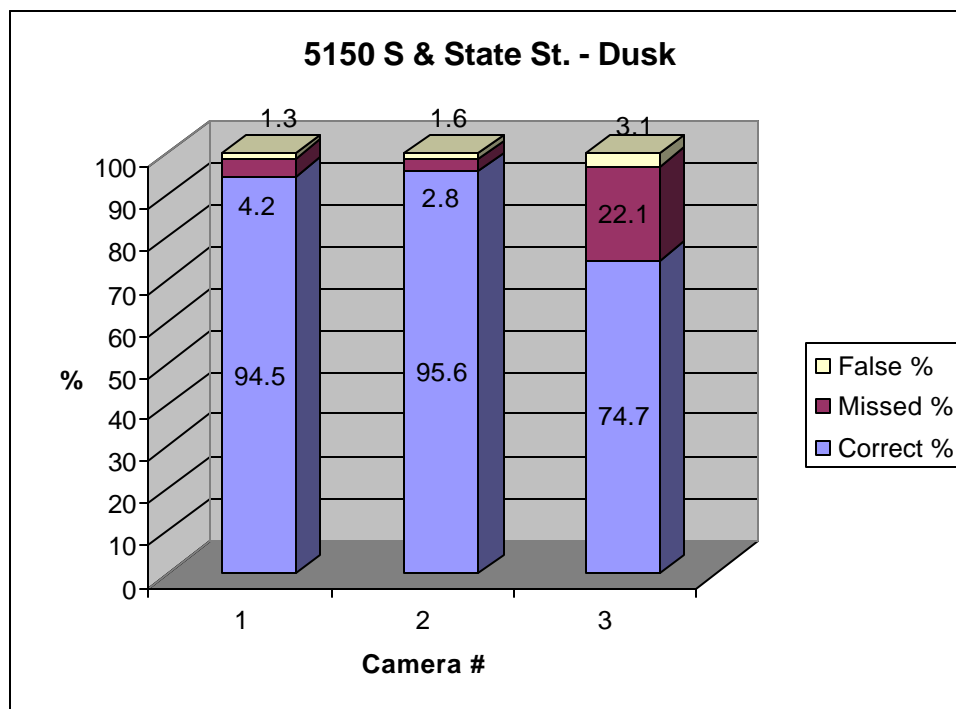
Figure 6.11: Performance of 5150 S & State Street in the Dusk Condition

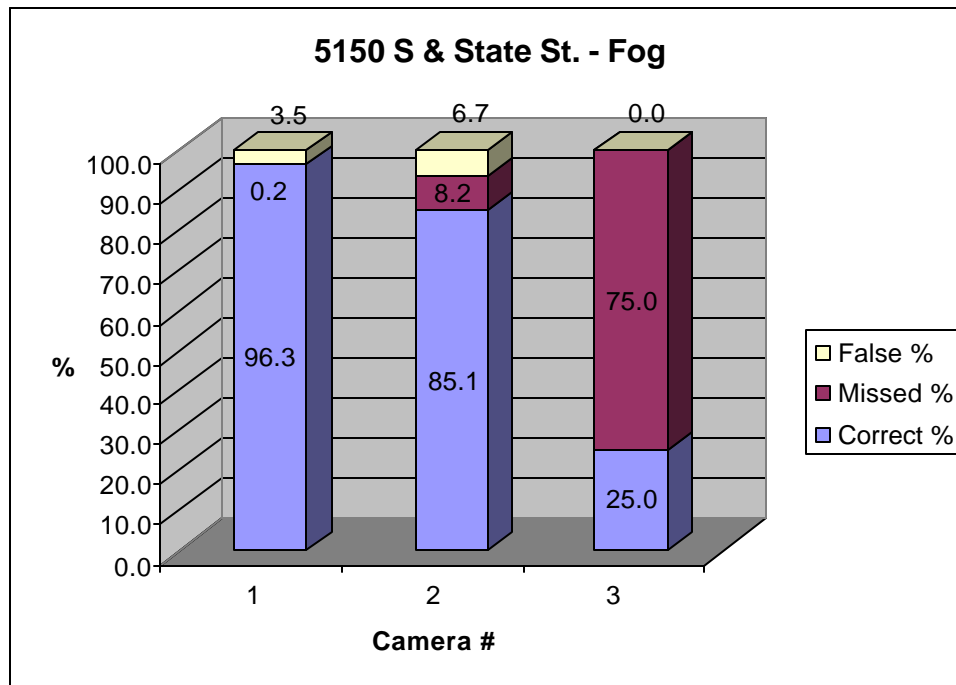
Figure 6.12 shows that the system performed well for the first two cameras. The dropping of vehicles after detection (class E) constituted the majority of missed calls in camera 3. During the morning, it was observed that there was minimal traffic on the eastbound lane. The small amount of missed calls produced an exaggerated result in camera 3, as shown in Figure 6.12.

Figure 6.12: Performance of 5150 S & State Street in the Fog Condition

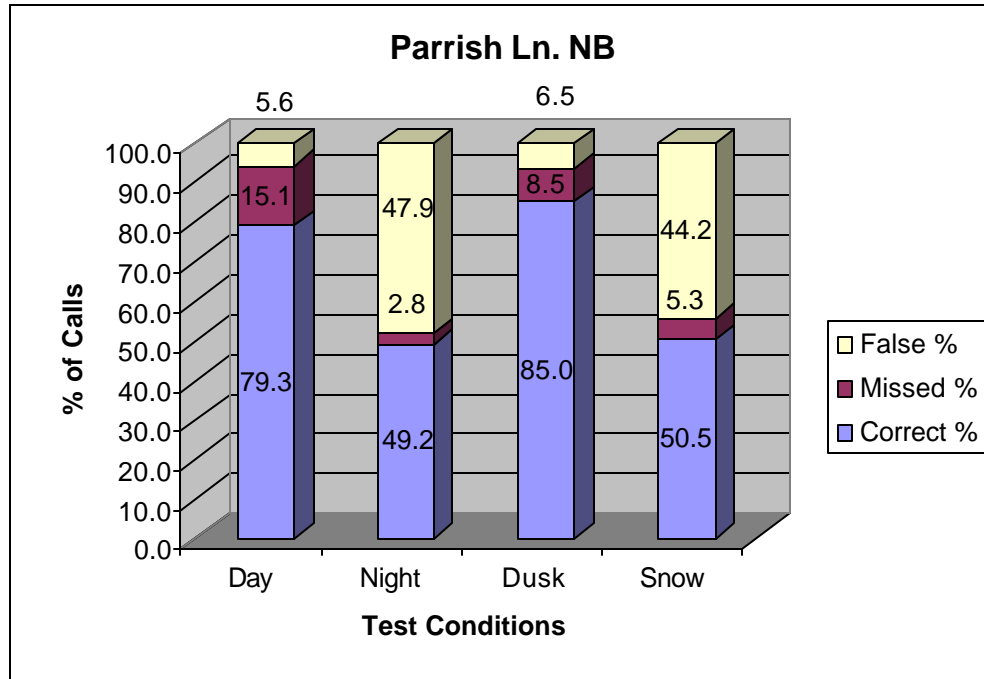
Figure 6.13: Performance of Parrish Lane & NB off ramp in Various Test Conditions

The overall performance of the system at this location is shown in Figure 6.13. It was observed that the discrepant calls during the day and dusk conditions were much lower when compared to the night and inclement weather conditions. Missed calls dominated the percentage of discrepant calls during the day and dusk conditions. Over 44 percent false calls were observed during the night and snow conditions.

The primary reason for the missed calls in all the cameras was noted to be class E. Vehicles blending in with the background (class A) was also observed to produce missed calls. The high percentages of false calls were associated with headlight activation of detectors (class H) and extended detection (class J). Also, camera 3, which overlooks NB traffic, showed some portions of EB traffic in its FOV. Thus the detectors in the NB lanes produced false calls because large vehicles like trucks in the EB direction activated these detectors. These errors could have brought down the performance of the system.

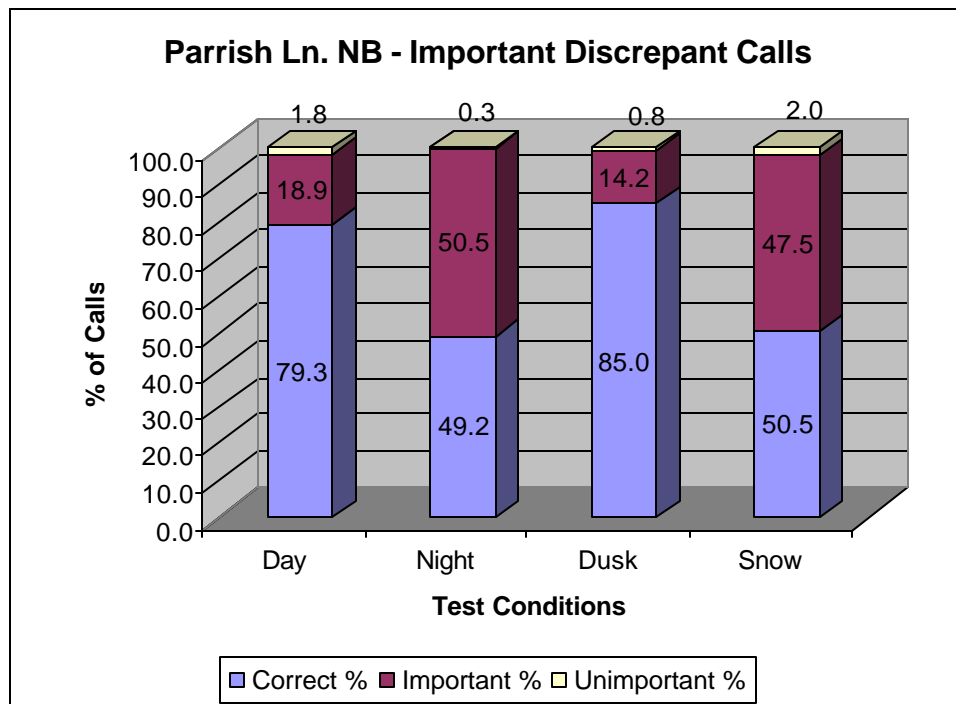
Figure 6.14: Important Discrepant Calls at Parrish Lane & NB off ramp in Various Test Conditions

Figure 6.1 shows the discrepant calls that could affect the performance of the traffic signals. The discrepant calls range from 14.2 percent to 50.5 percent. The important discrepant calls were classes A and E in the missed calls category and classes J and H in the false calls category. These high percentages could have brought down the performance of the system at this location.

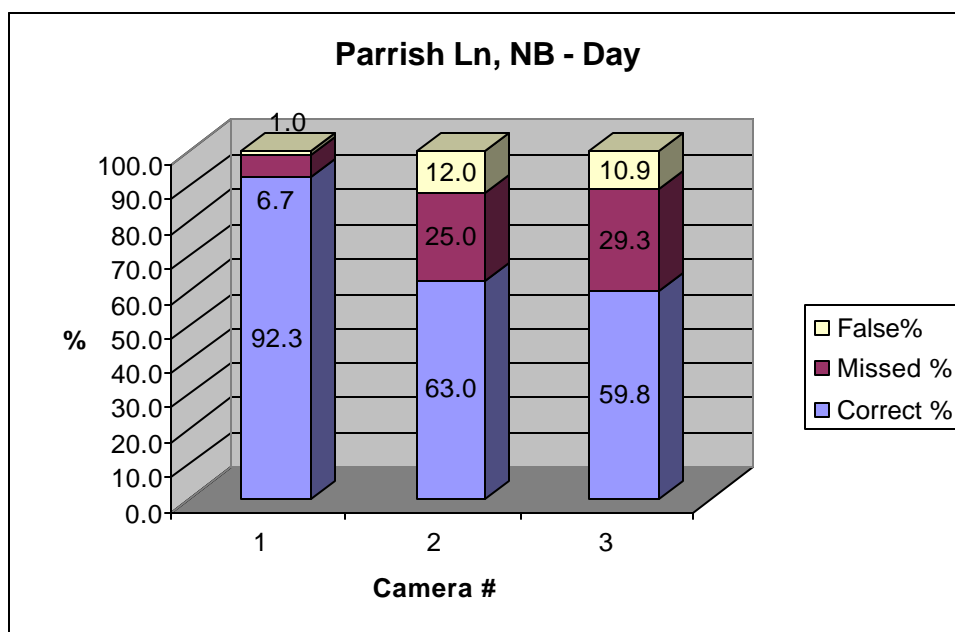
The data analysis for this condition is shown in Figure 6.15. Camera 1 showed the highest performance level for correct calls when compared to the other cameras. Of the missed calls, 7 percent were due to detection being dropped (class E) during the red phase. But about 25 percent to 29.5 percent missed calls and 10.9 percent to 12 percent false calls in the other two cameras resulted in correct detection about 60 percent of time during day time condition. Missed calls in camera 2 were associated with dark vehicles blending in with the background (class A). In camera 3, dropped detection (class J) constituted a higher percentage of missed calls. The tapes showed queue formation for the EB traffic because of the delay in detection. Detectors activated after the vehicles left the zone caused extended detection and were reported as false calls.

Figure 6.15: Performance of Parrish Lane NB Off-ramp in the Day Condition

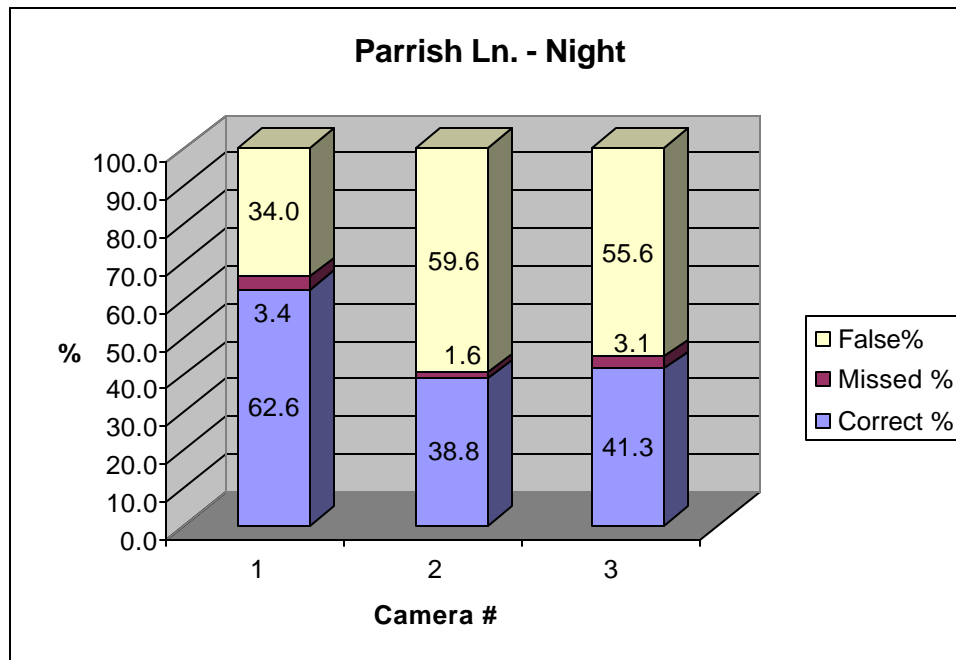
Figure 6.16 shows the performance of the system for the night condition. False calls for cameras 2 and 3 dominate the detection percentages. The reasons for this were noted to be headlight activation of detectors (class H) and extended call after the vehicles left the detection zone (class J). About 3 percent of missed calls were recorded in all the cameras as a result of dropped calls after detection in the detection zone (class E). Thus the high percentages of discrepant calls could have brought down the performance of the system.

Figure 6.16: Performance of Parrish Lane NB Off-ramp in the Night Condition

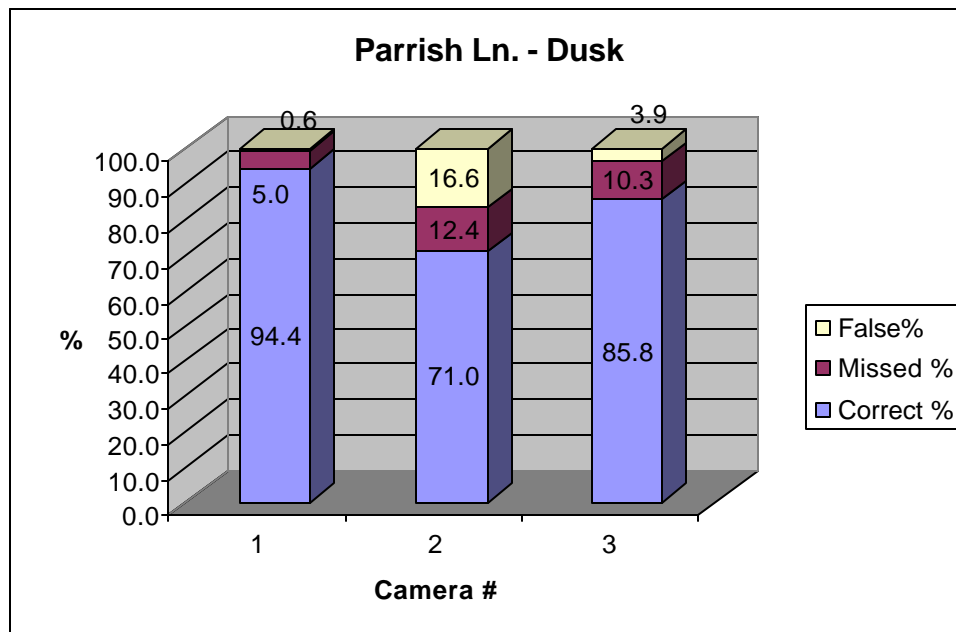
Figure 6.17 shows that camera 1 performed better than the other cameras. Camera 1 showed a correct detection percentage of 95 percent with only 5 percent discrepant detection. Cameras 2 and 3 produced 10.3 percent to 12.4 percent missed calls. The missed calls in camera 2 were attributed to vehicles blending in with the background (class A). But in the case of camera 3, missed calls occurred because of dropped calls after detection (class E).

The false call percentages dominated the discrepant calls in camera 2. Also, Figure 6.17 shows that camera 2 produced the highest percentages of false calls when compared to the other cameras. Extended detection (class J) and headlight activation of the detectors (class H) were noted to be the major causes for this discrepancy.

Figure 6.17: Performance of Parrish Lane NB Off-ramp in the Dusk Condition

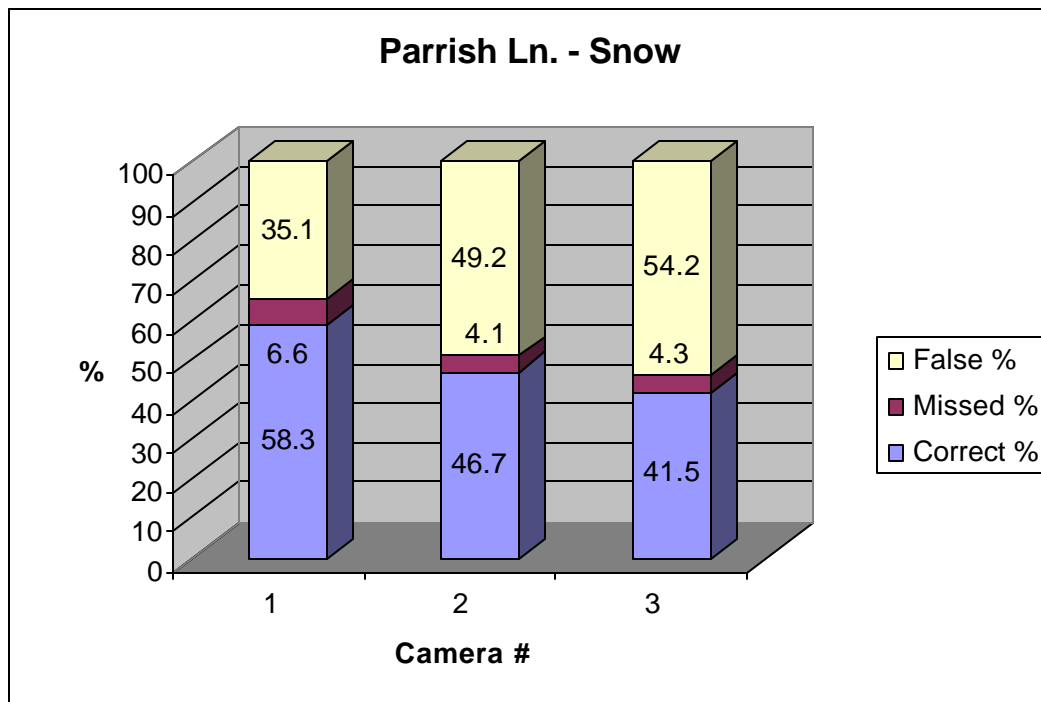
Figure 6.18 shows the performance of the system in the snow condition. From the low percentages of correct detection, it could be said that the system did not perform well at this location in the snow condition. The percentage of false calls increased from 35.1 percent to 54.2 percent (camera 1 to camera 3). The primary reason for false calls are headlight activation of detectors (class H) and extended detection after the vehicles have left the zone (class J). The majority of false calls in camera 3 were because of headlights activating the detectors in the adjacent lanes. The reason for the missed calls in all the cameras was noted to be the dropping of detection in the detection zone (class E) during the red phase.

Figure 6.18: Performance of Parrish Lane NB Off-ramp in the Snow/Night Condition

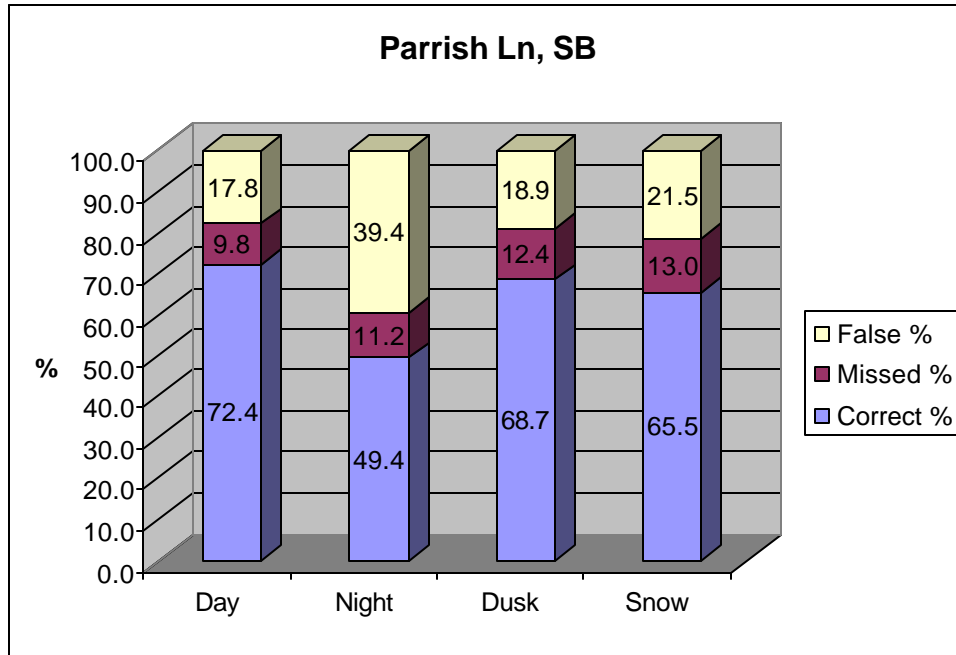
Figure 6.19: Overall performance of Parrish Lane SB in Various Test Conditions

The overall performance of the system at this location is shown in Figure 6.19. Correct detection during the day, dusk and snow conditions was in the 65.5 percent to 72.4 percent range, while correct detection dropped significantly below 50 percent during the night condition. The percentage of false calls during the night could have brought down the performance of the system. Just like the other locations running on Peek Systems, false calls were noted to be produced by headlight activation of detectors (class H) and extended detection (class J). Missed calls were caused by the dropping of vehicles in the detection zone.

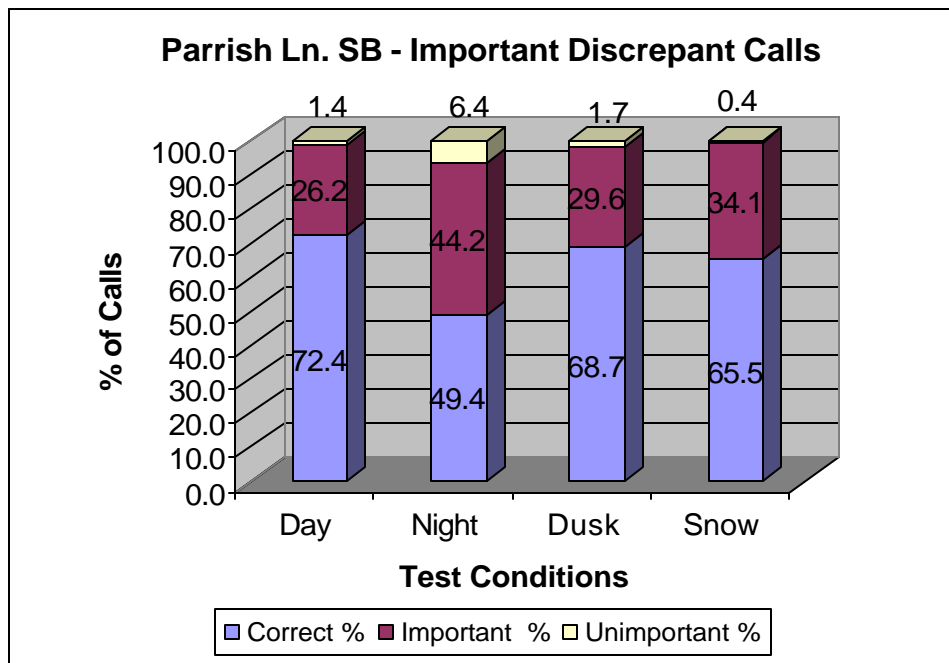
Figure 6.20: Important Discrepant Calls at Parrish Lane SB in Various Test Conditions

Figure 6.20 shows the effect of the important discrepant calls on the signal timings. The important discrepant calls under all the test conditions except the night condition were in the 26.2 percent to 34.1 percent range. Among the discrepant calls at night, about 44.2 percent of them were noted to be important. The important discrepant calls in all the test conditions included the headlight activation of detectors (class H) and extended detection (class J) under the false calls category. The missed calls that were rated important included dropped detection in the detection zone (class E).

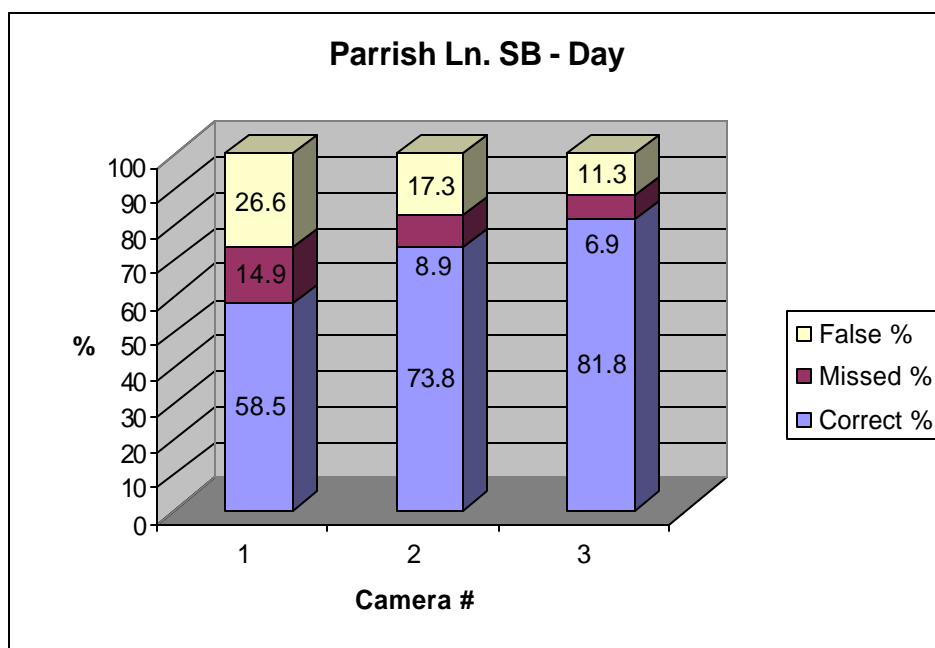
Figure 6.21 shows the data analysis for the day condition. It is observed that the performance of the system increased from camera 1 to camera 3. Camera 1 had the highest percentage of false calls (26%). These false calls were associated with extended call detection (class J). During the data reduction process, it was noted that the green phase for camera 1 lasted approximately 11 seconds. Queue formation was observed due to the short green phase. About 15 percent missed calls were recorded because of the dropping of detection (class E). The discrepant calls in the remaining cameras were lower than for camera 1.

Figure 6.21: Performance of SB Parrish Lane in the Day Condition

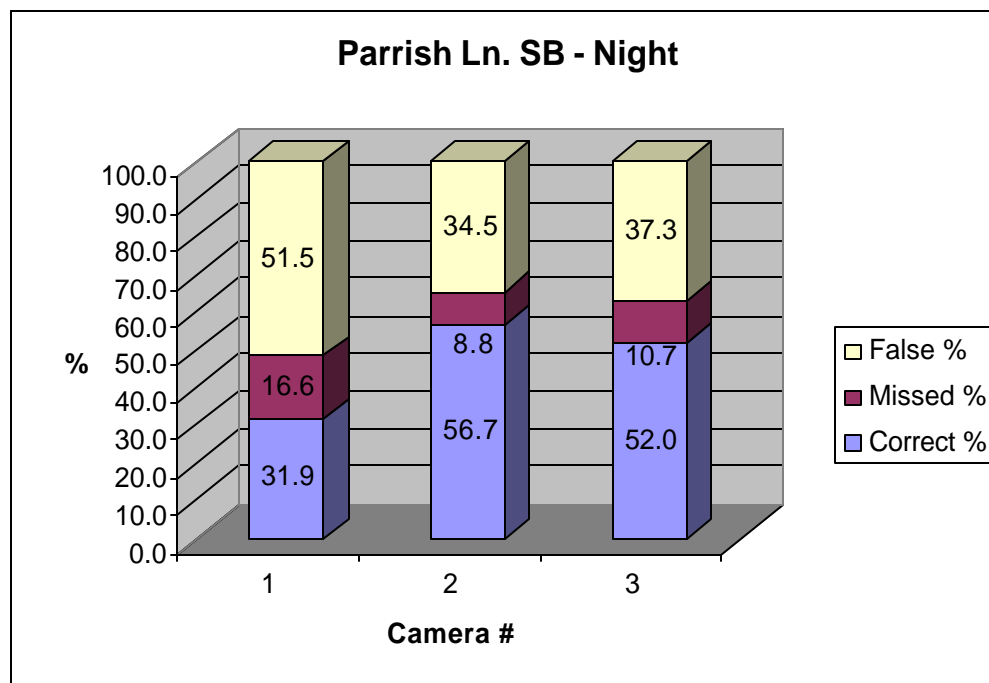
Figure 6.22: Performance of SB Parrish Lane in the Night Condition

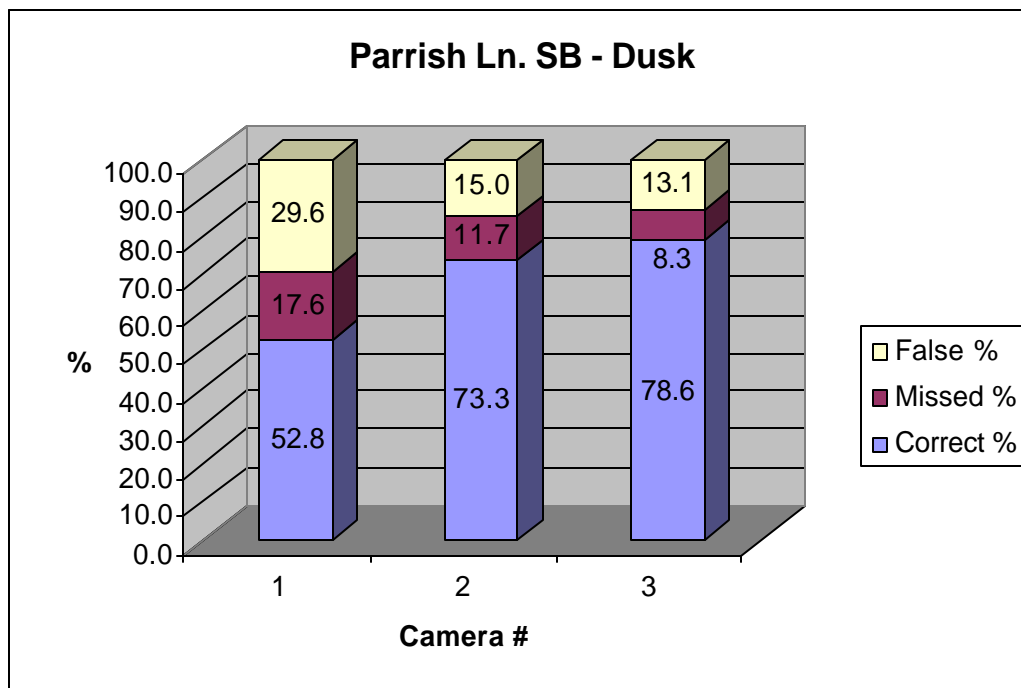
Figure 6.23: Performance of SB Parrish Lane in the Dusk Condition

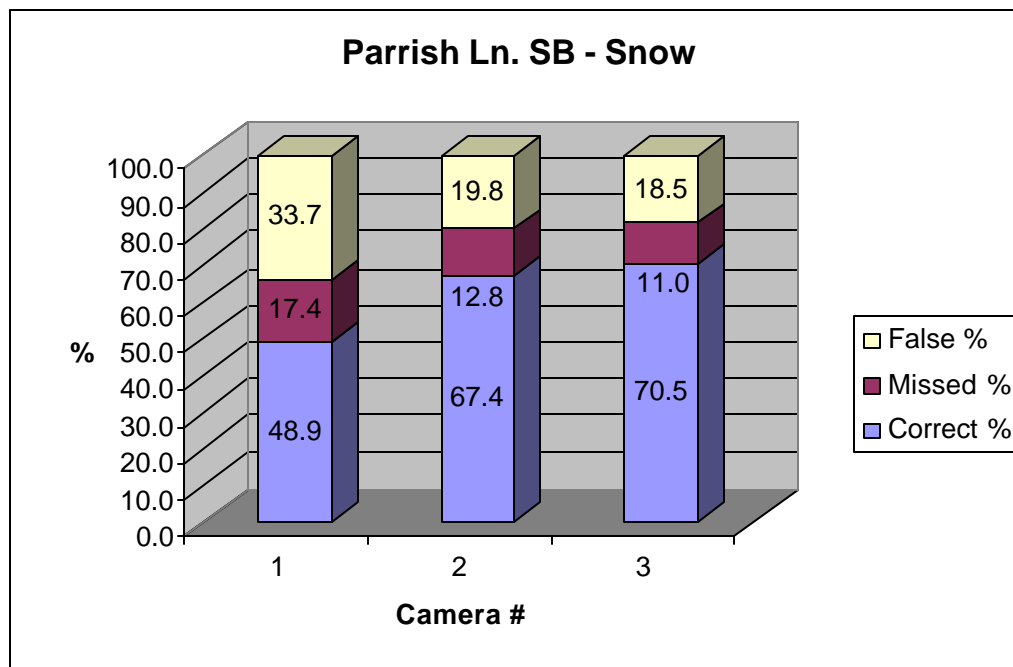
Figure 6.24: Performance of SB Parrish Lane in the Snow Condition

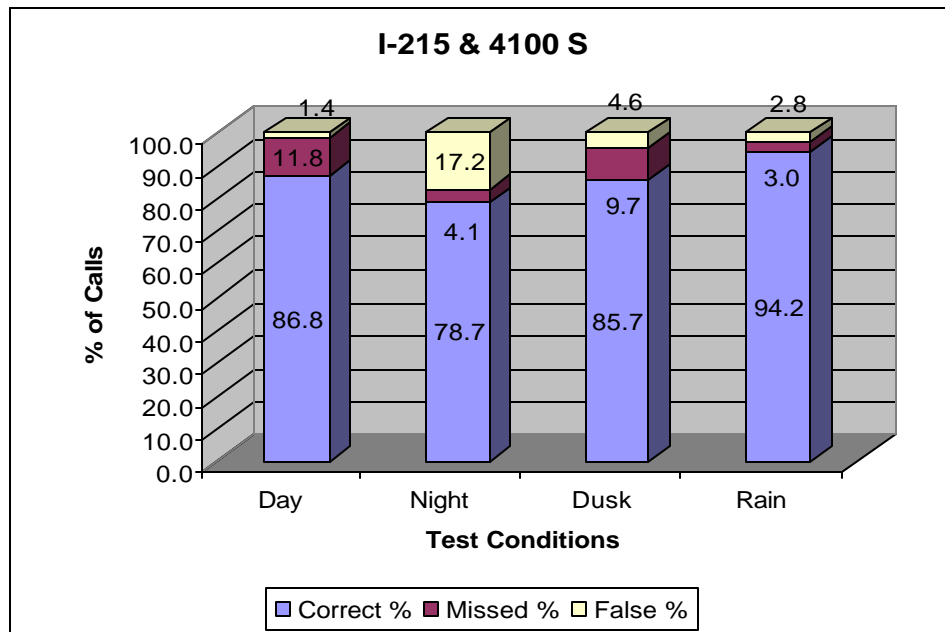
Figure 6.25: Overall performance of 4100 S and I-215 in Various Test Conditions

Like the Peek Systems, the false calls for the night condition were produced because of headlight activation of detectors. The missed calls were produced for various reasons. The main reason was dark vehicles blending in with the background (class A). Also, the detectors on the SB travel lane dropped the detection of vehicles which stopped over the stop line (class B). There were a higher number of vehicles in this lane during the day and dusk conditions. Because of the above stated reasons, these conditions had higher percentages of missed calls. However, on the whole, this system seemed to perform well in all the conditions.

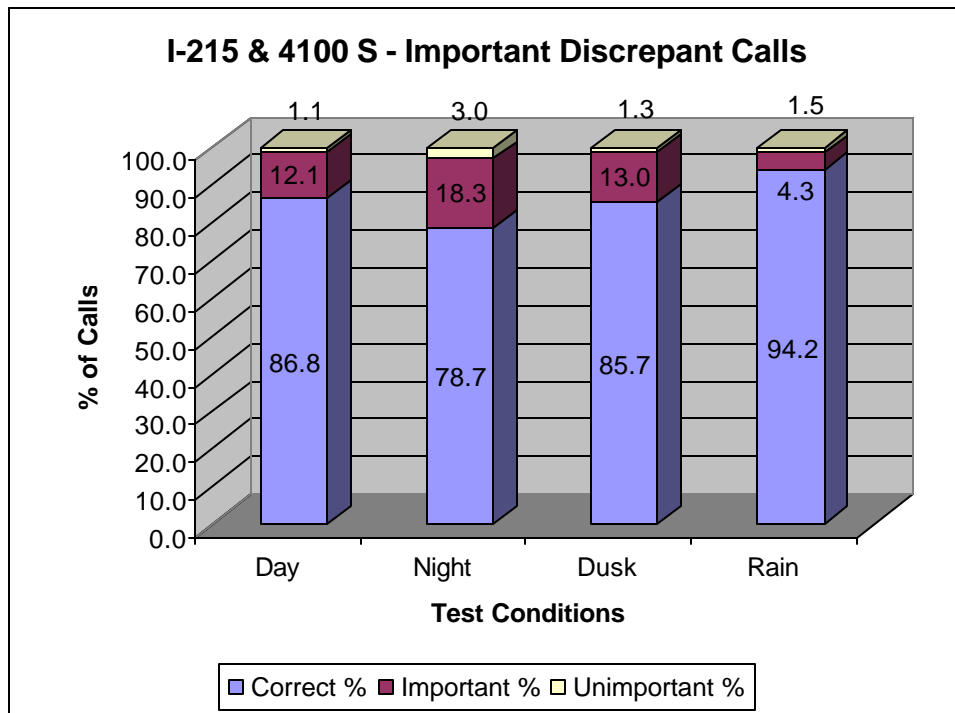
Figure 6.26: Important Discrepant Calls at 4100 S and I-215 in Various Test Conditions

The percentage of important discrepant calls is shown in Figure 6.26. Most of the discrepant calls at this location have to do with vehicles blending in the background and headlights activating the detectors (classes A and H, respectively). The range of these calls ranged from 4.3 percent to 18.3 percent, with the lowest percentage for the rain condition and the highest for the night condition.
