Evaluation of UDOT'S Video Detection Systems

System's Performance in Various Test Conditions

December 2004

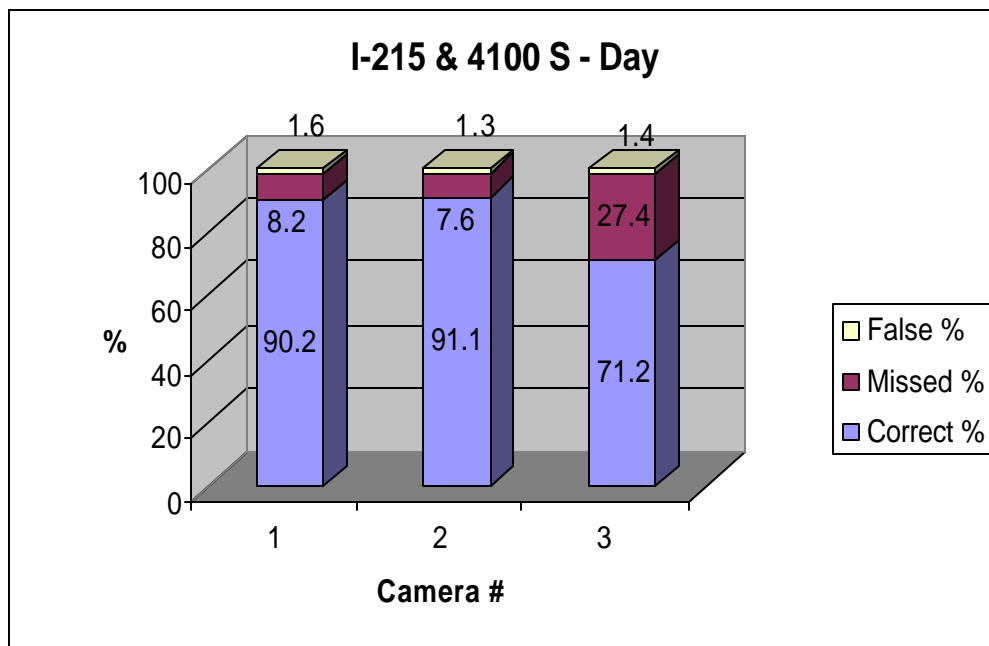
Figure 6.27: Performance of I-215 & 4100 S in the Day Condition

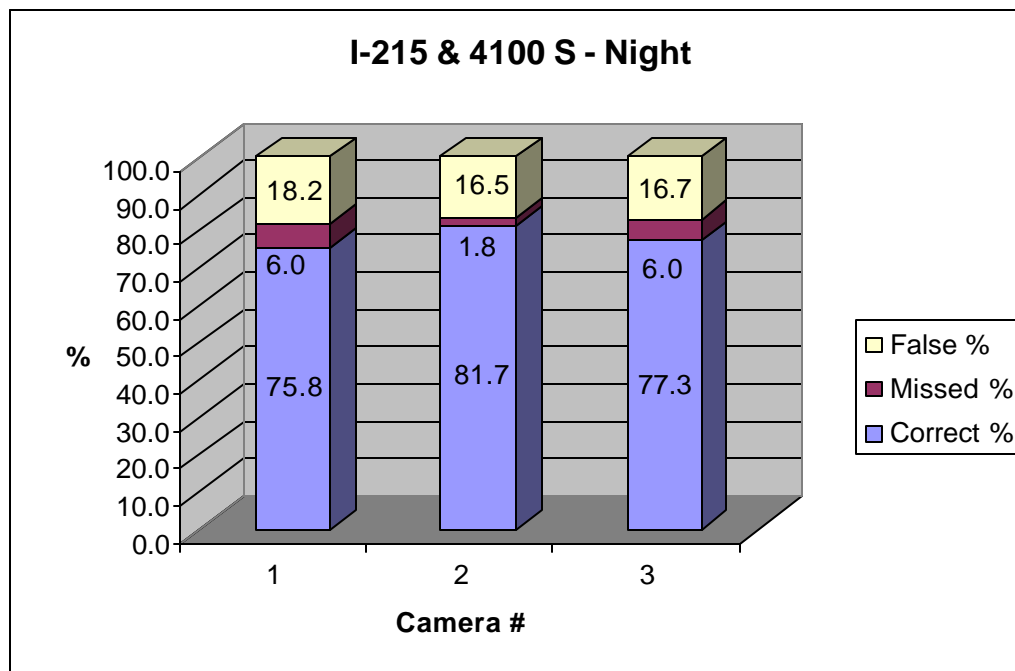
Figure 6.28: Performance of I-215 & 4100 S in the Night Condition

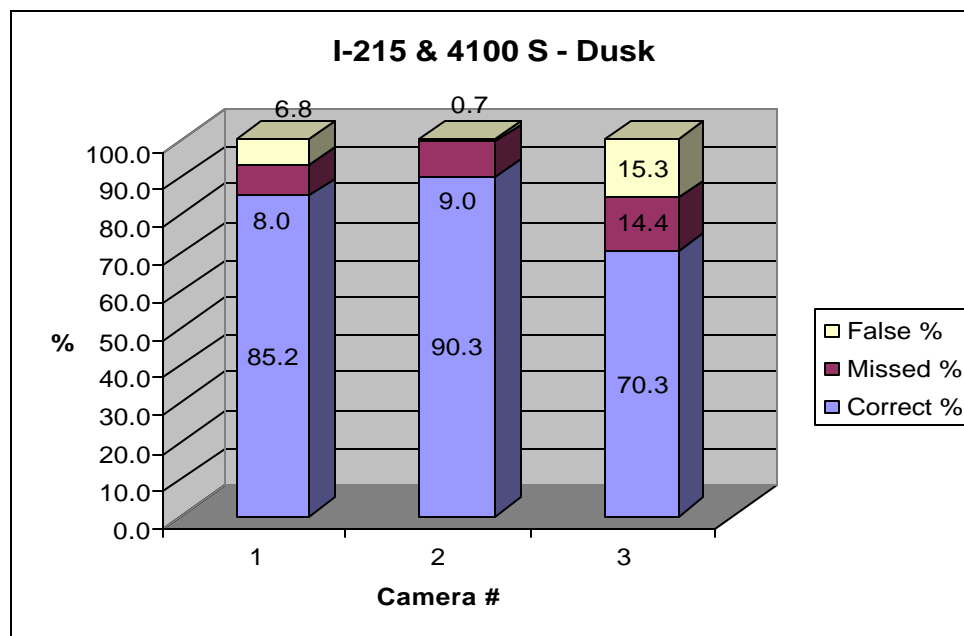
Figure 6.29: Performance of I-215 & 4100 S in the Night Condition

Figure 6.29 showed a variation of correct and discrepant calls from one camera to another for the dusk condition. Camera 1 showed about 6.8 percent false calls and 8 percent missed calls, while camera 3 produced twice the number of false and missed calls of camera 1. Camera 2 showed the least amount of false calls (< 1%) and about 9 percent missed calls.

The reason for false calls in all the cases was the multiple detections of vehicles (class K). This was the primary reason for the high percentage of false calls in camera 3. Activation of detectors because of headlights (class H) also caused false calls in camera 1. The high percentage of missed calls was due to vehicles blending in with the background (class A). Dropping of detection as the vehicles stopped on the stop line (class B) and dropping of vehicles in the detection zone (class E) were also noted. The dropping of detection as vehicles stopped on the stop line was only noted in camera 1.

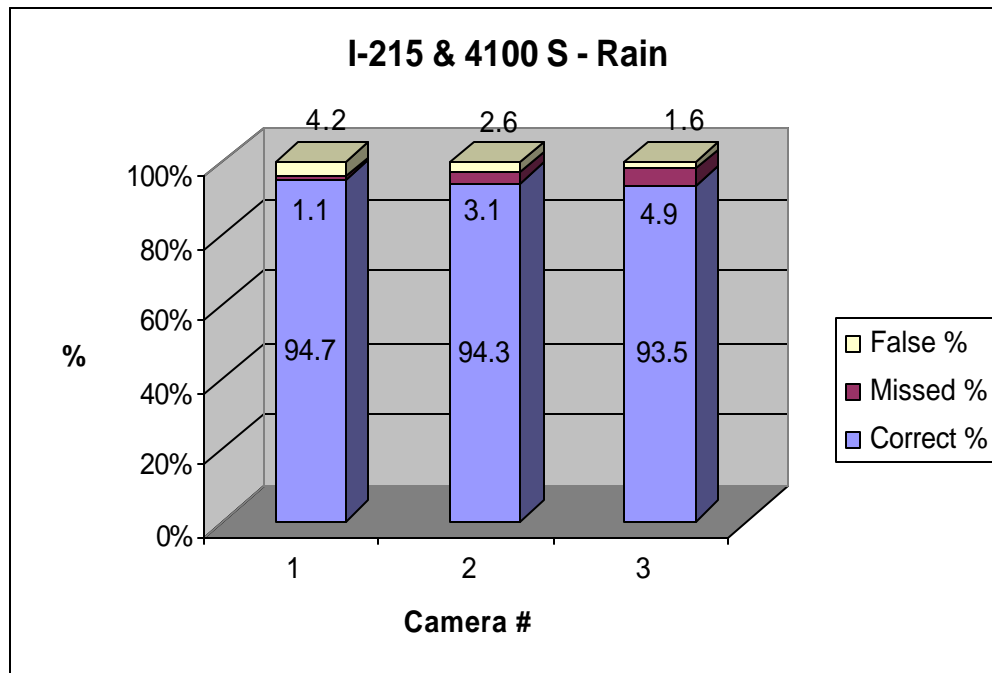
Figure 6.30: Performance of I-215 & 4100 S in the Rain Condition

Figure 6.30 shows the performance of the system in the rain condition. The system performed very well during the bad weather condition. A higher illumination level than the other locations could be one reason for this. The percentage of correct detection in all the cameras was noted to be over 93 percent. The small amount of false calls was because of detector activation due to headlights (class H). Vehicles blending in with the background (class A) and vehicle's stopping past the detectors and being dropped (class B) were the reasons for the missed calls.

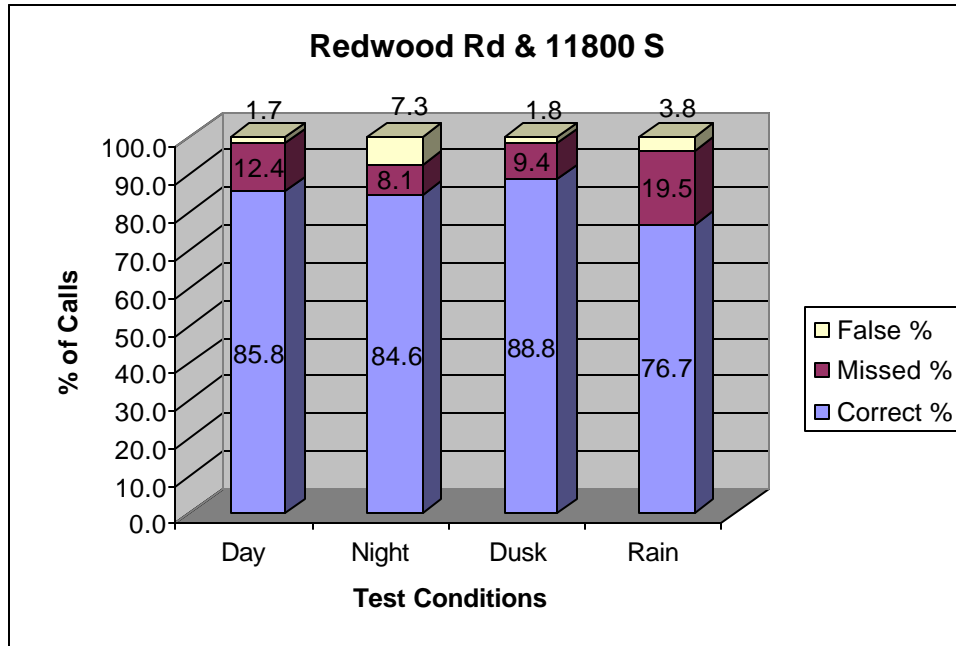
Figure 6.31: Overall performance at Redwood Rd and 11800 S in Various Test Conditions

Figure 6.31 shows the overall performance of this system in all the weather conditions. When compared to the I-215 & 4100 S intersection, this intersection seemed to produce a higher number of missed calls. But the correct detection at this intersection was in the same range as I-215 & 4100 S. It was observed that the missed calls were mainly caused by the geometry of the location. Cameras 1 and 2 did not have proper right turning pockets. At times the right turning vehicles in camera 1 moved onto the through lane. The through-moving vehicles consequently moved onto the stripped median instead of waiting for the right turning vehicles to finish their maneuver. Thus the through vehicles missed these detectors. Camera 2 also faced a similar problem with right turning vehicles missing the detectors. This error is most likely associated with the geometry of the location and public behavior. Vehicles blending in with the background also added to the percentage of missed calls. Headlight activation and multiple detection of the dilemma detector in camera 3 produced the high percentages of false calls.

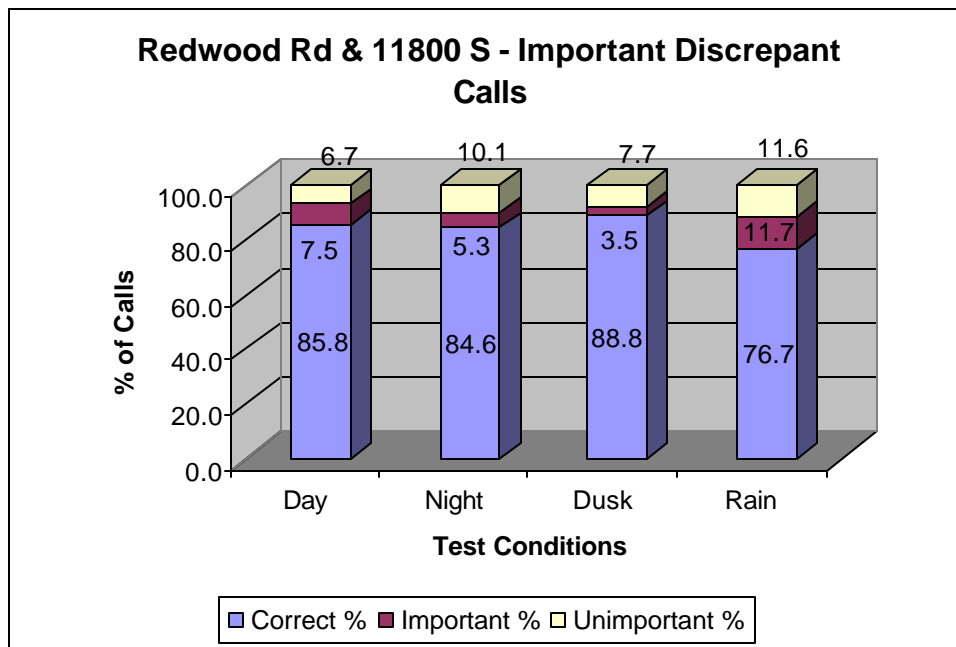
Figure 6.32: Important Discrepant Calls at Redwood Rd and 11800 S in Various Test Conditions

Although the system produced about 15 percent discrepant calls, the discrepant calls which could affect the signal timings were noted to be in the range of 3.5 percent to 11.7 percent. This is shown in Figure 6.32. The highest percentage of important calls was noted for the rain condition and the least for the dusk condition. Only class A was considered an important missed discrepant call. Even though cameras 1 and 2 missed right turning vehicles because of improper lane width and detector placement and this location allowed right turn for vehicles in the red phase, this was not considered a major issue.

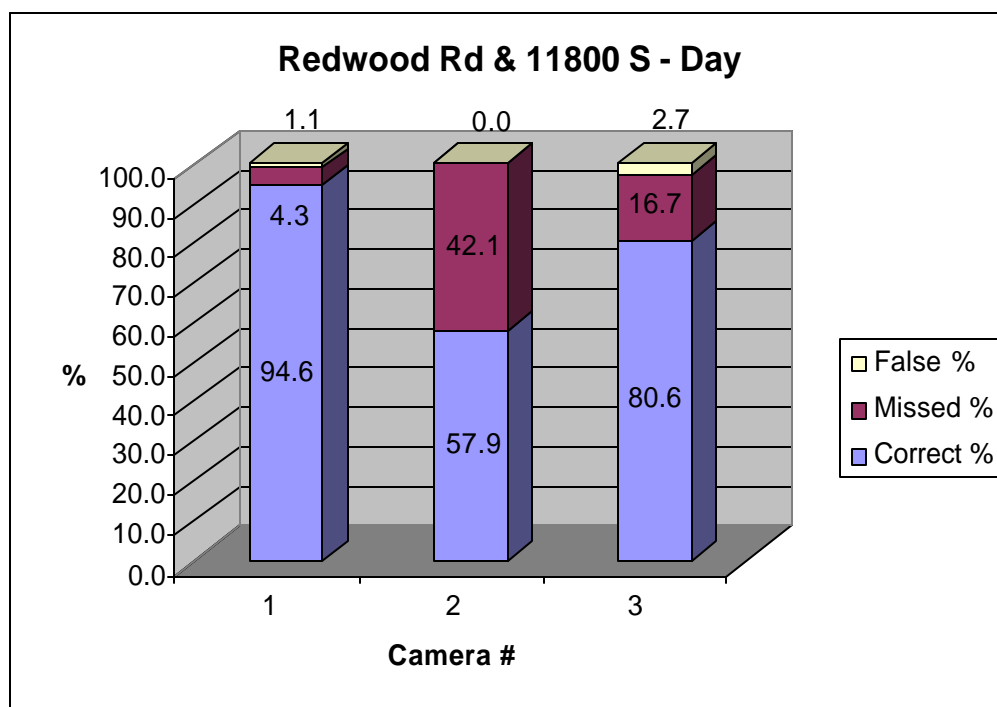
Figure 6.33: Performance of 11800 S & Redwood Road in the Day Condition

The analysis in Figure 6.33 shows that the system provided a higher percentage of missed calls than false calls. This is evident from the values shown by cameras 2 and 3. Correct detection was much higher for cameras 1 and 3 than for camera 2. The main reason for the missed calls in cameras 1 and 2 was vehicles blending in with the background (class A). Lane geometry and detector placement were the other reasons. Dropping of calls (class E) was also observed in camera 2. The missed calls in camera 3 were associated with classes A and E. False calls were observed because of multiple detections (class K) and extended detection (class J).

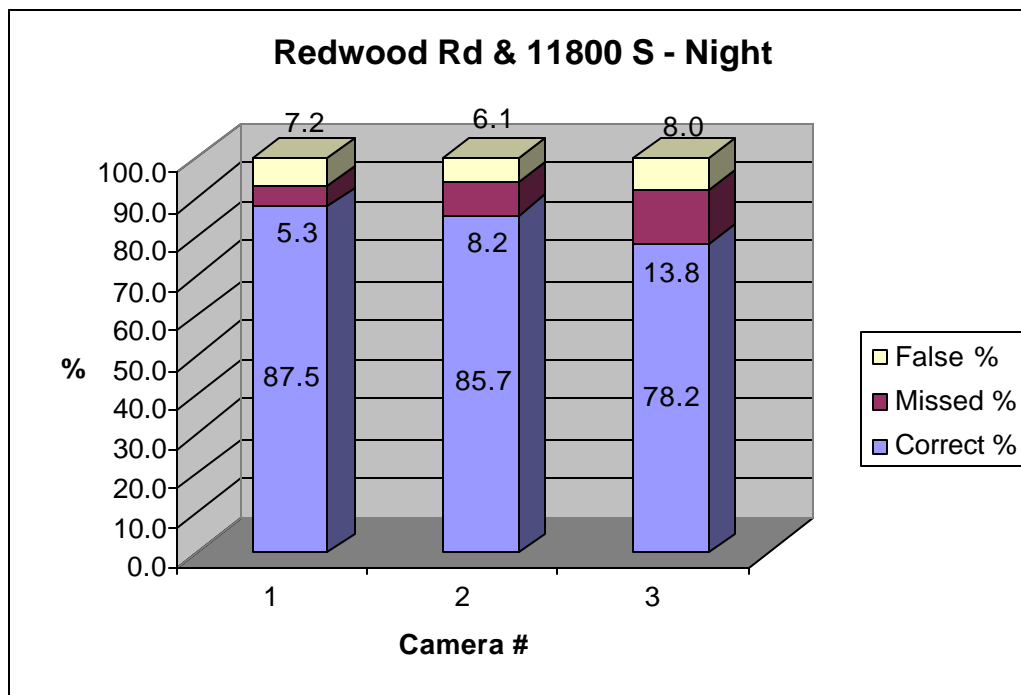
Figure 6.34: Performance of 11800 S & Redwood Road in the Night Condition

Data analysis for the night condition is shown in Figure 6.34. Correct detection for the cameras range from 78 percent to 88 percent while discrepant calls range from 12 percent to 21 percent. The performances of cameras 1 and 2 are nearly similar, with a slight difference in missed calls. The reasons for false and missed calls are similar to the day condition. Additionally, headlight activation of detectors increased the percentage of false calls in the night condition when compared to the day condition.

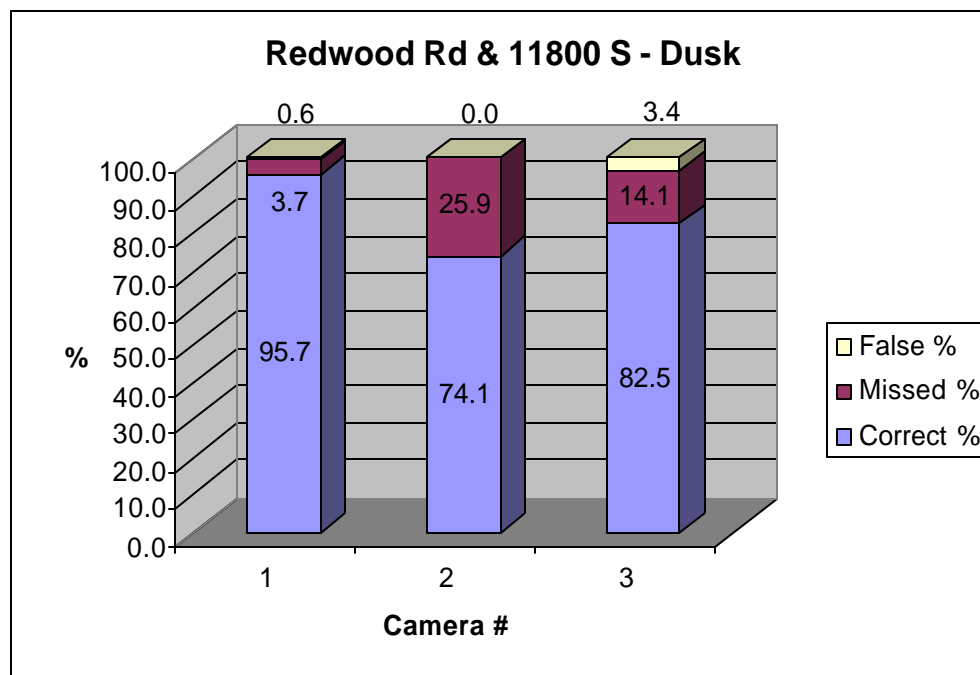
Figure 6.35: Performance of 11800 S & Redwood Road in the Dusk Condition

The data analysis in Figure 6.35 shows that the system worked well in the dusk condition. The performance of camera 1 seems to be the best, with about 95.7 percent correct detection. While cameras 2 and 3 have a decent value of correct detection (about 74.1 percent and 82.5 percent, respectively), the high values of missed calls seemed to bring down the performance of the system. Similar reasons for the high percentage of discrepant calls were noticed for this condition. The high percentage of missed calls in camera 2 was associated with vehicles blending in with the background and dropped detection in the detection zone.

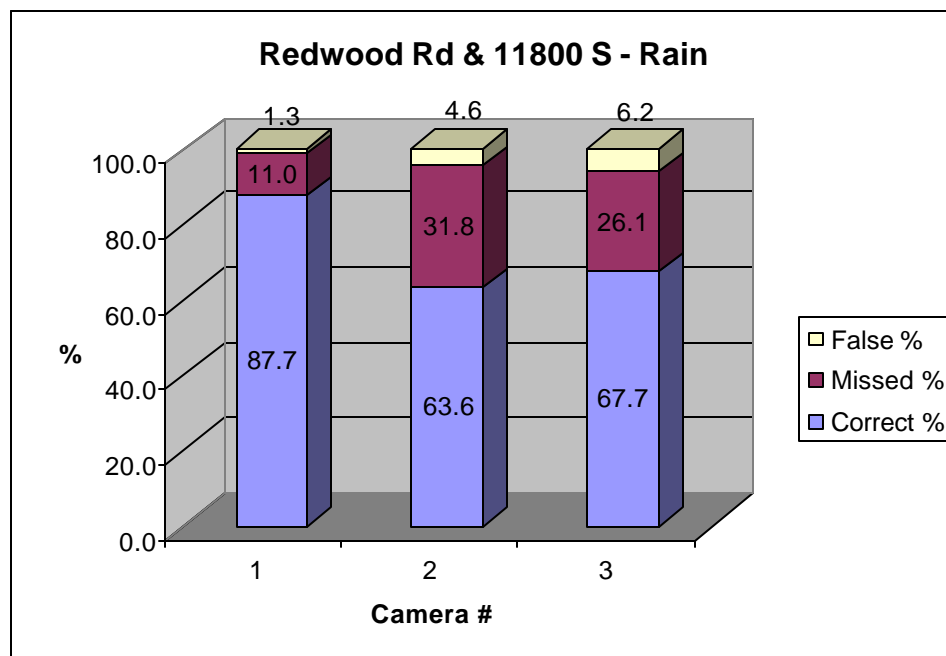
Figure 6.36: Performance of 11800 S & Redwood Road in the Rain/Snow Condition

From Figure 6.36 it is observed that only camera 1 seems to perform well in the bad weather condition with about 12 percent discrepant calls. The other 2 cameras showed about 32 percent to 35 percent discrepant calls. The reasons for this occurrence were similar to that of the day, night and dusk conditions. Missed calls for camera 2 could be explained by the high percentage of vehicles blending in with the background (class A), dropped detection (class E), and right turning vehicles moving onto the curb as the vehicles in front of them are waiting for the signal to change. For camera 3, the majority of the missed calls occurred because of vehicles blending in with the background. The asphalt roads looked much darker due to rain and all the dark vehicles were missed. When a green phase was given to EB traffic (camera 2), queues developed in the NB lanes (camera 3). During this time, the dilemma detectors missed most of the vehicles. The reasons for false calls are similar to the reasons stated for the other test conditions.

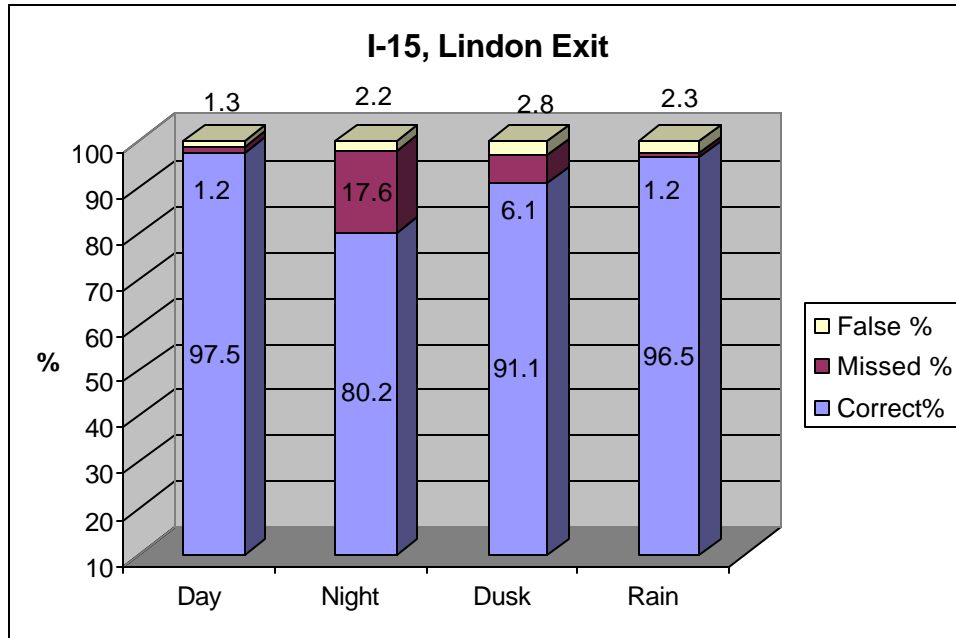
Figure 6.37: Overall performance of the I-15 Lindon Exit in Various Test Conditions

The overall performance of the system is shown in Figure 6.37. This system produced a minimal amount of false calls. Unlike the other systems, false calls were not produced because of headlight activation of detectors (class H). Vehicles activating the detectors in the adjacent lanes were the primary reason for the false calls in most of the cameras.

There was not a significant amount of missed calls except for the night and dusk condition. During the data analysis, it was observed that a call was not given, although the detectors were activated. This seemed to start during the dusk period and worsen at night, which explains the higher percentage of missed calls at night. The lower percentage of missed calls during the rain condition suggested that the system was fixed.

During data reduction it was also observed that most of the left turning vehicles for camera 1 made the maneuver before reaching the stop line, thus missing detection. It was also noted that all the cameras showed more of the other legs of the intersection rather than the subject approach. False calls in all the cameras were caused by vehicles in the adjacent legs of the intersection activating the detectors in the subject lanes.

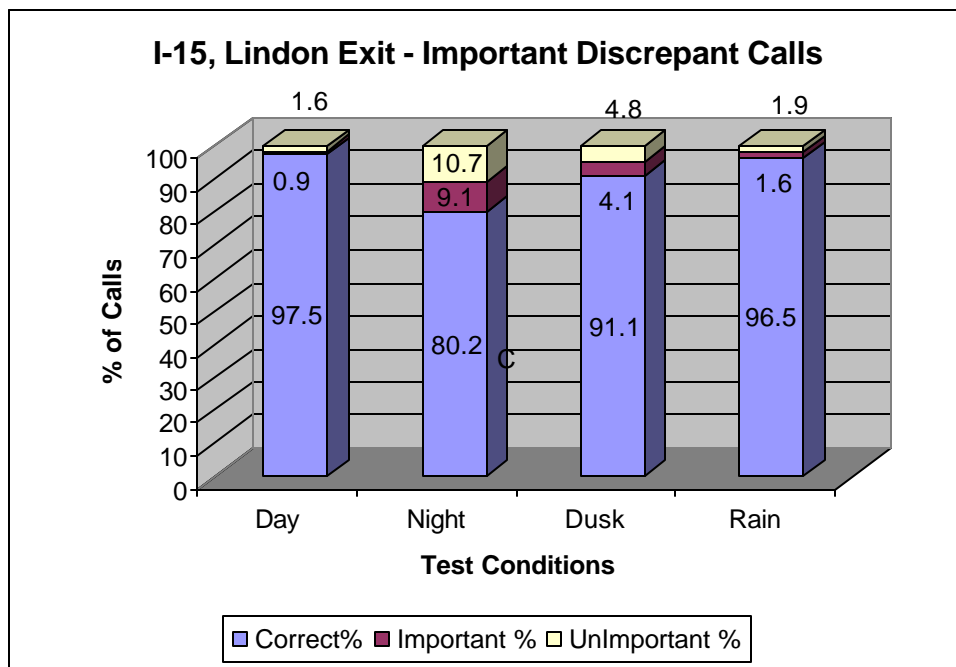
Figure 6.38: Important Discrepant Calls at the I-15 Lindon Exit in Various Test Conditions

Figure 6.38 shows the important discrepant calls for all the conditions. It should be noted that the lowest amount of these calls were produced during the day condition and the highest during the night condition. The left turn phase in camera 1 being protected/permissive, missed calls during the red phase were noted as important missed calls. This could be one of the reasons for the decrease in important discrepant calls at this location.

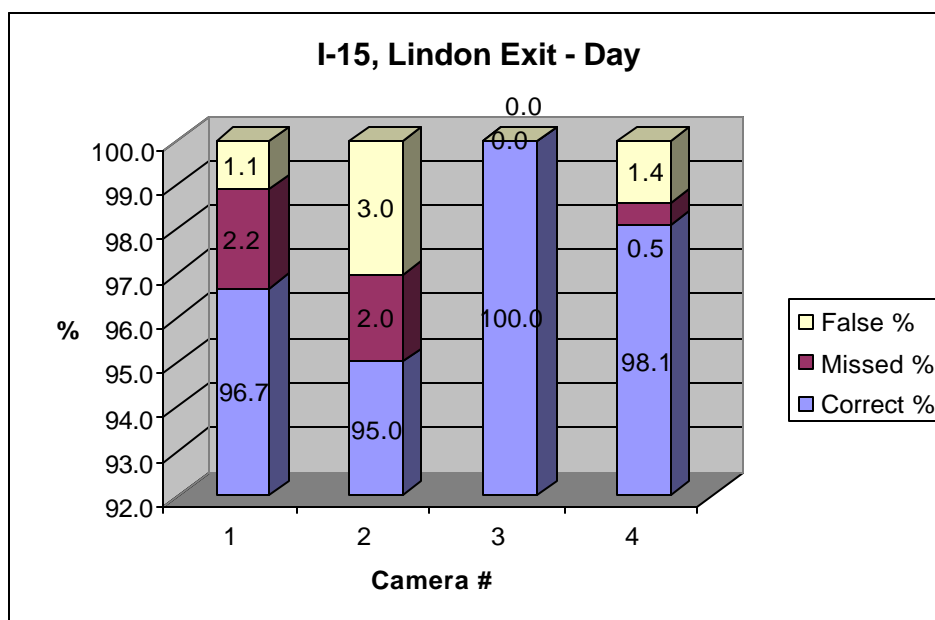
Figure 6.39: Performance of the I-15 Lindon Exit in the Day Condition

Figure 6.39 shows the performance of the cameras for the day condition. It should be noted that the system has a correct call percentage of 95 percent, the highest so far. Missed calls observed in camera 1 were reasoned to be the left turning vehicles making the maneuver before reaching the detection zone. Camera 2 observed about 5 percent discrepant calls. The false calls observed in this camera were because of right turning vehicles activating the detectors in the through lanes. The same was the case for camera 4, with the only difference being that the detectors were activated because of WB traffic.

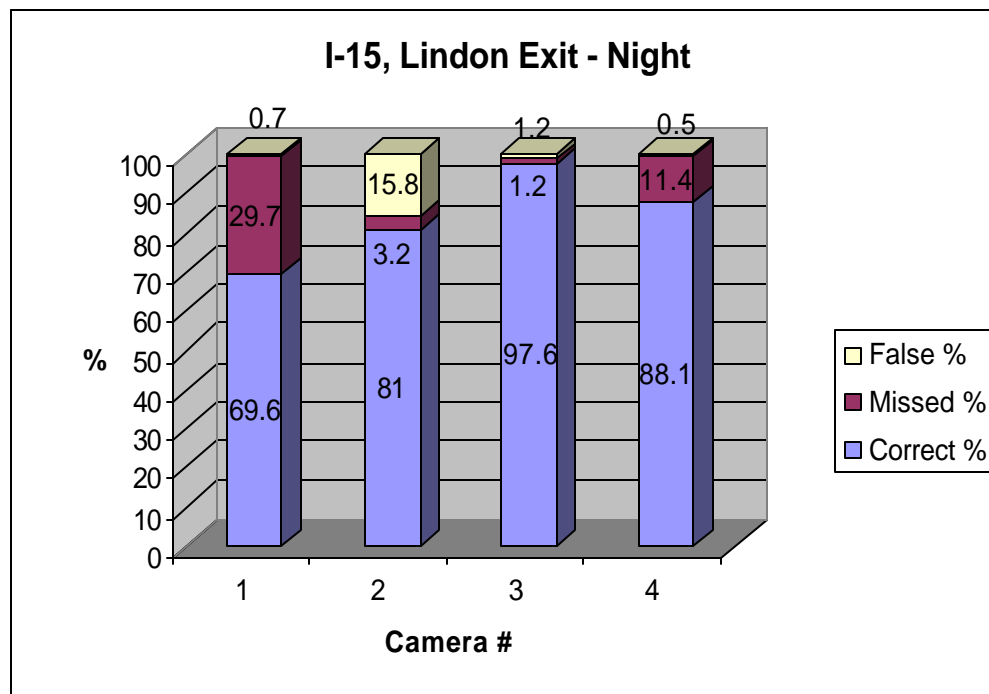
Figure 6.40: Performance of the I-15 Landon Exit in the Night Condition

The data analysis for the clear/night condition is shown in Figure 6.40. Cameras 1 and 4 showed higher percentages of missed detection. Vehicles turning left before reaching the detection zone were the only reason observed for the missed calls in camera 1 the 11.4 percent missed calls in camera 4 were associated with the system defect as explained in the overall performance. The high percentage of false calls in camera 2 was mainly associated with vehicles activating the detectors in the adjacent lanes. A slight amount of headlight activation of detectors (class H) also added to the false calls.

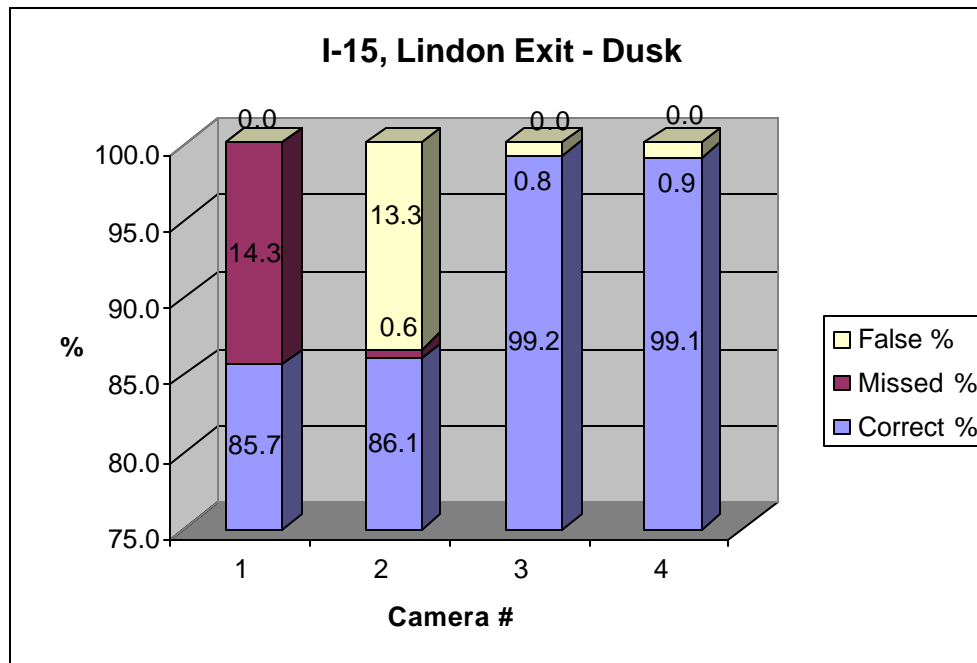
Figure 6.41: Performance of the I-15 Lindon Exit in the Dusk Condition

The performance of the system in the dusk condition is shown in Figure 6.41. Cameras 1 and 2 have a correct detection percentage of about 86 percent. Camera 1 observed about 14.3 percent missed calls while camera 2 produced 13.3 percent false calls. The reasons for these discrepant calls are the same as for the clear/day and clear/night. Cameras 3 and 4 performed extremely well in this condition with as little as 1 percent false calls and no missed calls. The correct detection for these cameras is about 99 percent.

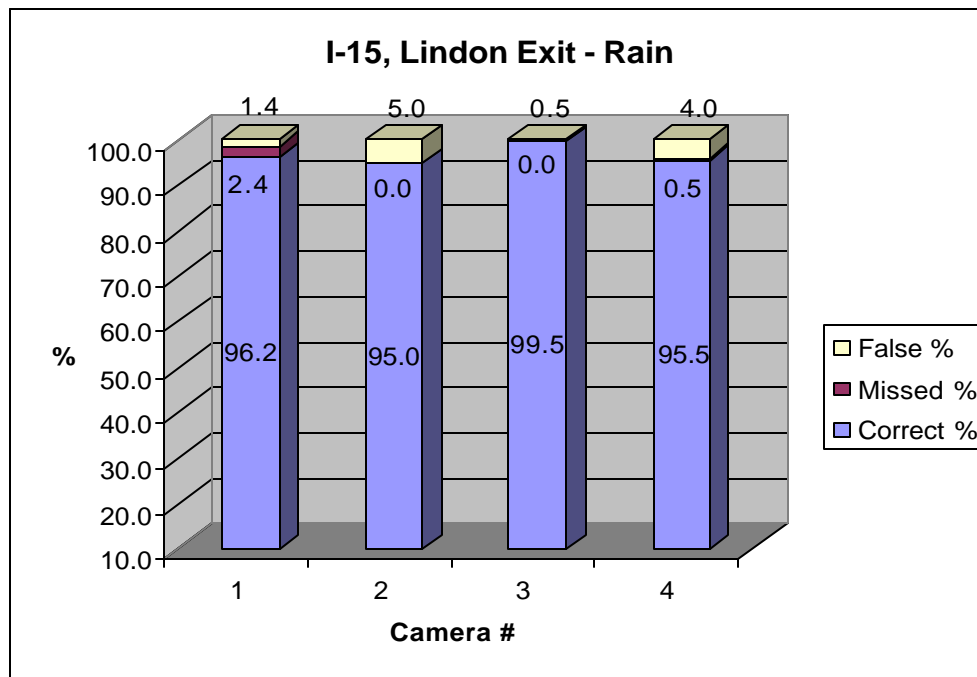
Figure 6.42: Performance of I-15 Lindon Exit in the Rain Condition

Figure 6.42 shows that the system worked well in the bad weather condition. Correct detection in all the cameras is over 95 percent. Camera 3 has the highest percentage of correct detection. In cameras 2 and 4, about 4 percent false calls brought down the correct detection value to about 95 percent. The reasons for discrepant calls in camera 1 were similar to the reasons stated for the other test conditions. False detection in camera 2 was because of the adjacent vehicles activating the detectors in the subject lane. There were a couple of calls because of headlight activation of detectors. The activation of detectors because of a spider on the lens of camera 2 added to the false calls percentage. Camera 4 observed false calls because of headlight activation of detectors.

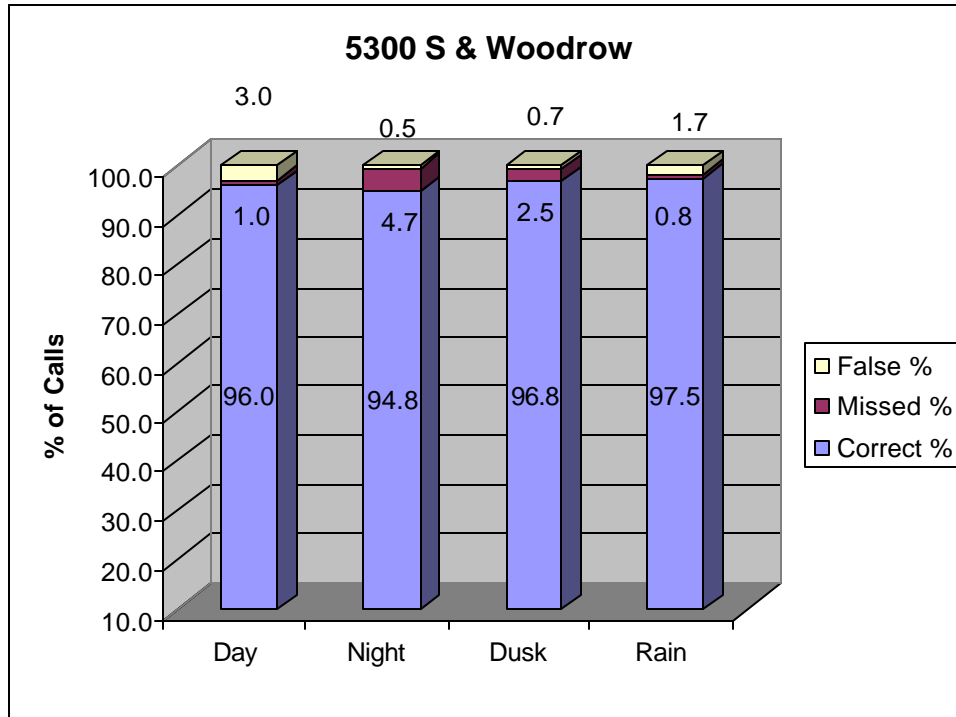
Figure 6.43: Overall performance at 5100 S and Woodrow in Various Test Conditions

The overall performance of this system is shown in Figure 6.43. The discrepant calls in all the test conditions were less than 5.2 percent. Thus it could be said that this system performed better than the other systems. The day condition produced the highest number of false calls. Shaking of the camera was observed during the day condition because of wind. During this condition, detectors were constantly giving a call even when vehicles were absent. This error seemed to have been rectified because the system showed fewer false calls in the other test conditions, which were tested after the day condition.

Camera 1 faces an access lane parallel to the SB direction. The vehicles from these lanes that join the NB traffic stopped on the detectors at an angle. This was due to a lower turning radius of that lane which produced high false calls in camera 1. The occurrence of missed calls was mainly associated with vehicles moving on the stripped median. During the night condition, the system seemed to produce no calls, even though vehicles traveled the lanes. Also, the focus of the cameras was not clear during the night condition.

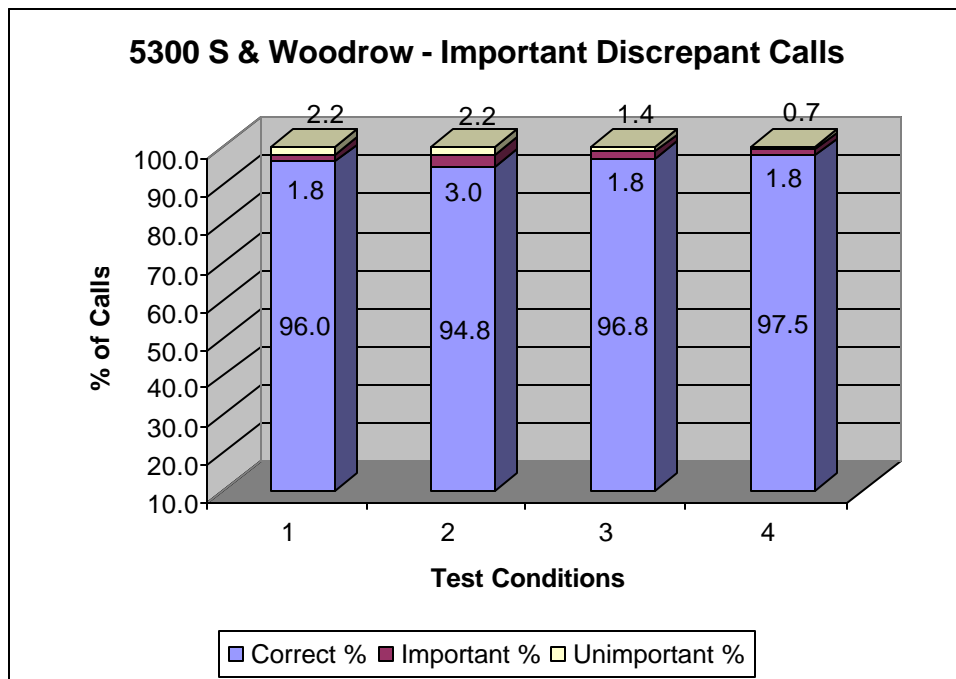
Figure 6.44: Overall performance at 5100 S and Woodrow in Various Test Conditions

Figure 6.44 shows the important discrepant calls produced by the system. The low percentage of these calls shows that the system performed well at this intersection. Camera 2 showed 3 percent important discrepant calls, though the system produced about 5.2 percent discrepant calls on the whole.

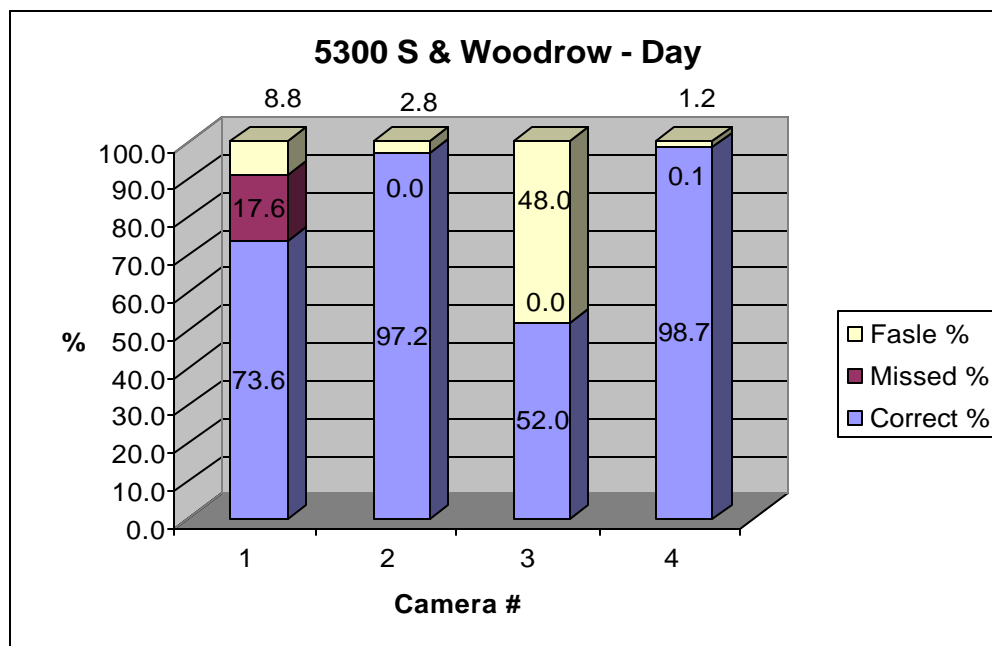
Figure 6.45: Performance of 5300 S & Woodrow in the Day Condition

The data was recorded on a breezy day. Considerable shaking of the camera was observed during the data reduction process. The high percentage of false calls in camera 3 was because the detector in the left turn lane gave multiple calls when there were no vehicles present in the zone. When a vehicle was present, it produced constant calls, but as soon as the vehicle left the zone multiple calls resumed. This error could be associated with the shaking of the cameras. There is also the possibility of a defect in the connections of the system. This was the main reason for the high percentage of false calls in camera 3. Camera 1 observed about 9 percent false calls due to vehicles from the exit lane joining the NB lanes. The vehicles moved on the through and the left turned detectors to join the NB traffic. Because of this maneuver, detectors were activated and false calls were generated. The SB direction had comparatively less traffic when compared to the other directions. Therefore, even a slight amount of false calls could have resulted in an exaggerated result, as shown in Figure 6.45.

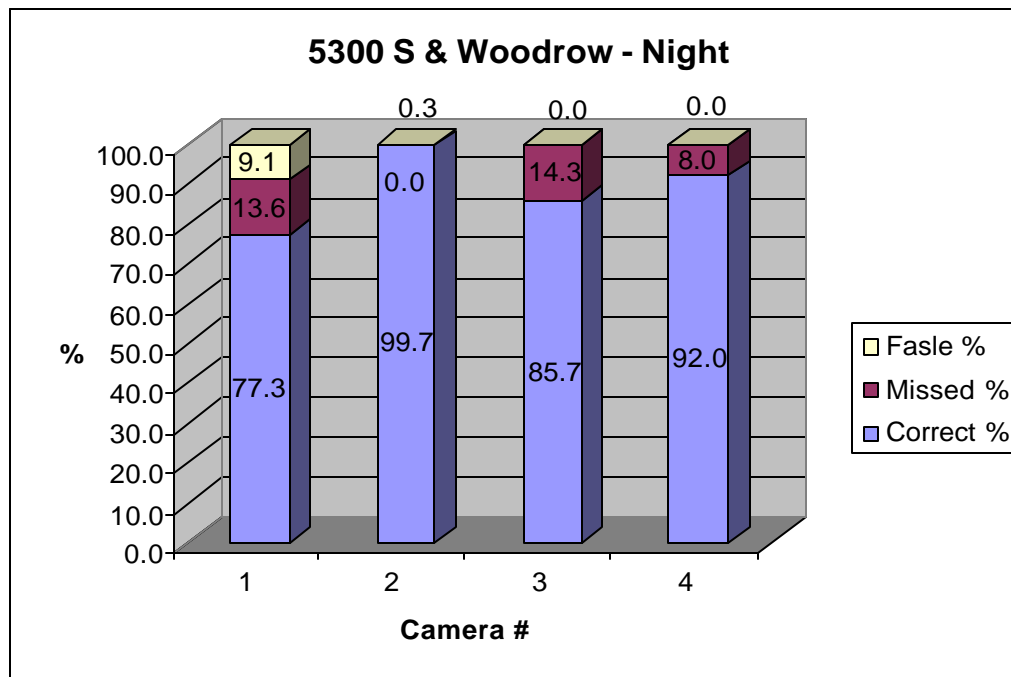
Figure 6.46: Performance of 5300 S & Woodrow in the Night Condition

Figure 6.46 shows the performance of the system in the night condition. The correct detection percentage ranged from 77.3 percent to 99.7 percent. Missed calls occurred because the vehicles moved on the median and were not detected (class D). The false calls can be explained by the vehicles activating the vehicles in adjacent lanes (class I). Camera 2 seemed to perform well in this condition with about 99.7 percent correct detection. While cameras 3 and 4 produced no false calls, there were about 8 percent to 14.3 percent missed calls. The missed calls in camera 4 were because calls were not placed when a vehicle was detected. This could be associated with the defect in the system.

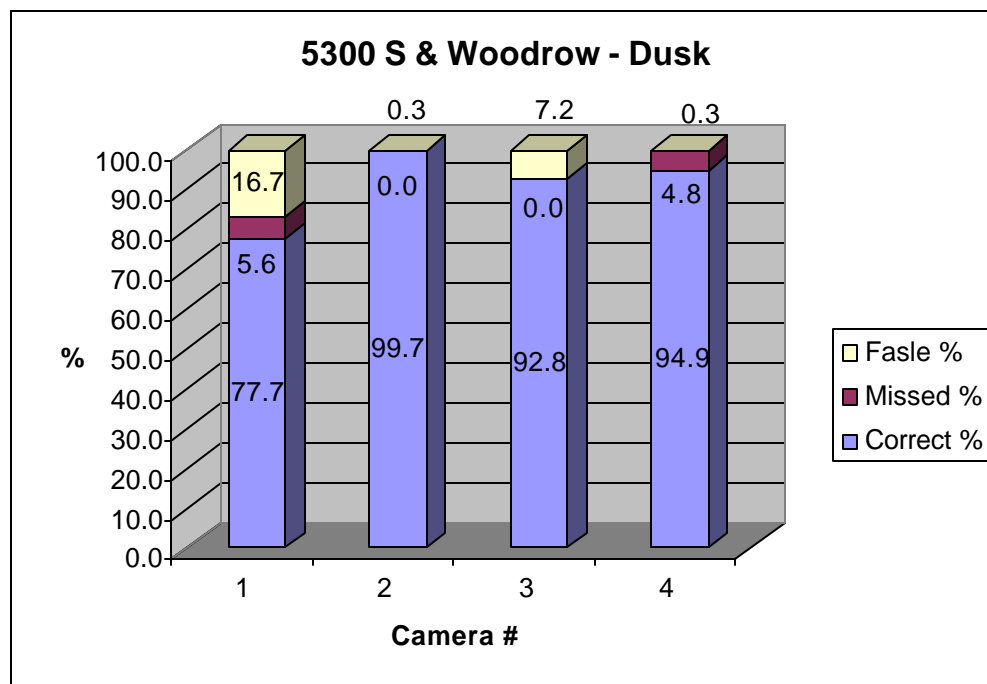
Figure 6.47: Performance of 5300 S & Woodrow in the Dusk Condition

Figure 6.47 shows that the system performed well with more than 90 percent correct detection in cameras 2, 3 and 4. During the data reduction, it was observed that the focus of this camera was blurry. A specific reason cannot be provided as to how the focus produced blurred images. A defect in the way the camera was connected could be one reason. Camera 2 performed well again, while cameras 3 and 4 had correct detection percentages of around 93 percent. Vehicles activating detectors in adjacent lanes caused false calls in camera 3.

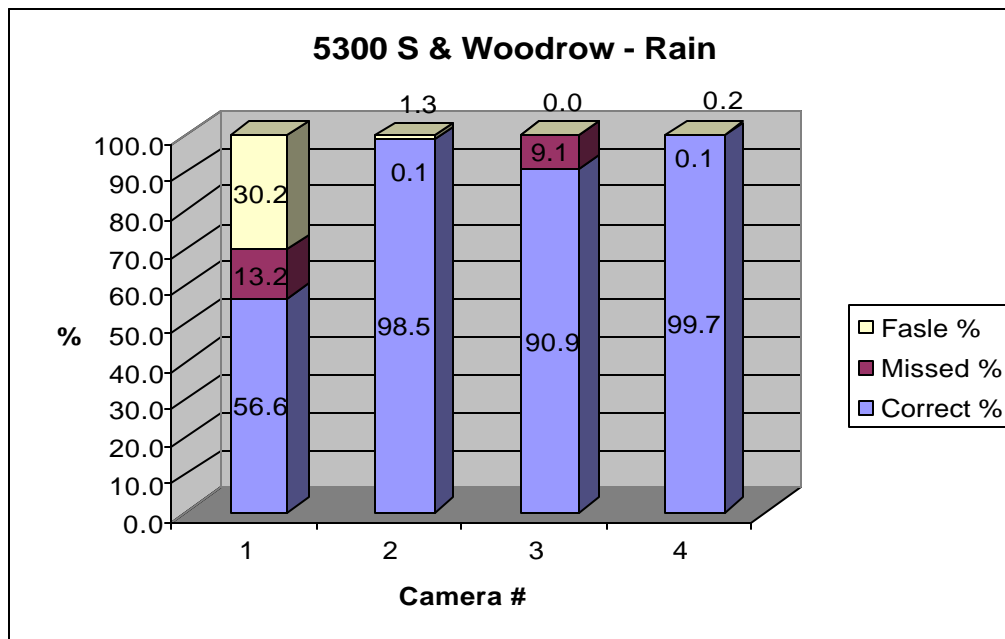
Figure 6.48: Performance of 5300 S & Woodrow in the Rain Condition

Figure 6.48 shows that most of the false calls produced by camera 1 were because of EB traffic activating the detectors when they moved across the stop line. Moreover, the vehicles from the exit stopped on the through lane at an angle. About 9 percent of the missed calls in camera 3 were because of the dropping of the calls in the detection zone (class E). This occurred because the vehicles were not fully in the detection zone. Other than that, this camera worked well in the other test conditions. Overall, camera 2 showed a consistent performance under all the test conditions with a correct detection percentage of about 97 percent to 98 percent. This location did not produce false calls because of headlight activation and extended detection. The geometry of the location could be one reason for the false calls produced by the system.

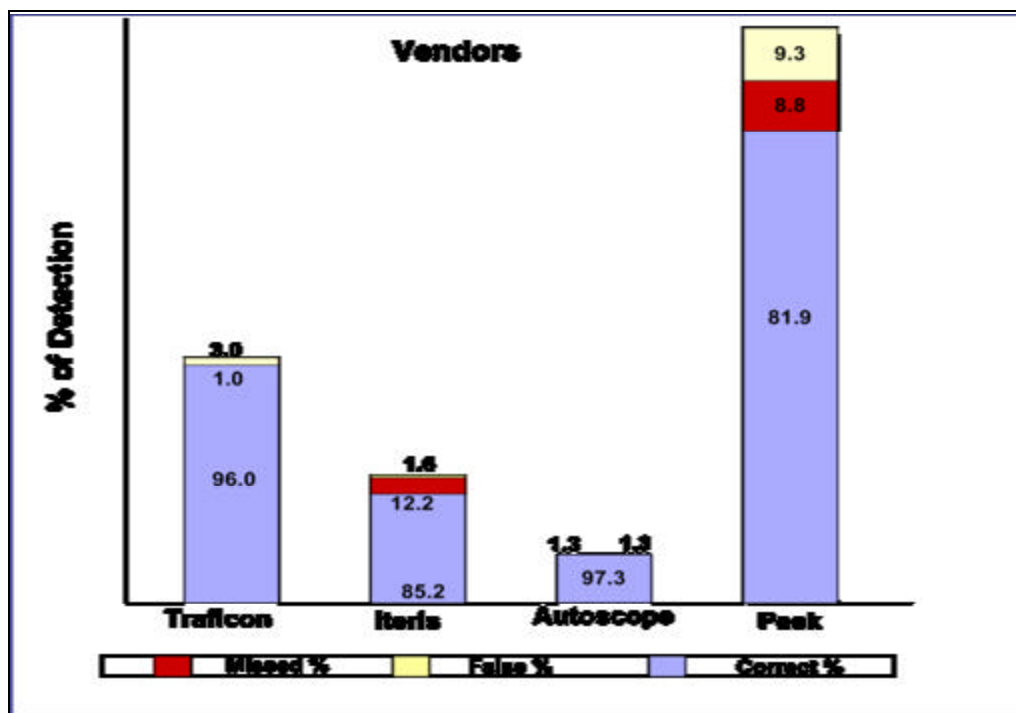
Figure 7.1: Vendor Performance in the Day Condition

Figure 7.1 shows the performance of the vendors for the day condition. Autoscope performed very well with 97.3 percent correct detection. The Traficon and Iteris systems generated 96 percent and 86.2 percent correct detection. False calls by Traficon were higher when compared to the Iteris system. The main reasons for false calls in Traficon were location geometry and a temporary defect in the system. However, Iteris generated high percentages of missed detection. The reasons for the missed detection were the dropping of detected calls and vehicles stopping over the stop line and consequently being dropped. Another reason was that dark vehicles blended in with the background.

Correct detection for Peek was the lowest (81.9 percent) when compared to the other systems. The dropping of detected vehicles in the red phase was the major reason for 8.8% of the missed calls. The majority of the false calls were caused by vehicles activating the detectors in the adjacent lanes. At some locations (1460 W & North Temple), pedestrians crossing at the intersections also activated the detectors. Overall, all of the vendors generated more than 81 percent correct detection.

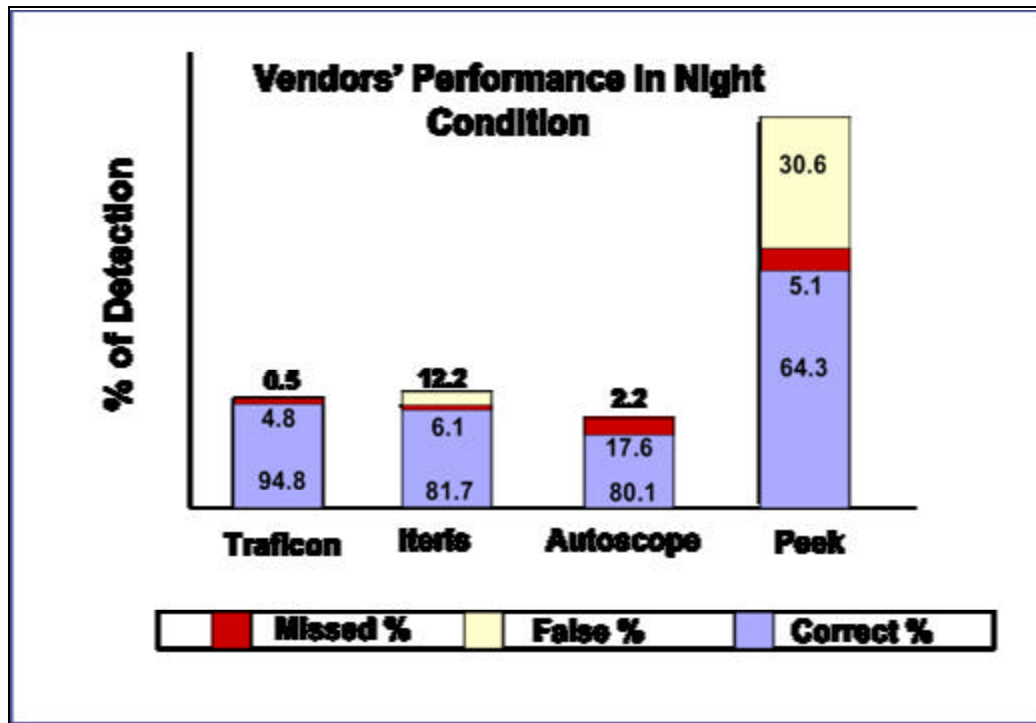
Figure 7.2: Vendor Performance in the Night Condition

Vendor performance for the night condition is shown in Figure 7.2. Peek generated the highest percentage of false calls (30.6%) because of headlight activation of detectors, extended calls and activation of detectors in the adjacent lanes. Most false calls produced by Iteris were due to headlight activation. Traficon and Autoscope produced the least amount of false calls for the night condition.

Traficon had the lowest number of missed calls, while Autoscope had the highest. The main reason for the high number of missed calls was associated with a temporary defect in the system. Vehicles were detected but no call was given to the traffic controller. Also, the placement of the detectors/detection zone on the WB approach was not accurate. The missed calls in Peek were caused entirely by the dropping of calls after detecting them, while Iteris observed a detection drop when vehicles stopped on the stop line and missed calls when vehicles traveled on the median on Redwood Road.

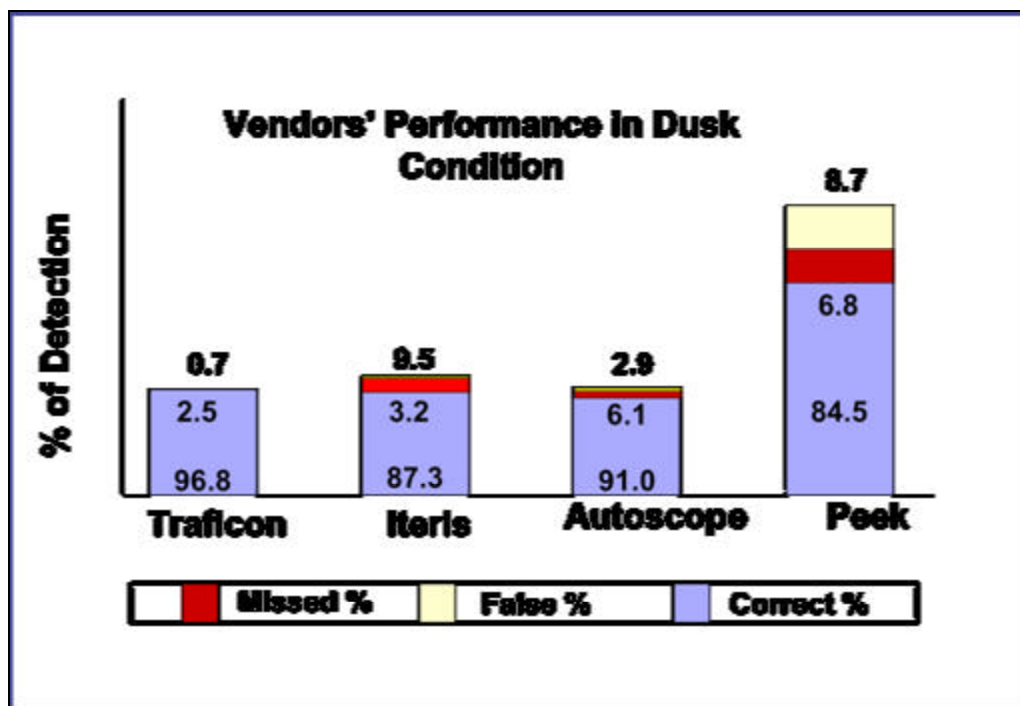
Figure 7.3: Vendor Performance in the Dusk Condition

Figure 7.3 shows that Traficon and Autoscope generated 91 percent correct calls. False calls in Traficon were caused by multiple detections and a temporary problem with the system and cameras. Considerable shaking of the cameras may have also added to the false calls. False calls in Autoscope were associated with a temporary defect in the system's connections. Vehicles activating the detectors in adjacent lanes also generated false calls.

False calls in the Peek systems were due to extended detection, headlight activation of detectors and vehicles activating the detectors in adjacent lanes. These types of discrepant calls were mostly observed at 1460 W and North Temple and at the Parrish Lane NB off ramp. Missed calls in Peek were mostly because of dropped detection. Missed calls with Iteris were due to vehicles blending in with the background. Therefore, most dark vehicles were not detected. Moreover, at I-215 and 4100 S, the vehicles stopping over the stop line were dropped. At Redwood Road and 11800 S, missed calls were generated because of vehicles moving very close to the median and sometimes moving onto the stripped median.

On the whole, the systems seemed to perform well with Traficon and Autoscope, producing more than 90 percent correct detection. Iteris produced about 84 percent correct detection. The discrepant calls generated by Peek systems during the dusk condition were much lower when compared to the night condition.
