Evaluation of UDOT'S Video Detection Systems

System's Performance in Various Test Conditions

December 2004

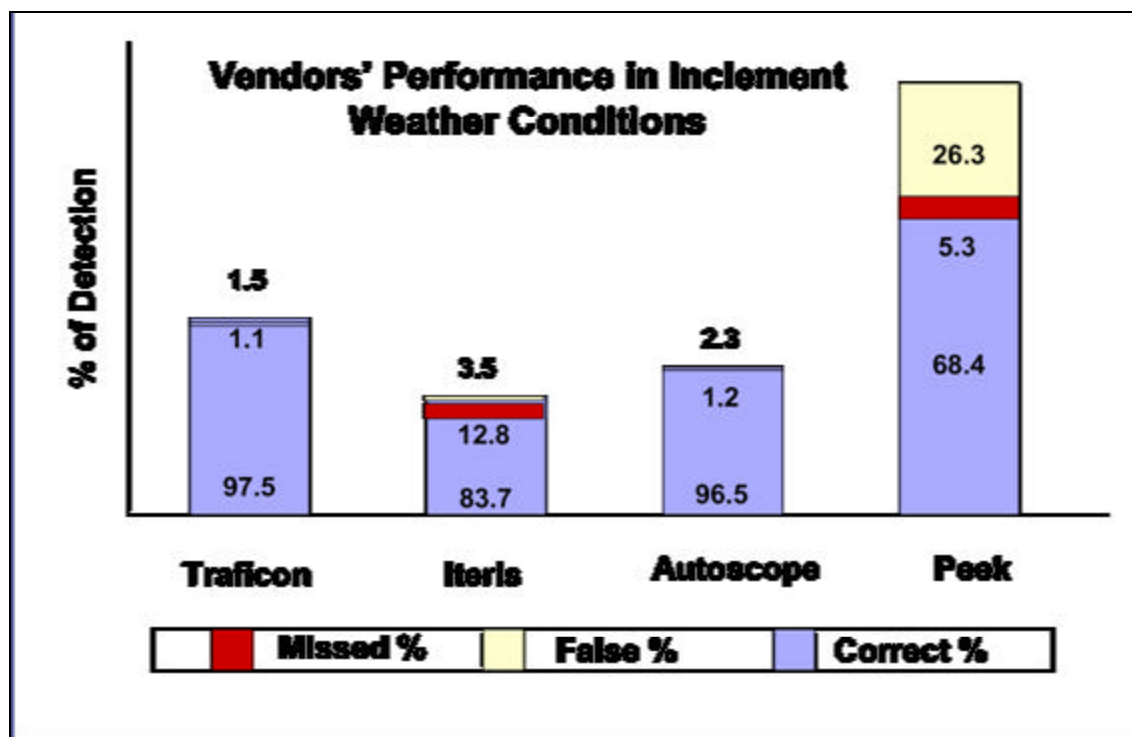
Figure 7.4: Vendor Performance in Snow/Rain/Fog Conditions

Vendor performance in Figure 7.4 shows that Traficon and Autoscope generated over 95 percent correct detection. Iteris produced a higher number of missed calls (12.8%). On the other hand, 26.3 percent false calls dominated the discrepant calls in Peek systems.

Headlights activating the detectors, vehicles activating the detectors in the adjacent lanes and extended detection were the major reasons for false calls in the Peek systems. The high percentage of missed calls in the Iteris system were mainly associated with vehicles blending in with the background and dropped detection as vehicles stopped over the stop lines at I-215 & 4100 South. Redwood Road caused missed calls because of vehicles moving onto the stripped median and right turning vehicles missing the detectors. Dark vehicles blending in with the background were also observed at this location.

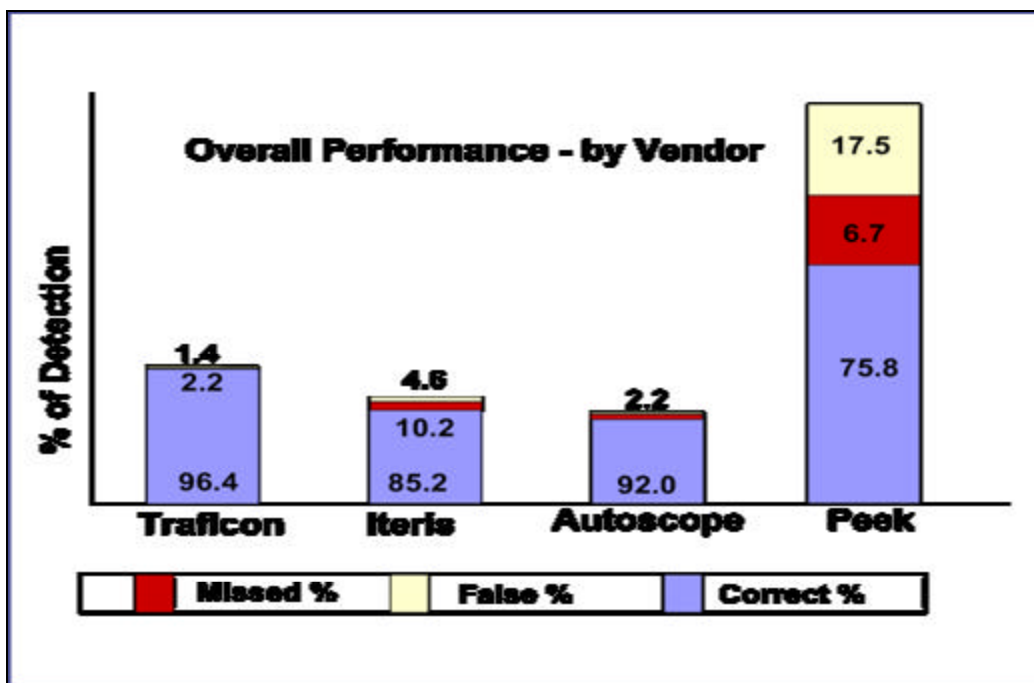
Figure 7.5: Overall Performance of Vendors in Test Conditions

Figure 7.5 shows vendor performance under all test conditions. It is observed that the highest percentage of missed calls was produced by Iteris, followed by Peek and Autoscope. The main reasons for the high percentage of missed calls in Iteris were associated with vehicles blending in with the background, placement of detectors and lane geometry at Redwood Road and 11800 S. Also, dropping of detection because vehicles stopped over the stop line caused missed detection at I-215 & 4100 S. Missed calls with Autoscope were mainly associated with a temporary defect in the system at the I-15 Lindon Exit. Improper placement of the detection zone also caused missed calls at this intersection. The missed calls with Peek systems were mainly because of dropped detection in the detection zone.

False calls in the Peek systems were mainly due to headlight activation of detectors, extended detection and vehicles activating the detectors in the adjacent lanes. The camera's FOV at some locations operating on Peek provided views of the other approaches to the intersection. This activated the detectors in the subject approach. About 4.6% of the false calls in Iteris were caused by headlight activation of detectors and multiple detections.

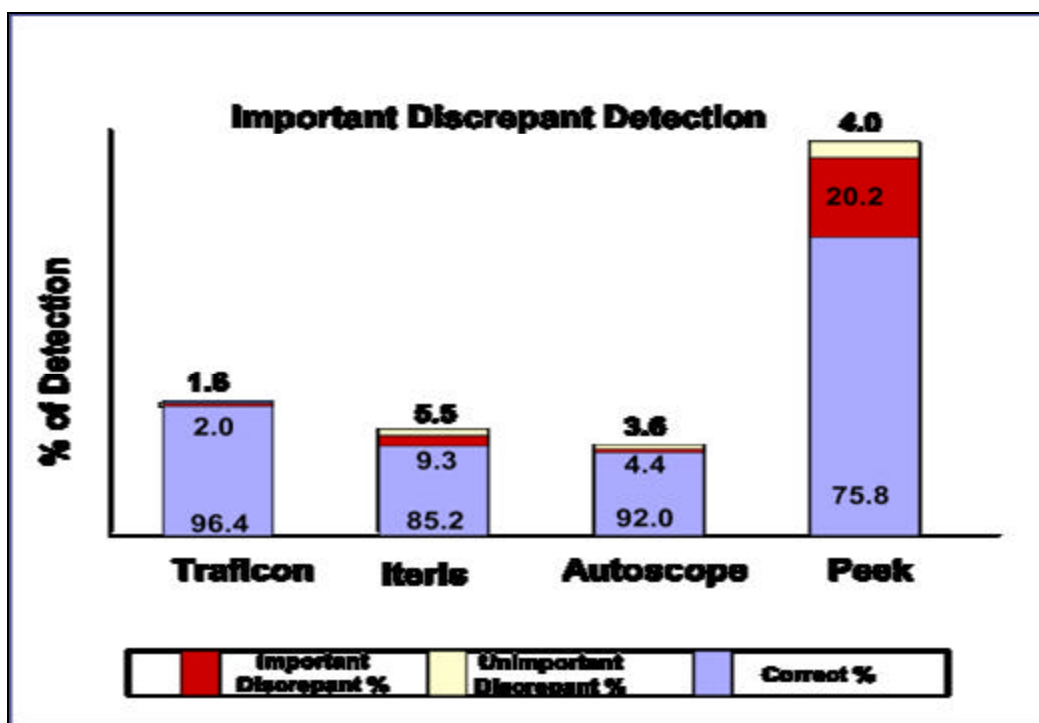
Figure 7.6: Vendor Performance and Important Discrepant Calls

The statistical test was also performed for the important discrepant calls generated by the vendors under various test conditions. It showed that the results varied statistically because of the large sample sizes. At a 99 percent confidence level, it showed that Traficon performed better than Autoscope in all the test conditions. It can also be inferred that Traficon performed better than the Iteris and Peek systems.

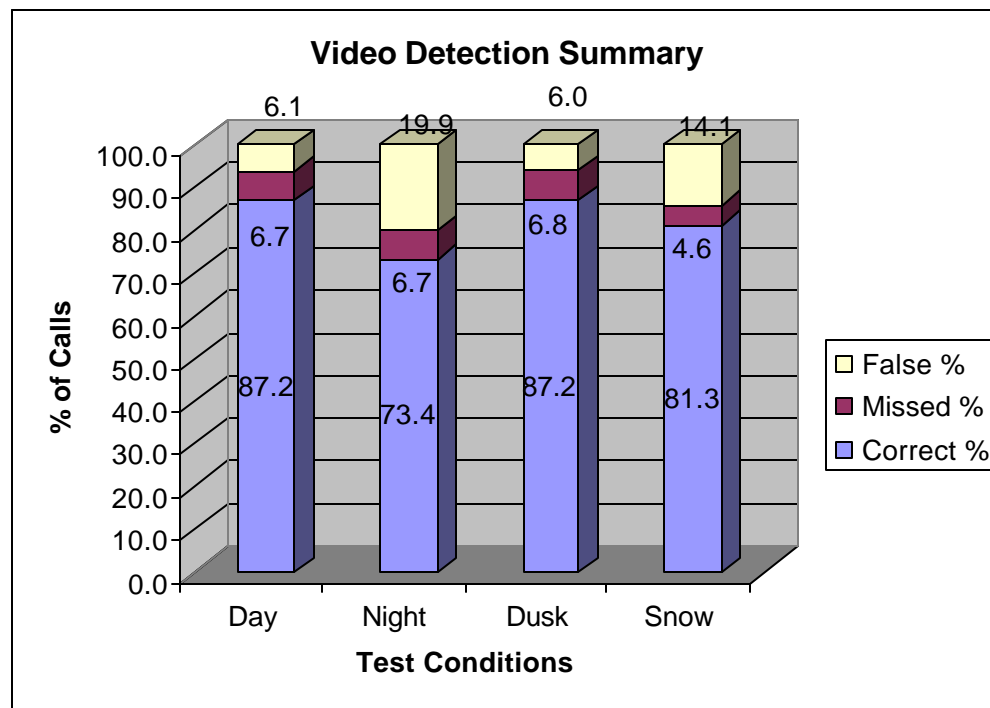
Figure 7.7: Video Detection Summary in Various Test Conditions

Figure 7.7 shows the general performance of all the vendors under different test conditions. The day and dusk conditions showed similar performances, generating correct detection percentages of 87.2 percent. The highest number of discrepant calls (26.6 %) was obtained for the night condition. Correct detection during the snow condition was noted as 81.3 percent, which was better than the night condition (73.4%).

The high number of false calls for the night and snow conditions was mainly associated with headlights activating the detectors. Some other reasons for false calls were vehicles activating the detectors in the adjacent lanes, extended detection and multiple detections. Missed calls in all the test conditions ranged from 4.6 percent to 6.8 percent. The main reasons for the missed calls were dropped detection, dark vehicles blending in with the background, vehicles moving on the median and vehicles stopping over the stop line and consequently being dropped. Right turning vehicles at some locations also missed the detectors, generating missed calls.

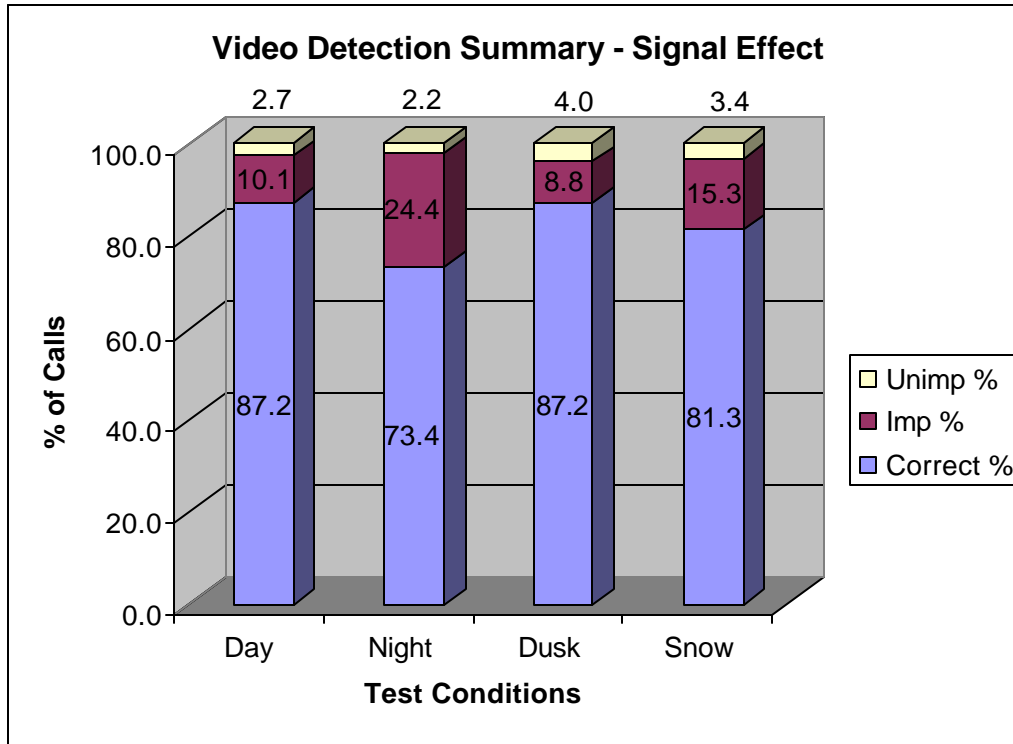
Figure 7.8: Important Discrepant Calls in Various Test Conditions

The important discrepant calls are shown in Figure 7.8. The highest percentage of important discrepant calls were observed for the night condition (24.4%), followed by the dusk condition (15.3%). The day and dusk conditions performed better, generating important discrepant calls below 10 percent. The statistical test between the day and dusk conditions, with important discrepant calls as the criteria showed that, at a 99 percent confidence level, the day and dusk conditions differed significantly. It can also be inferred from the test that video detection systems perform better in the dusk conditions than in the night and inclement weather conditions.

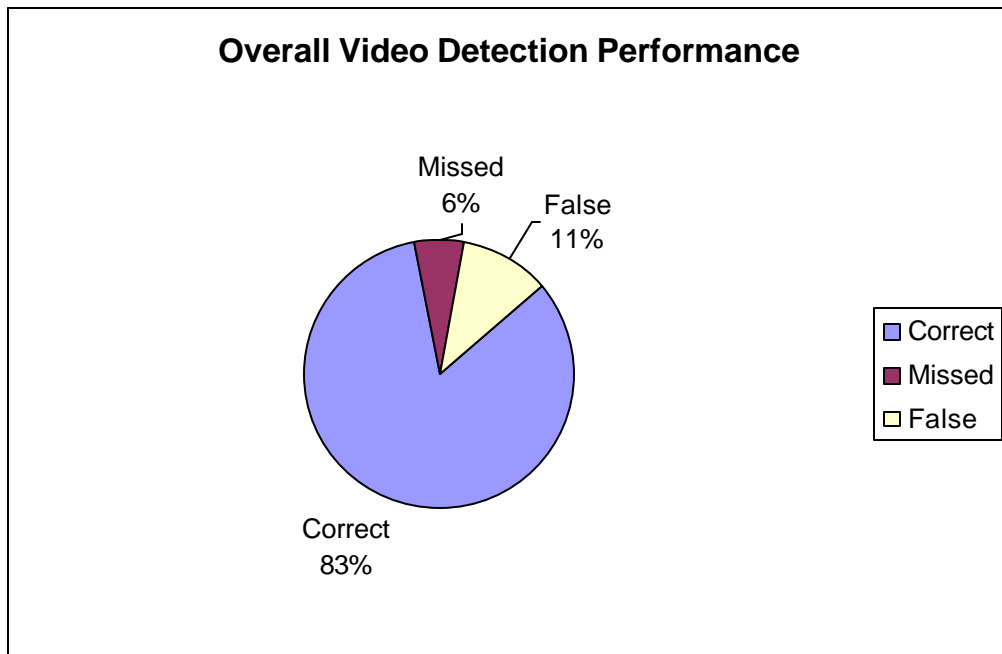
Figure 7.9: Overall Video Detection Performance

Figures 7.9 and 7.10 show the overall performance of video detection and the important discrepant calls affecting overall performance. There was 83 percent correct detection when the data was combined for all vendor and test conditions. It was observed that from the 17 percent discrepant calls, video detection generated higher percentages of false calls (11%) when compared to missed calls (6%). About 14 percent of the discrepant calls could have consequences on signal timings. This error rate was higher than for inductive loops (3%-9%) [11]. The consequences could be max out and gap out in the green phase. Queue formation and delays during the red phase could be related to missed detection in the red phase.

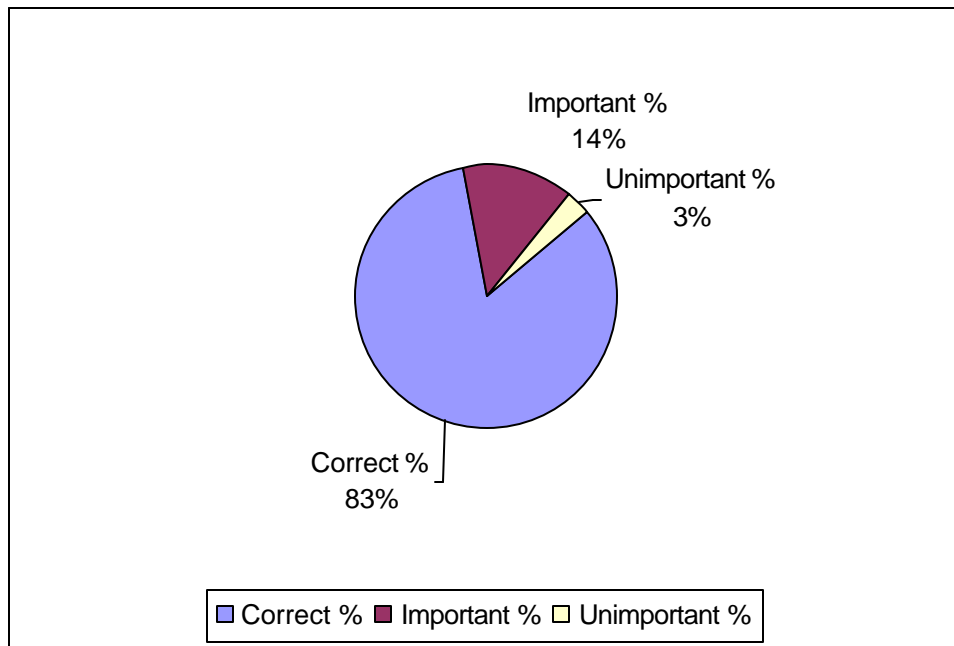
Figure 7.10: Overall Video Detection Performance – Important Discrepant Calls

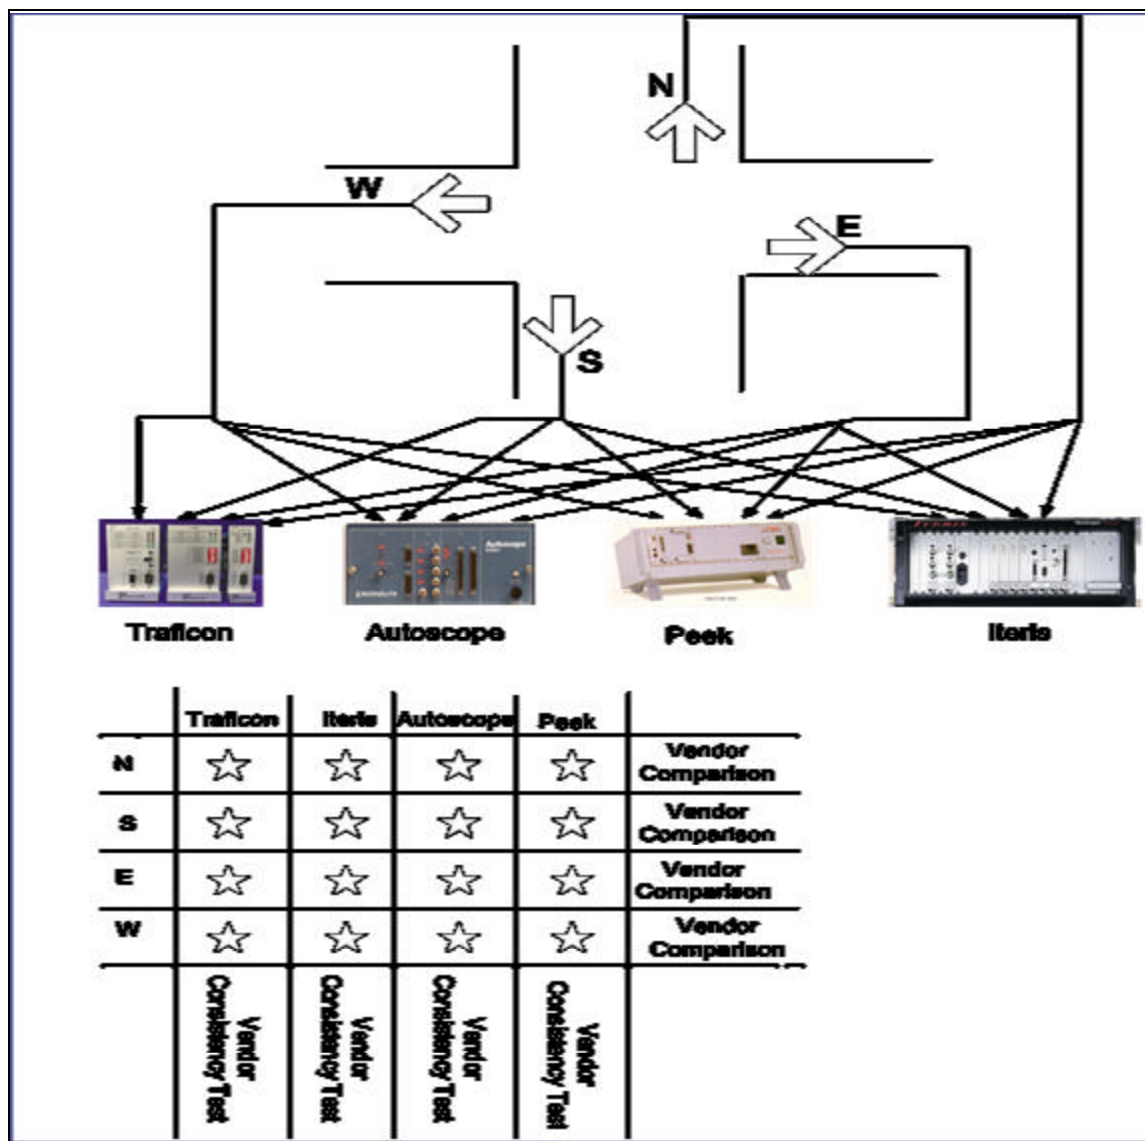
Figure 9.1: Testing of the Vendors at a Single Intersection

This study considered four locations for Peek, two intersections for Iteris and one each for Autoscope and Traficon. The evaluation showed that Traficon and Autoscope performed well in all the test conditions. These results cannot be generalized because of the difference in the numbers of locations tested. Results could be better inferred if the performance of all the vendors were checked under different test and traffic conditions at one intersection at the same time, as shown in Figure 9.1.
