Remote Sensing of Roads and Highways in Colorado

**Large-Area Road-Surface Quality and Land-Cover Classification Using
Very-High Spatial Resolution Aerial and Satellite Data**

Quarterly Progress Report #2

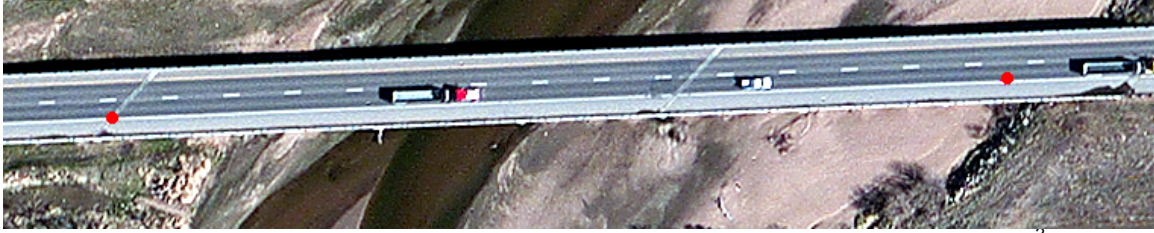
Figures 4 and 5 show road pieces in aerial imagery with low fatigue values of 171 and 414 ft², respectively. The road surfaces look consistently dark and smooth.

Figure 4. Aerial imagery Mile 114.6-114.7 (between red circles), Fatigue 171 ft²

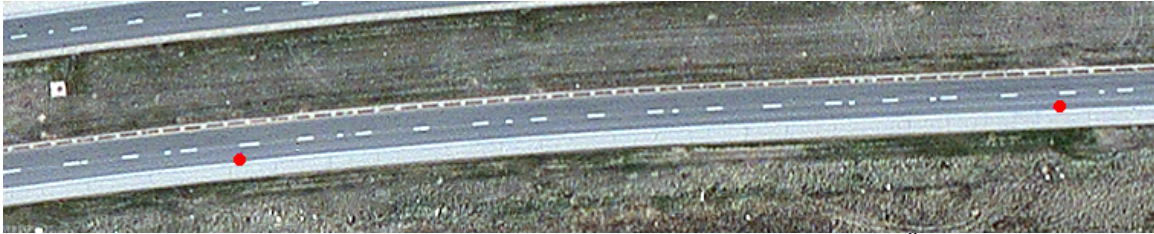
Figure 5. Aerial imagery Mile 114.1-114.2, Fatigue 414 ft²

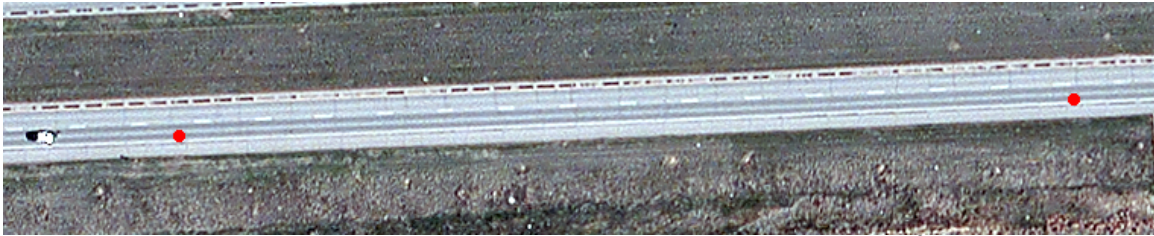
Figures 6 and 7 show road pieces with moderately high fatigue values of 5760 and 5014 ft² respectively. The road surfaces look brighter with higher fatigue values and thin perpendicular stripes are visually recognized. They are categorized as transverse cracking.

Figure 6. Aerial imagery Mile 115.0-115.1, Fatigue 5760 ft²

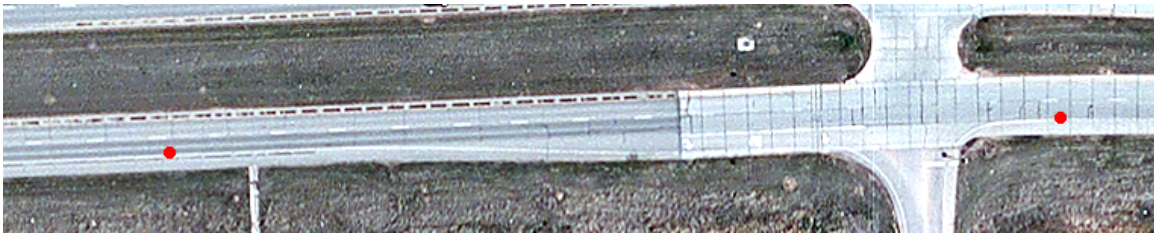
Figure 7. Mile 115.1-115.2, Fatigue 5014 ft²

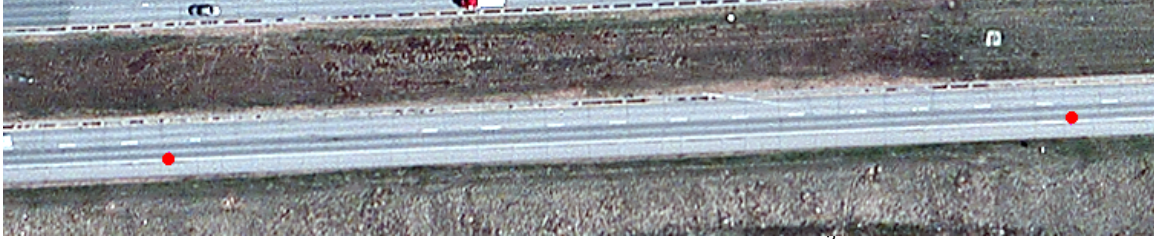
Figures 8 and 9 show road pieces with high fatigue values of 6567 and 6225 ft² respectively. The road surfaces also look bright and many cracks are clearly exhibited on the imagery.

Figure 8. Mile 114.8-114.9, Fatigue 6567 ft²

The aerial imagery observed on 4/22/2011 was also used for this study. The region of interest is an extended area of Figure 8, which is along Highway Stretch #34A in eastern Greeley, CO. This segment showed a high fatigue value of 6567 ft² in 2011 CDOT data as described in the previous section. Given that the spatial resolutions of aerial and WV2 imagery are 30 cm and 50 cm, respectively, resampling was performed to generate a synthetic WV2 image from the aerial image. While the original aerial image chip size was 1212 x 493 pixels, the synthetic WV2 panchromatic image size needs to be 726 x 295 pixels. Among several resampling algorithms, the Lanczos method was adopted in this study. The Luminosity method was adopted for the color conversion from RGB to gray scale, and the formula is $0.21*(red) + 0.71*(green) + 0.07*(blue)$. The color conversion was performed after image resampling.

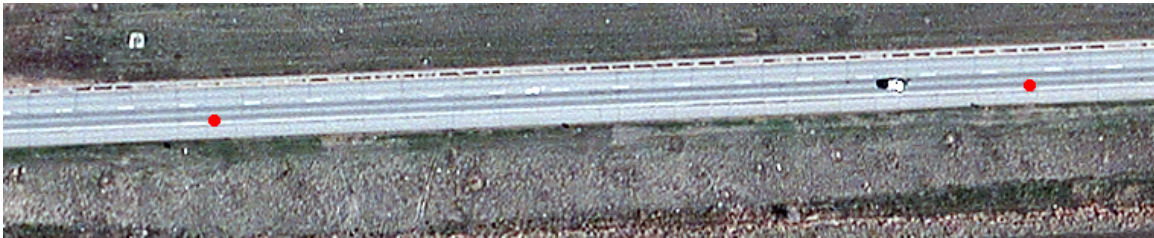
Figure 9. Mile 114.9-115.0, Fatigue 6225 ft²

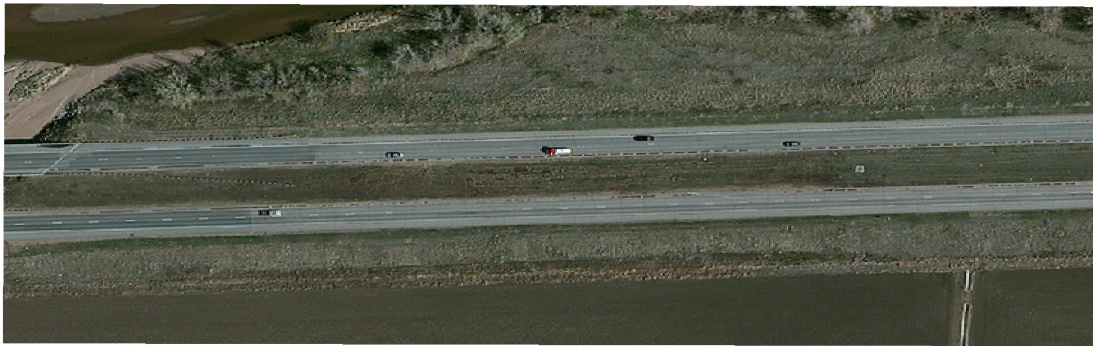
Figures 10, 11, and 12 show aerial, resampled RGB, and synthetic WV2 panchromatic images, respectively. Transverse cracking is visible in both aerial and synthetic WV2 images as shown in Figure 13. These results indicate that WV2 imagery can be utilized for automated detection of severely distressed road surfaces where in-situ fatigue values are high.

Figure 10. Aerial image (original), 1212 x 493 pixels

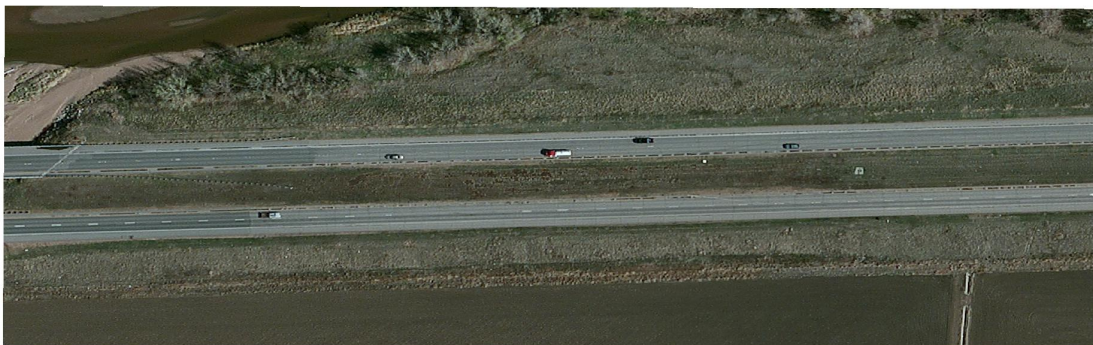
Figure 11. Resampled RGB image, 726 x 295 pixels

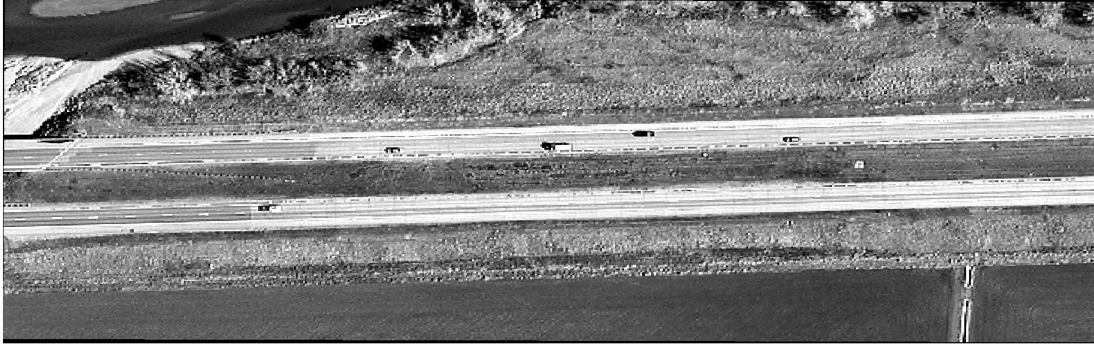
Figure 12. Synthetic WV2 (resampled gray scale) image, 726 x 295 pixels

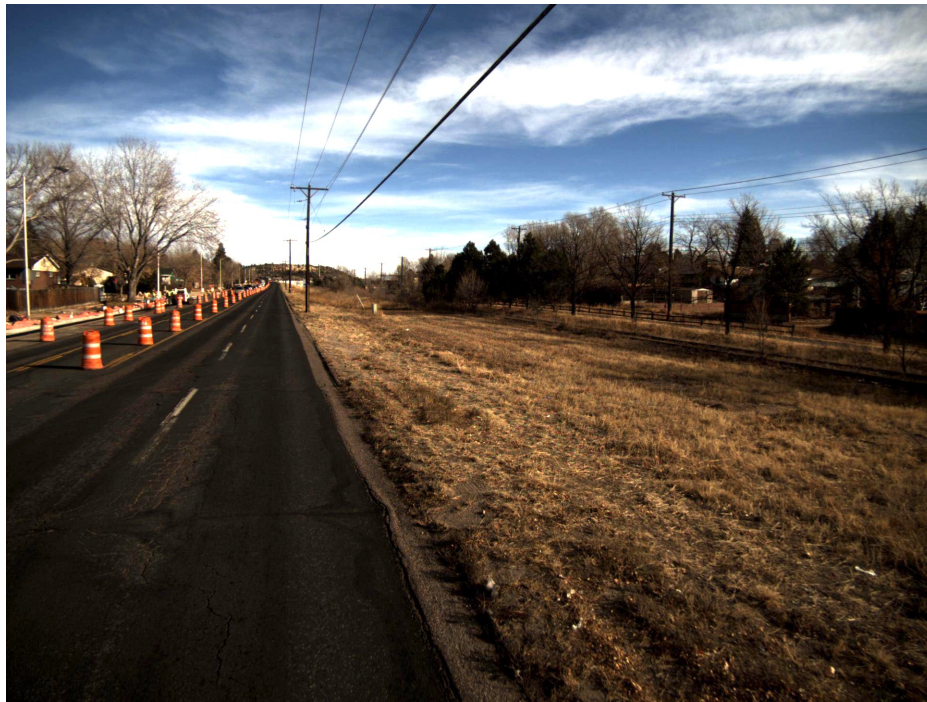
The acquired dataset includes shapefiles showing where the distresses are located and photographs from the van used for the survey. Figure 15 shows a map of a specific intersection, Constitution Ave. and Wynkoop Dr., in Colorado Springs. Figure 16 shows a photograph of the corresponding intersection as a sample data.

Figure 16. A photograph of Constitution Ave. and Wynkoop Dr. in Colorado Springs. Obvious road fatiguing can be recognized.
