ancing transportation systems in second-tier cities through the use of davanced th analysis and ITS solutions to safety and mobility problems

North Dakota State University

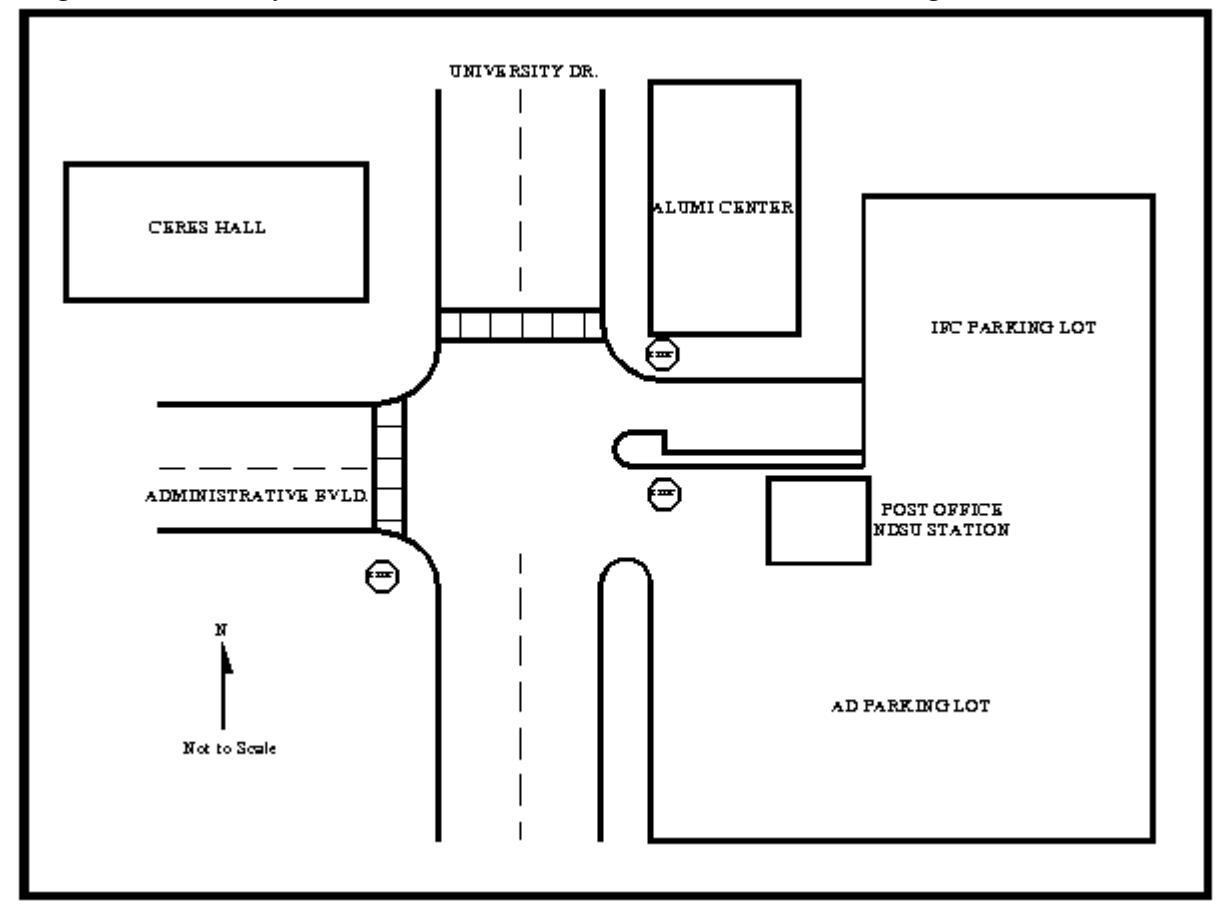
The intersection has a unique geometric design due to the close proximity of the Alumni Center's and the Post Office's driveways. Motorists from both driveways may either turn left on University or proceed westbound through the intersection onto Administration Ave.

Figure 1. University Dr. and Administration Ave. Intersection Drawing.

There are two designated pedestrian crosswalks at the intersection (Figures 1 and 2). These crosswalks are intended to guide the pedestrians to the north side of the Administration Ave. before crossing University Dr. and vice versa.

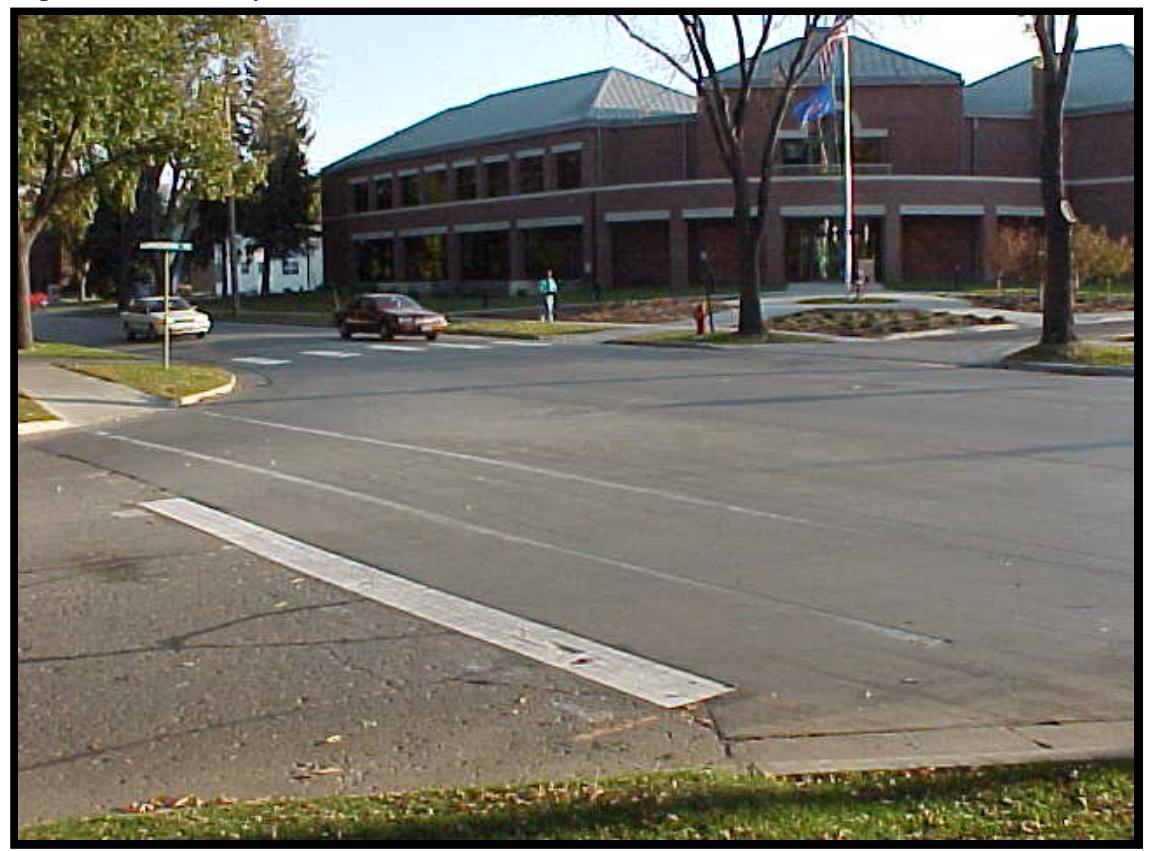
Figure 2. University Dr. and Administration Ave. Crosswalks.

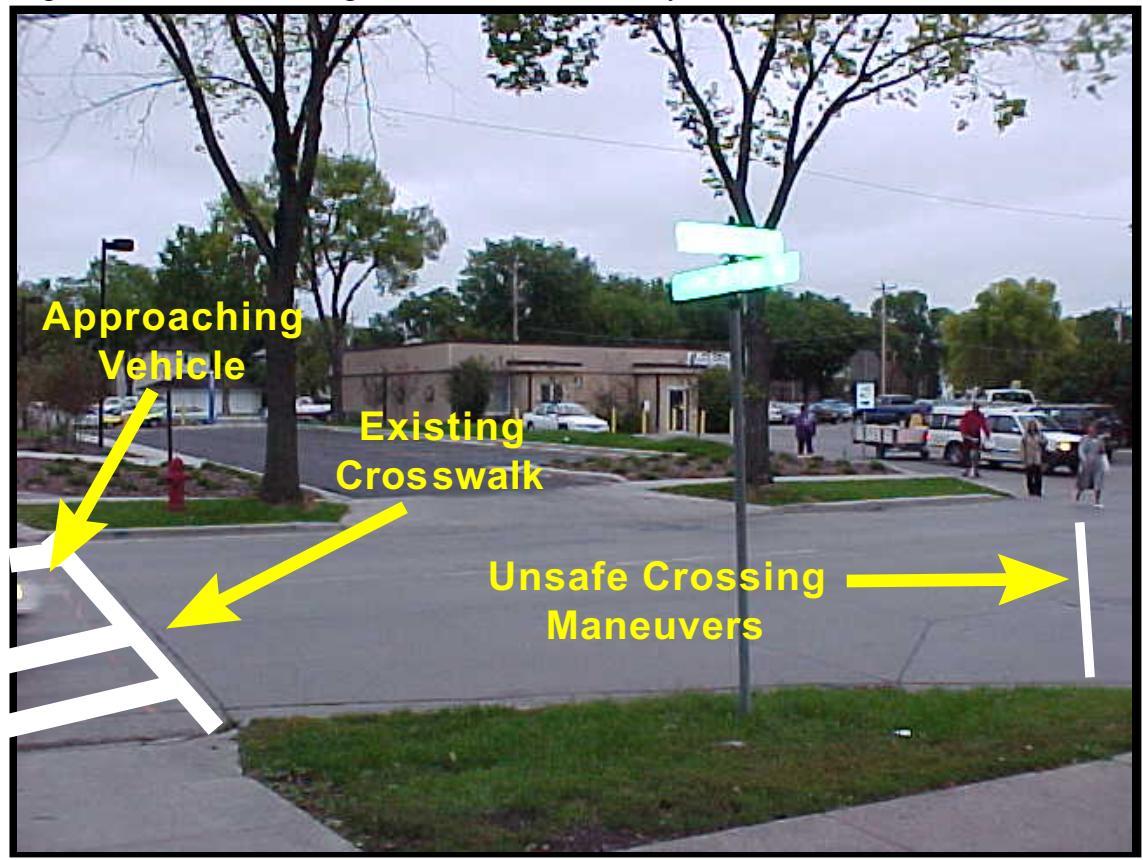
The layout of the University Dr. and Administration Ave. intersection, specifically the approach on the east side, causes some confusion to pedestrians. The two driveways tempt pedestrians to make unsafe crossing maneuvers. Most of the unsafe maneuvers consist of pedestrians crossing University Dr. diagonally from the AD parking lot (Figure 3). The diagonal crossings create more pedestrian/vehicle conflicts and require a longer pedestrian walk time, therefore, increasing the chances of pedestrian/vehicle incidents.

Figure 3. Unsafe Crossing Maneuvers at University Dr. and Administration Ave.

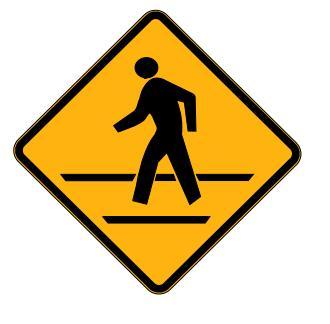
School or pedestrian crossing signs could also be installed along University Dr. near the crosswalk. These signs are intended to advise motorists that a crosswalk exists on the facility that they should look for crossing pedestrians and students. The signs also encourage pedestrians to use the crossing since it becomes more prominent. Examples of a pedestrian crossing sign and a school crossing sign are shown below.

Pedestrian Crossing Sign

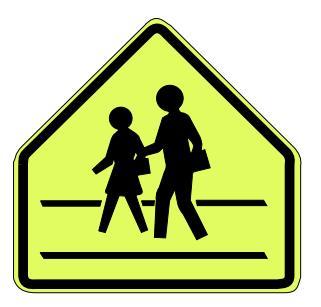
School Crossing Sign

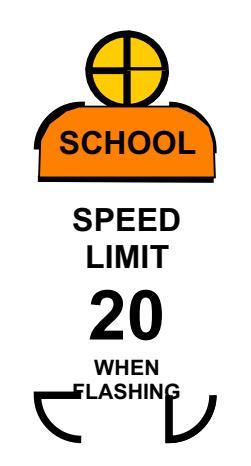
Speed reductions may also be imposed along University Dr. between 13th Ave. N. and Administration Ave. as vehicles approach the crosswalk. Typically, speed limits at a school crossing are 20 mph when school is in session. The speed reduction will allow longer pedestrian gaps since the travel time of the vehicles departing from 13th Ave. N. will be greater. An example of a school speed limit sign is shown below.

School Speed Limit Sign

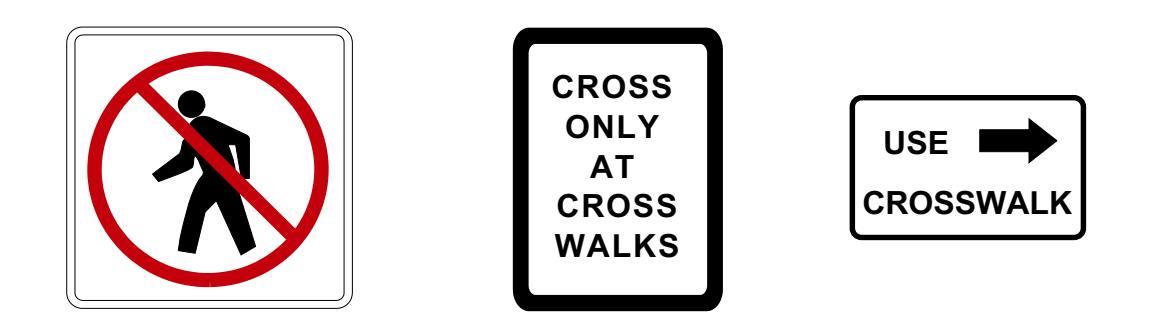
Another short-term enhancement of the intersection is related to pedestrian guide signs. These signs are intended to guide the pedestrians to crosswalks and to discourage jaywalking. Field observations recorded a significant number of pedestrians not using the provided crosswalks. In fact, more pedestrians crossed University Dr. without using the crosswalk during the morning

observation period (Appendix A). The improper crossings consisted of pedestrians crossing on the south side of Administration Ave. and crossing diagonally from the AD Parking Lot or NDSU Station. Both of these maneuvers are safety hazards since they have more pedestrian/vehicle conflicts and require more time to complete. Pedestrian signs inform pedestrians that they should not cross at hazardous locations and guide them to proper crosswalks. Examples of pedestrian signs are shown below.

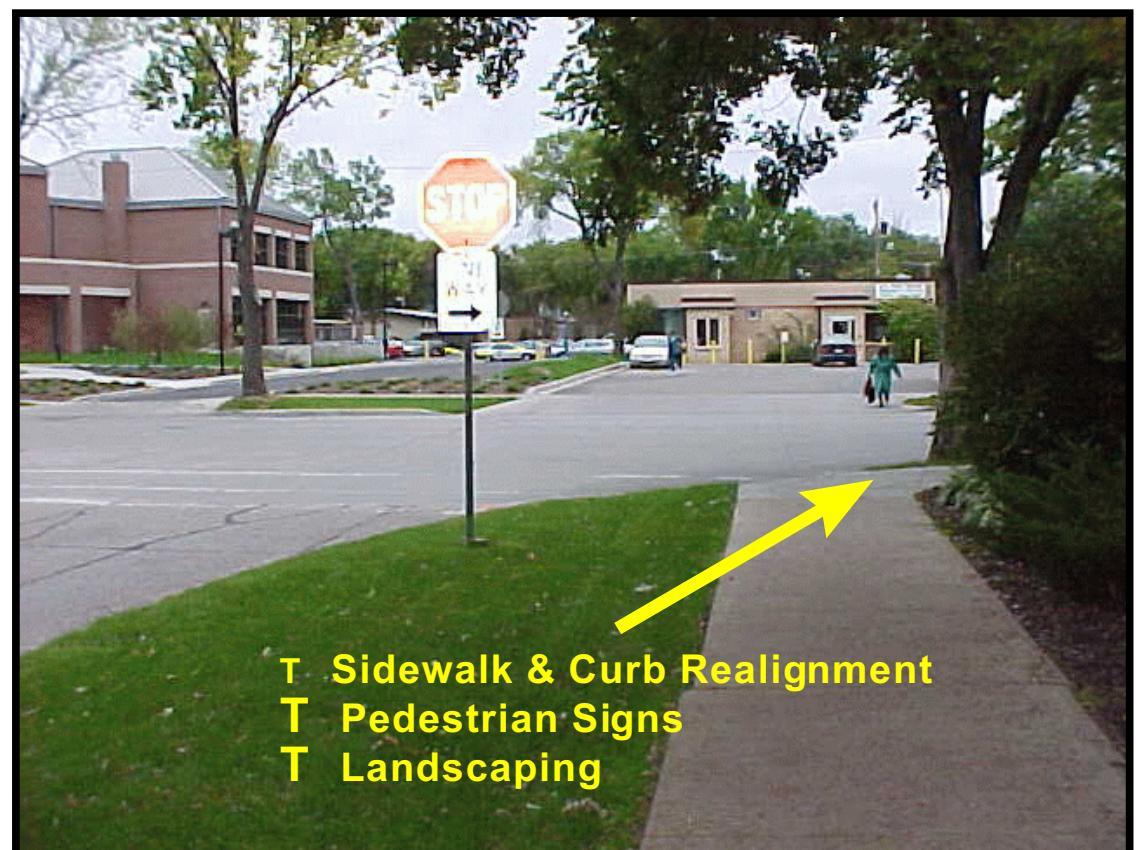
Sidewalk and curb realignment on the south side of Administration Ave. could be an effective method to guide pedestrians to the crosswalks (Figure 4). Currently, the south sidewalk attracts pedestrians to proceed across the street to the east (or the west as shown in Figure 4) instead of crossing north via the crosswalk. These geometric changes along with pedestrian signs or landscaping could guide pedestrians to the current crosswalks.

Figure 4. Enhancements of Sidewalk (South Side of Administration Ave.).

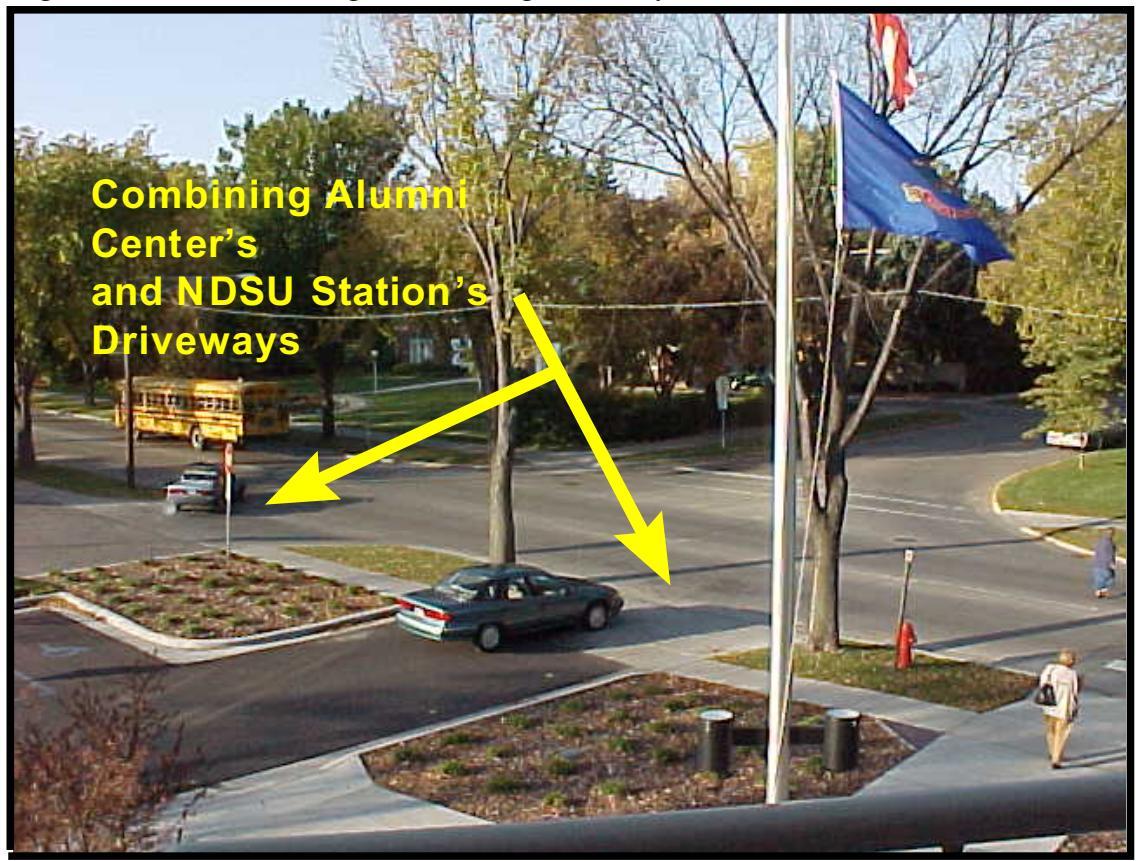
The driveways to the Alumni Center and NDSU Station could also be reconfigured (Figure 5). Combining the two driveways would serve two purposes: 1) reducing the confusion and conflicts of motorists leaving the two facilities and 2) providing an easier path for pedestrians to the north side crosswalk.

Figure 5. Geometric Changes to Existing Driveways.

Rerouting the traffic leaving the Alumni Center and NDSU Station could be another long-term improvement option. Fewer pedestrian/vehicle interactions would occur if vehicles entered the two facilities from University Dr. and exited using 12th St. N., which is on the east side of the parking lots.
