Impact Performance Testing of Roadway Safety and Security Barriers

(Phase 2)

Misty L. Butler Richard M. Gutkowski, Ph.D., P.E.

Department of Civil Engineering Colorado State University

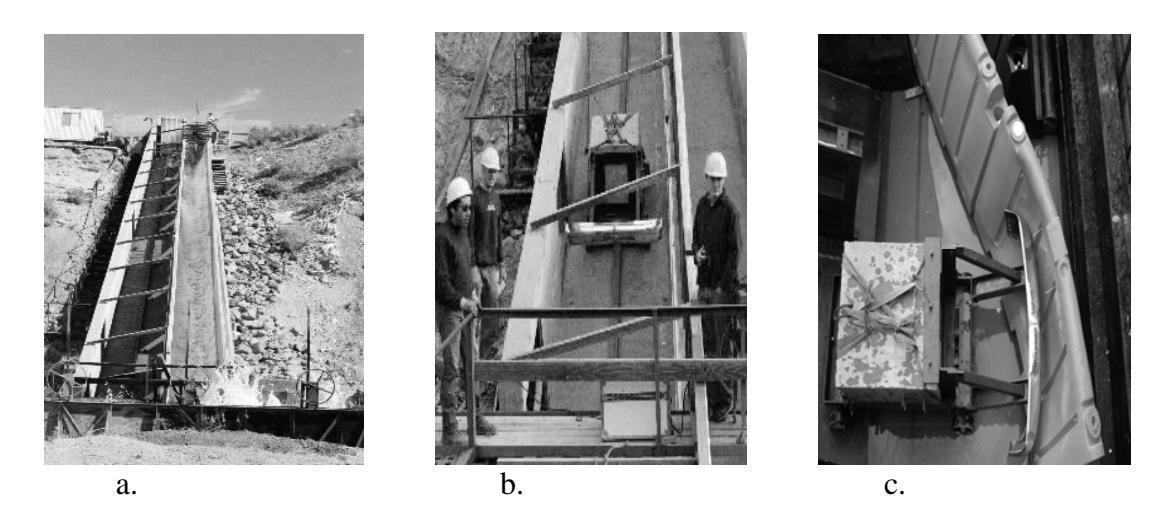
Figure 1: Phase 1 test site setup, surrogate vehicle, and test specimen (2)

The first phase of the project involved adapting an existing 110-foot long hydraulic flume to enable a crash test to be conducted using a surrogate vehicle (2). Figures 1a, 1b, and 1c show the flume, the surrogate vehicle, and test specimen after impact, respectively. Detailed dimensions of the surrogate vehicle are depicted in Figure 2.

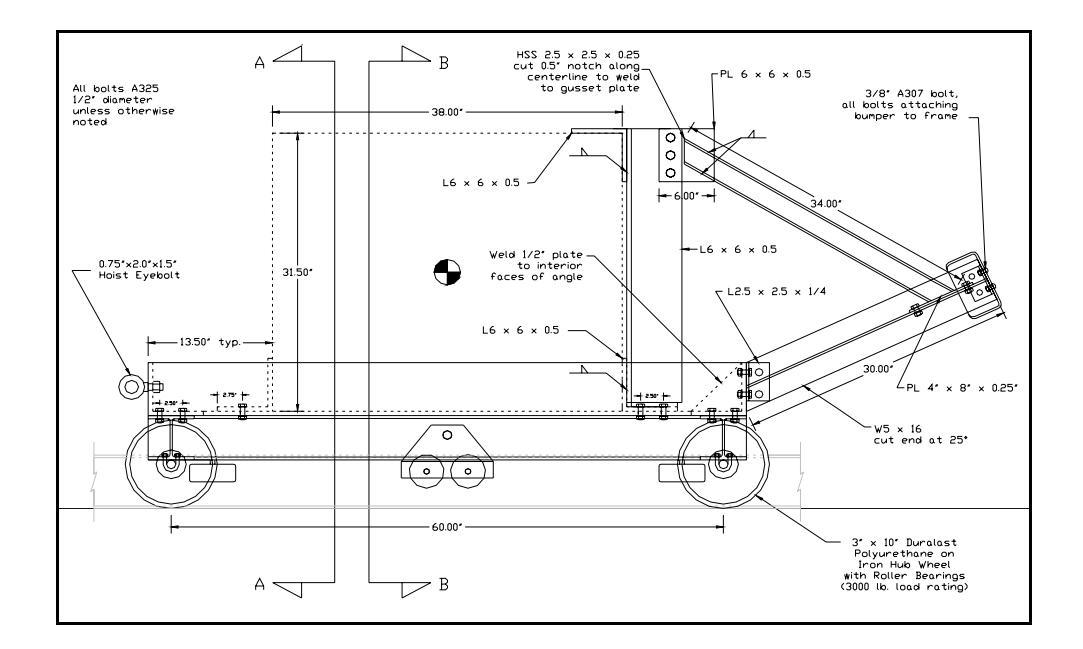
Figure 2: The surrogate vehicle (2)

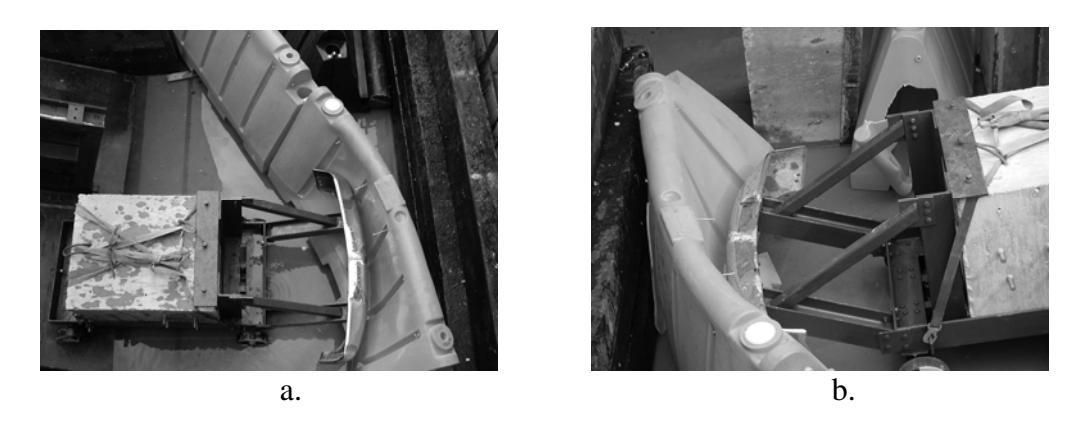
Figure 3: Deflection position of the test specimen and final position of surrogate vehicle following first test. a. Overhead view. b. View showing tearing of the barrier connector bar (2).

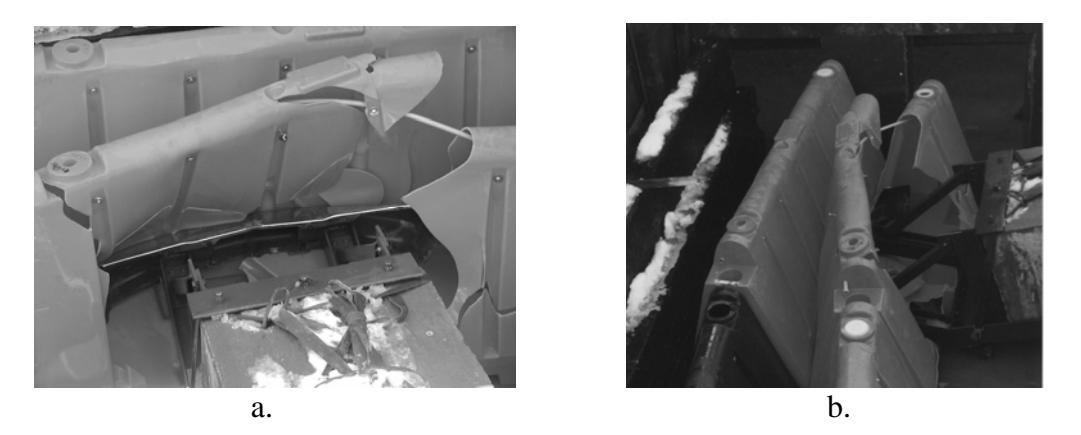
Figure 4: Final condition of the barrier specimen and surrogate vehicle after test (2).

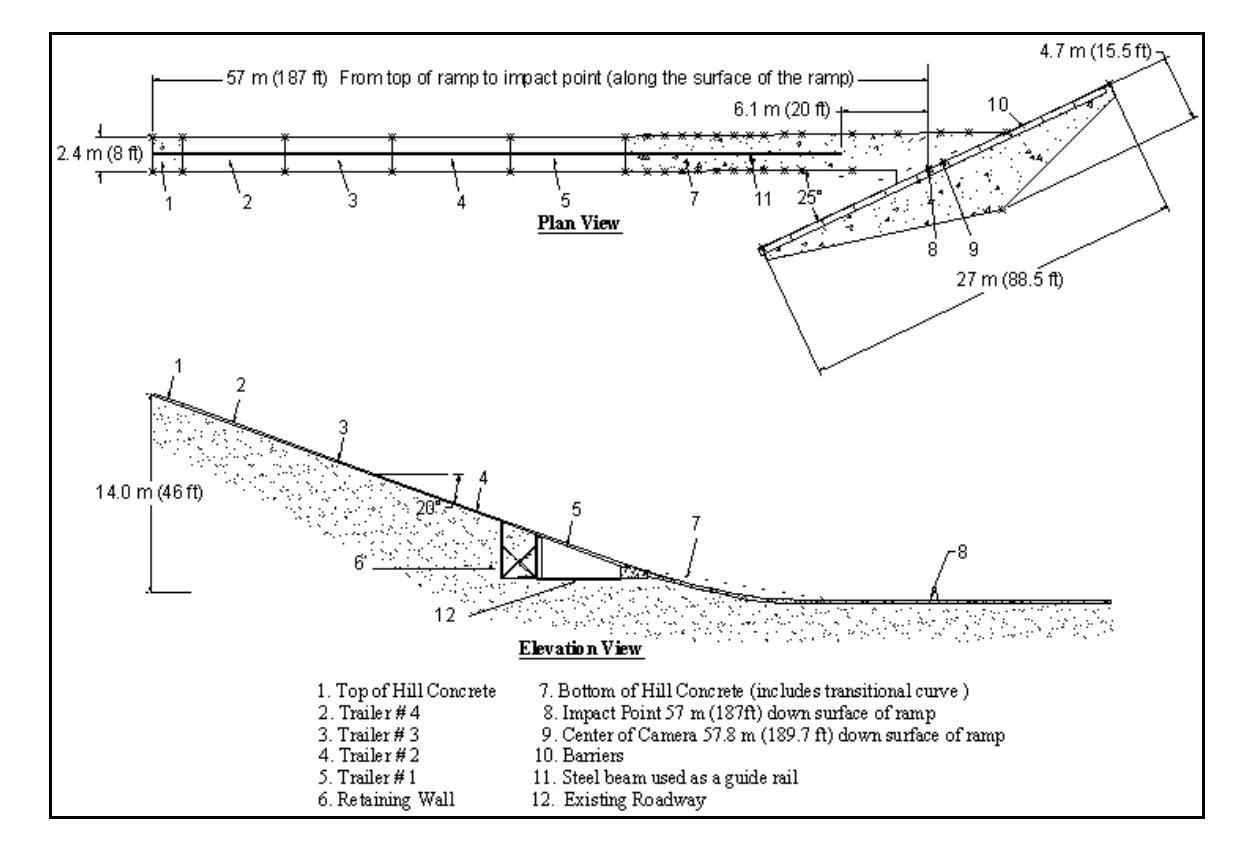
Figure 5: Plan and elevation view of ramp

Various locations for the facility were considered. The chosen location was on a hill, located south of the Engineering Research Center at Colorado State University in Fort Collins, Colo. The hill was surveyed at 14.3 m (46.9 ft) high with a slope of 21.5 degrees, and had room at the base for eleven longitudinal barriers. A plan view and elevation view of the ramp constructed are shown in Figure 5.

Recycled materials were used to construct the majority of the ramp. Four salvaged semi-truck trailer beds were incorporated as the major components in the inclined section of the ramp. These trailer beds were laid end-to end up the hill making a 20-degree angle to the horizontal. The first trailer bed on the lower end of the ramp passes over a roadway, and thus was designed as a removable bridge. This design feature was included for two reasons: there was a large underground waterline that ran underneath this portion of the ramp that could not be damaged and there was also a highly-used road running over the top of this waterline that needed to stay in service when the ramp was not in use. Therefore, the first trailer is held in place by a concrete pad at the bottom and a steel support towards the top, which allows it to be removed without disturbing the rest of the ramp. The remaining three trailer beds were supported on each end with concrete piles and supported in the center of each span with steel jacks that ensured low deflection of the trailer beds as the heavy vehicle rolled along them. The combined length of the

four trailer beds was not long enough for the ramp to reach the top of the hill. Therefore, a sixinch layer of concrete was placed along the last 2.13 m (7 ft) to bring the ramp all the way to the top of the hill.

At the base of the ramp a curved segment (configured using a spline function) was constructed to ensure a smooth transition of the vehicle from the 20-degree incline of the ramp to a horizontal level before impacting the safety barriers. A 102 mm (4 in) layer of concrete was placed along this curve and continues down into the horizontal base where the safety barriers are located. The horizontal stretch at the bottom of the ramp brings all four tires of the vehicle to a level position before the vehicle impacts the safety barriers. It is intended that the vehicle impact the safety barriers at the desired 25-degree angle relative to the longitudinal line of safety barriers. Thus, a concrete pad was constructed at a 25-degree angle in plan to the ramp and extends 4.72 m (15.5 ft) back to ensure a consistency of friction under the barriers if they slide backwards upon impact. The layout of the concrete is shown in the plan view of the site (Figure 5). A W6 x 12 steel beam was installed as a rail along the centerline of the ramp to guide the test vehicle. This rail extends from the top of ramp down to the base of the curved section of ramp. The rail ends 6.1 m (20 ft) before the impact point on the barriers to permit unrestricted vehicle travel prior to impact.

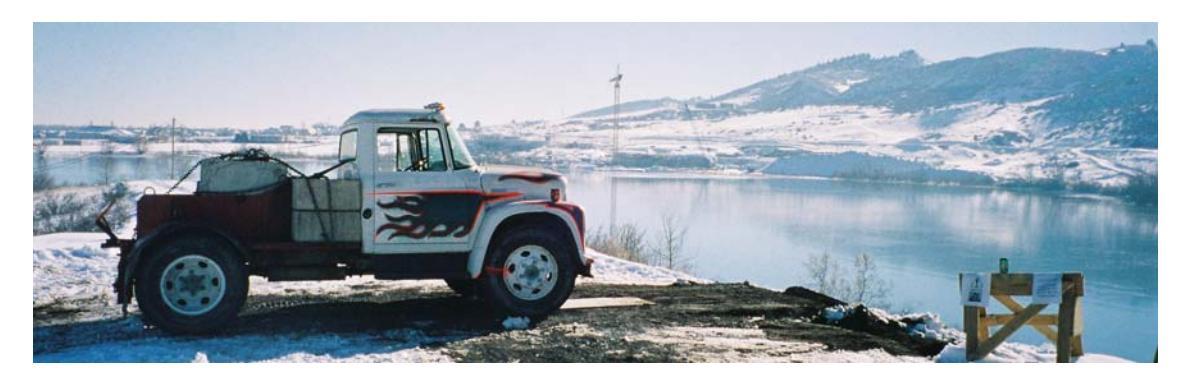
Figure 6: The LoadStar 1700 test vehicle

The vehicle chosen for the initial impact test was a LoadStar 1700 truck (Figure 6) donated to the project by a local salvage yard. The base weight of the truck was 3338 kg (7470 lbs). To meet test level 3 requirements the total weight of the vehicle had to be 5600 kg (12400 lb). To achieve this total weight, three pre-cast concrete blocks, each weighing approximately 999 kg (2200 lbs), were loaded on the truck. The resulting total weight of the loaded truck was 6414 kg (14140 lbs).

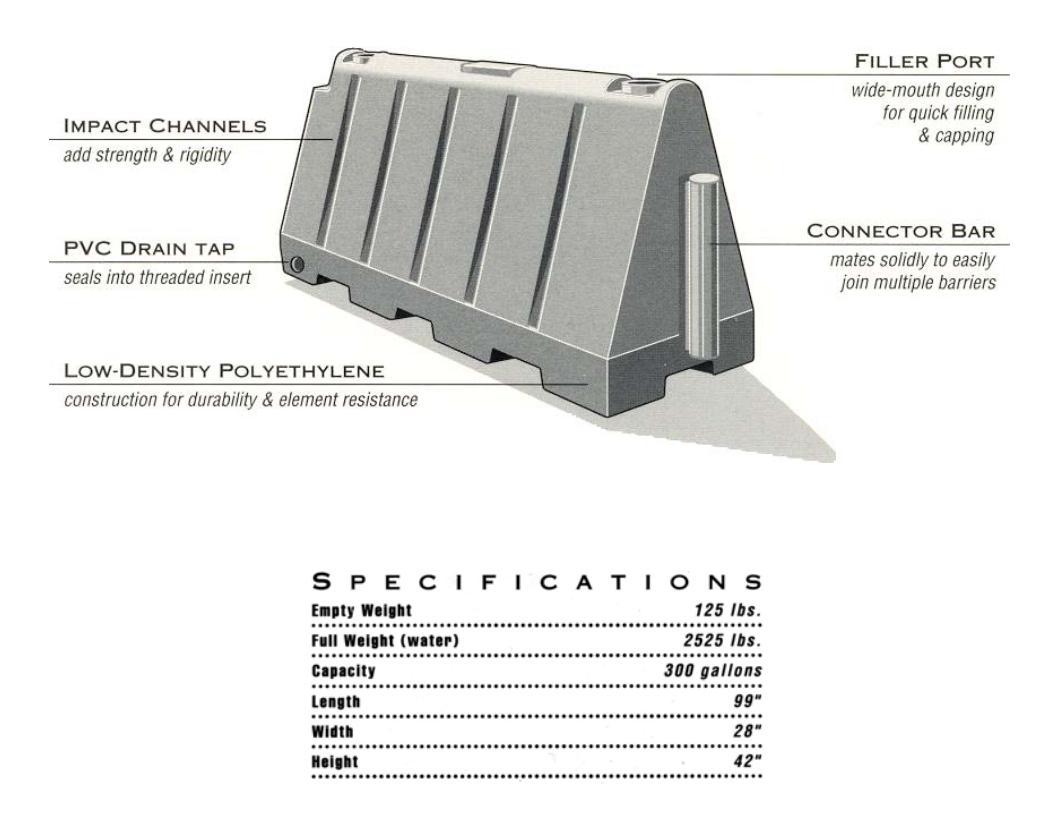
Figure 7: The E-Z Barrier (from vendor product literature)

As previously mentioned, the test specimens used for the trial test on the newly constructed ramp were to be hollow, water and/or sand-filled, portable longitudinal barriers intended only for temporary use. The safety barriers used were provided by Safety Barriers Corporation of Colorado. An illustration describing the physical characteristics of their barrier (trade name "E-Z BARRIER") is shown in Figure 7.

The E-Z Barrier is comprised of low-density polyethylene. These temporary barriers, not intended for individual use, are linked together by interconnecting the vertical connector bar of one unit to the formed slot in the adjacent unit. A cable is then strung through the ports at the nose (top) of the barriers from end to end, forming a chain. The setup typically used by the manufacturer is shown in Figure 8.

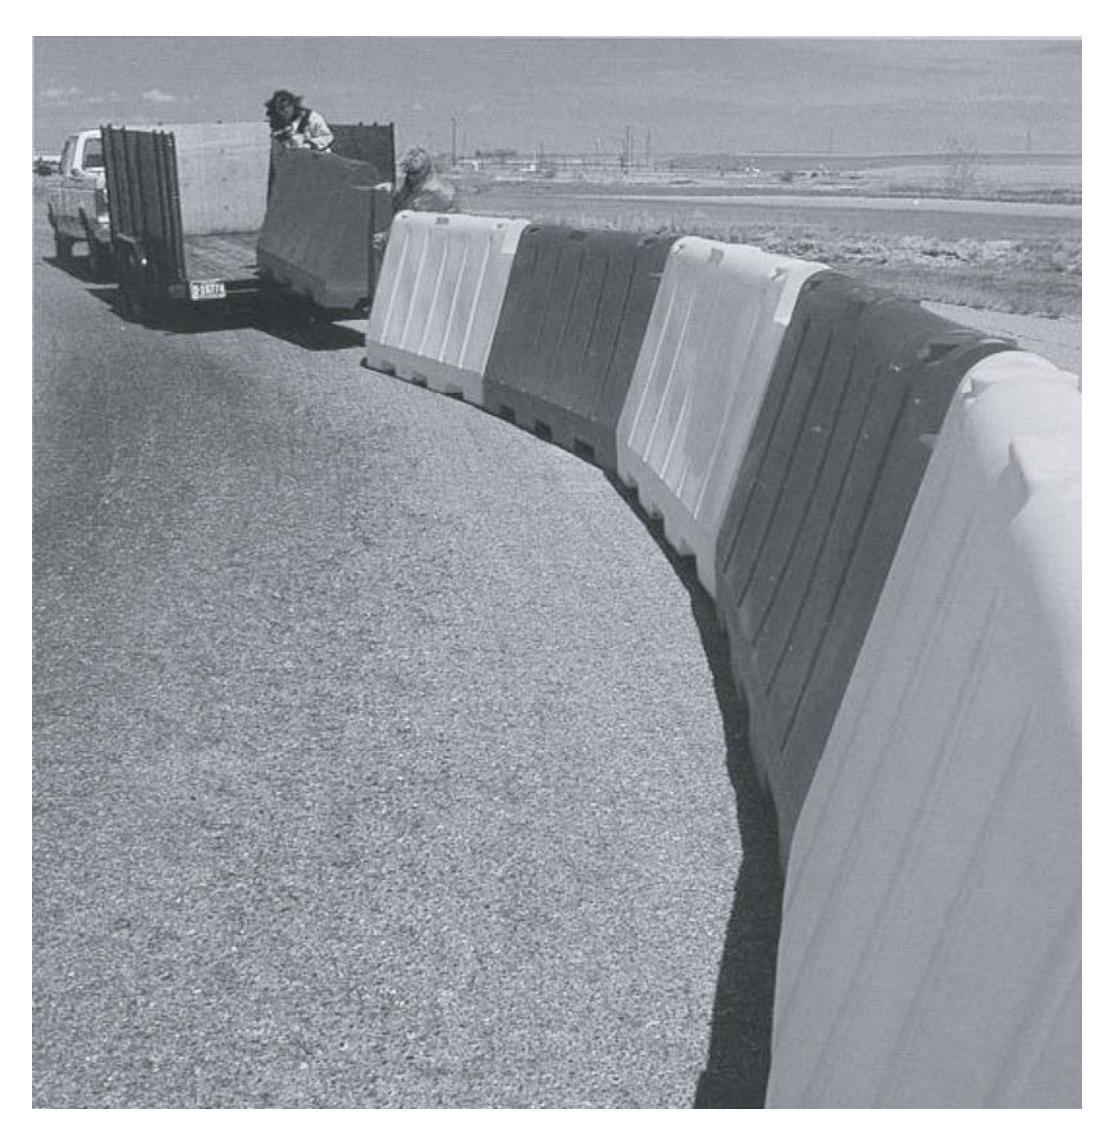
Figure 8: Typical set-up of E-Z Barriers (from vender product literature)

Once interconnected, the barriers act to absorb energy like a flexible cable when impacted by a vehicle. However, unlike a cable, the entire mass of the barriers as well as the friction against the bottom of the barrier and the concrete act to slow and eventually stop the vehicle.

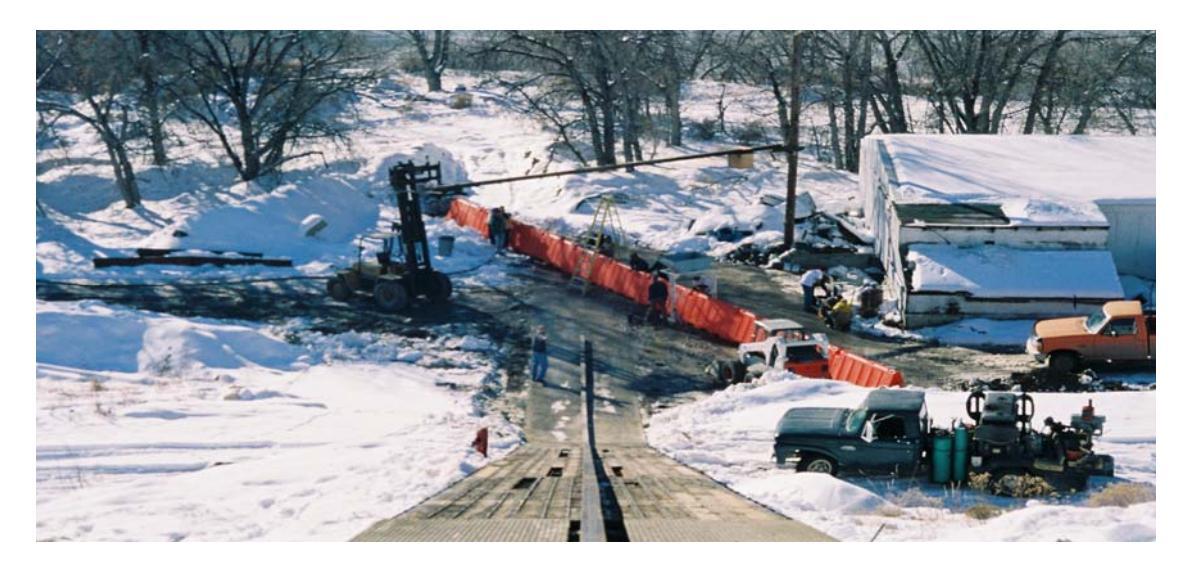
Figure 9: Test specimen in position before test

The trial test was conducted on Dec. 4, 2004, and weather conditions were a factor in the preparation. A heavy snowfall had occurred a week before the test, followed by unusually warm weather which melted most of the snow. Considering the weather limitations, it was decided that only one test would be conducted, with the truck released from the very top of the ramp to observe the facility's ultimate capabilities. Set-up began three days before the test was conducted and included clearing snow and mud from the ramp and concrete pad, setting up the barriers at the 25-degree orientation to the ramp, and positioning of the cameras. The barriers were linked together, centering the middle barrier so that it would receive the direct impact of the vehicle. A 16mm (5/8 in) diameter cable was then strung through the ports at the nose (top) of the 11 barriers and several clamps were attached at the end of the near and far barriers to keep the cable from slipping without being anchored to the ground. On the second day two of the middle barriers were slowly filled with sand to near capacity and "topped off" with water to saturate the sand and fill the void space. After realizing the extended amount of time it took to fill each barrier with the wet sand that resulted from the snow earlier in the week, a new plan to fill the barriers at a quicker pace was attempted. A hole was cut in the top of the barriers and a steel funnel was constructed to allow the wet sand to flow into the barriers at a faster rate. By late morning on the third day, only the middle five barriers had been successfully filled with sand and water. Realizing the limited amount of daylight was going to be a concern for the quality of the highspeed video pictures, it was decided the remaining six barriers were to be filled only with water. It was not feasible to weigh the in-place units, so actual weights are unknown. Figure 9 shows a photograph of the test specimen in its initial position.

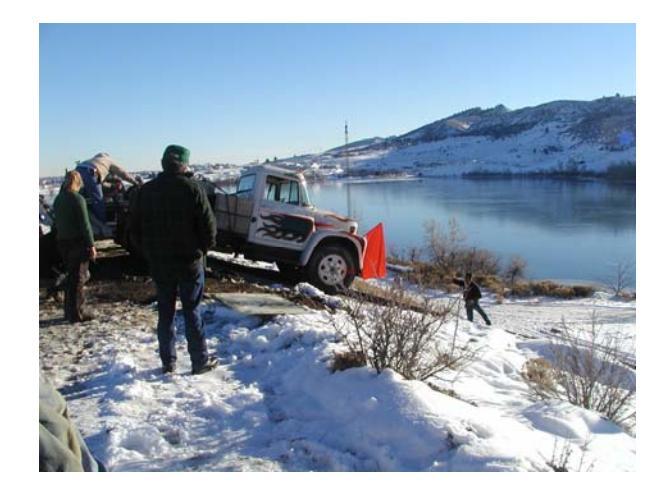
Figure 10: The test vehicle placed at the top of the ramp before it is released.

Figure 11 shows a picture of the truck in its initial position. The truck then engaged the steel rail and rolled down the ramp through horizontal transition and impacted the barrier.

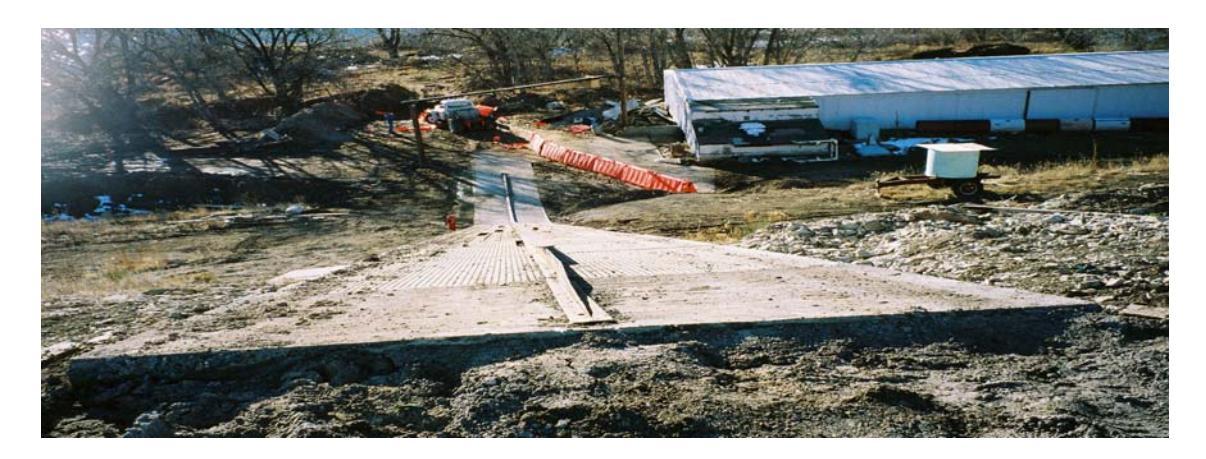
Figure 11: Vehicle and test specimen after impact

The truck rolled smoothly and successfully down the hill on the guide rail. There was no apparent shifting of the trailer beds or any other defects that were apparent with the ramp. The truck made the transition from the incline to a horizontal position using the curve with no jolts of any kind. The ramp proved to be structurally adequate for the test. The concrete pad was also more than adequate with regard to allowing enough room for the barriers to travel upon impact. The test proceeded as desired, indicating that the design and construction of the facility was a success. Figure 12 shows the post-impact state of the truck and the "E-Z Barriers."

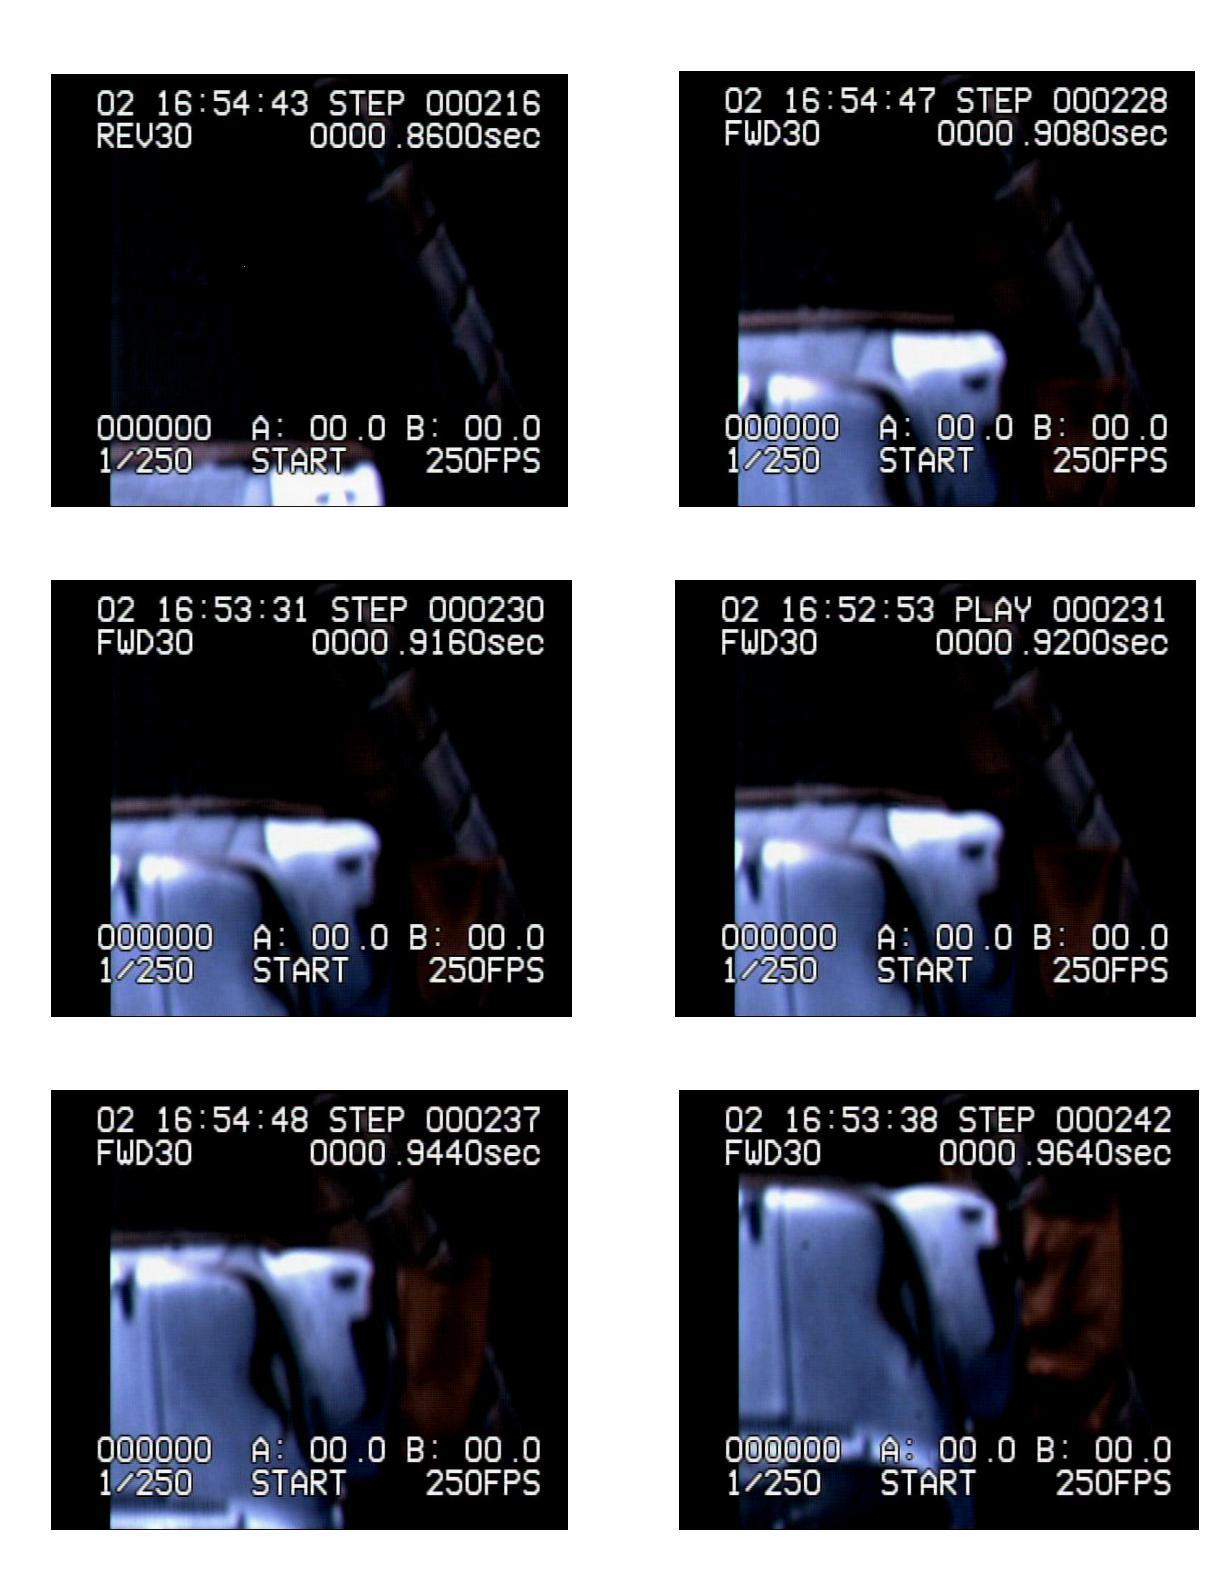
Figure 12: Selected frames of the impact from the high-speed camera.

The height, location, and timing of the trigger for the high-speed camera were also correctly estimated. The speed of the truck upon impact according to the high-speed camera was approximately 64.4 km/h (40 mph). The only problem encountered was the loss of daylight that affected the quality of the photos. Selected still-frames from the high-speed camera recordings are shown in Figures 13 and 14. A radar gun placed at the top of the ramp estimated the speed of the truck upon impact to be 62.8 km/h (39 mph). An average speed of 63.6 km/h (39.5 mph) between the two sources results in a speed 3.9 km/h (2.4 mph) faster than required to reach a test level 3. Overall, the impact severity reached during the test was 157 kJ (116.2 ft-lb), 19.5 kJ (14.4 ft-lb) higher than recommended for a test level 3.

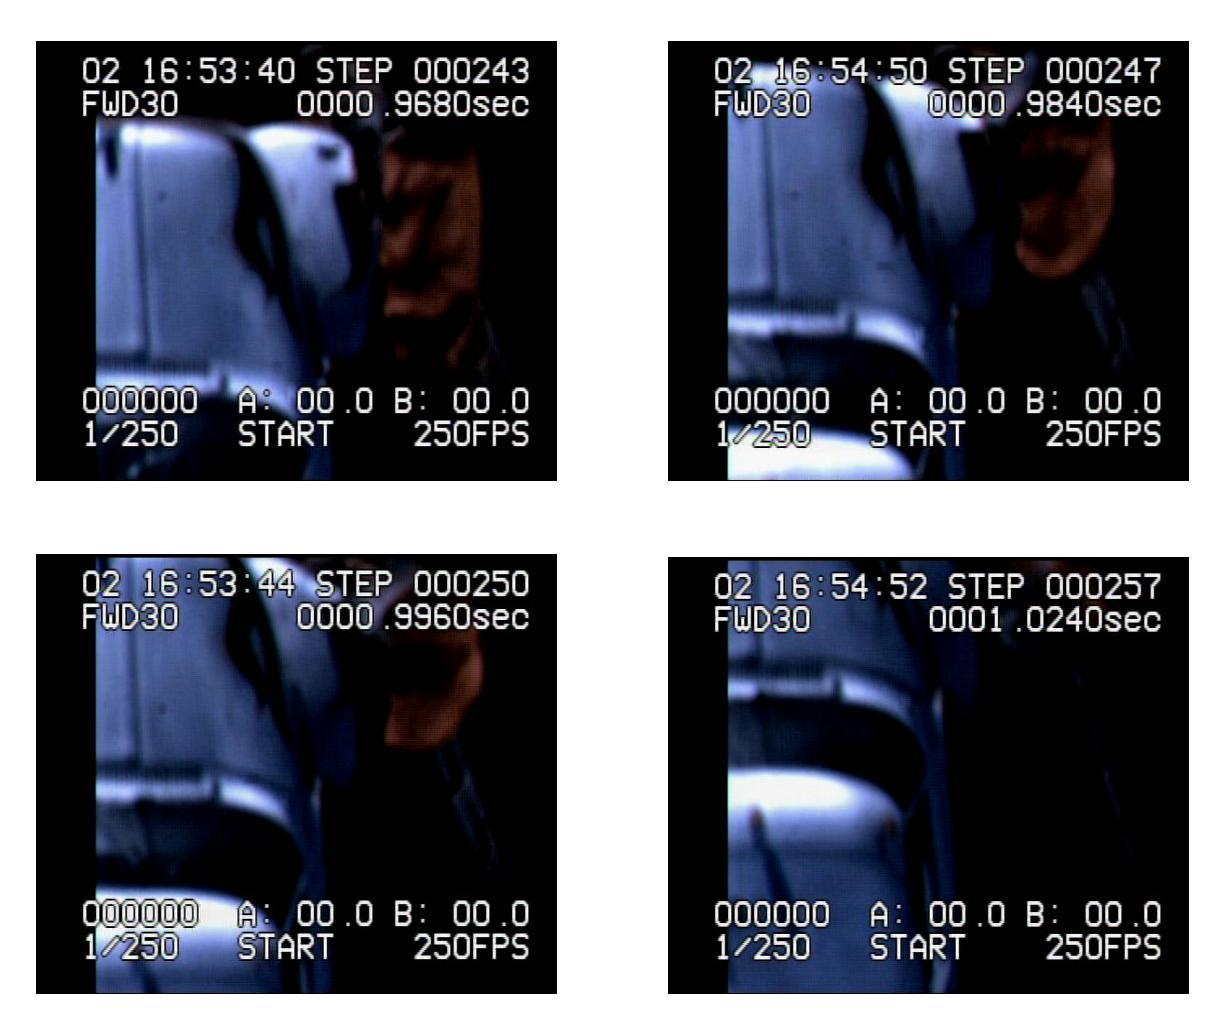
Figure 13: Selected frames of the impact from the high-speed camera.

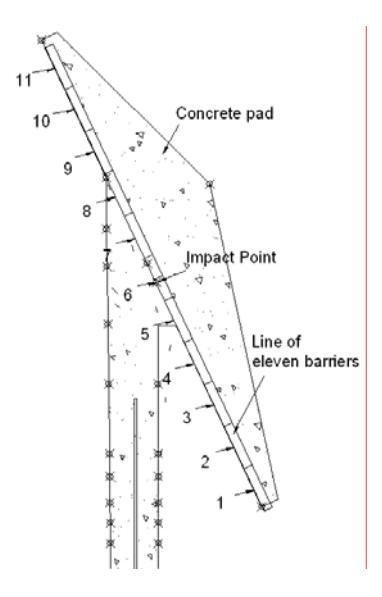
Figure 15: Plan view and labeling the eleven longitudinal barriers

A diagram labeling each of the eleven barriers is shown in Figure 16. The middle barrier (barrier number 6) sustained the initial impact and remained intact but, as stated, was pushed approximately .91 m (3 ft) back from its original position. Barriers 7-10 were crushed and torn apart. Barrier 11 was unmarred, but was pushed 1.8 m (6 ft) forward from its original position and turned on its side. Barriers 2-5 remained undamaged, but barrier number 1 had been crushed like an accordion on the near end due to the large amount of tension in the cable that strung all eleven barriers together. Figures 17a, b, and c show the final position of the truck and the barriers after impact. The cable was still intact after the impact. The truck sustained only minor damage to the passenger side bumper and fender, which were bent toward the front tire. None of the tires on the truck were punctured.

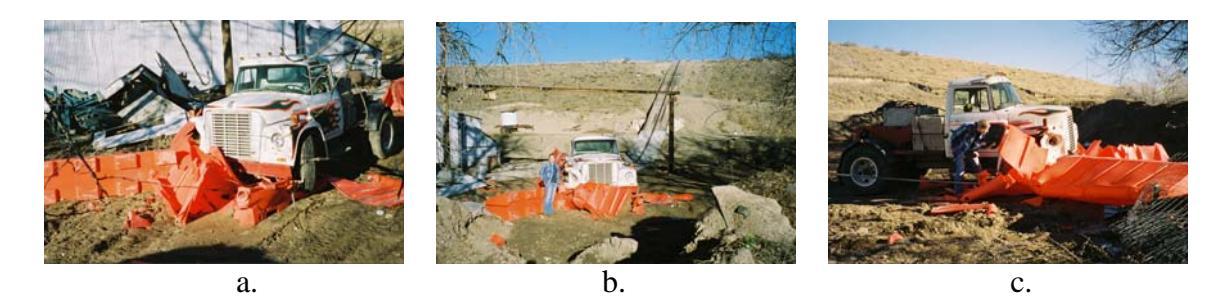
Figures 16 a, b, c: Final position of truck and barriers following the test run

The performance of the facility also allowed the barriers to be effectively evaluated for structural adequacy and post-impact vehicle trajectory. The truck impacted the center barrier in the essentially the location it was anticipated to strike. The impact of the LoadStar 1700 truck pushed the center barrier approximately .91 m (3 ft) forward. The truck then changed angle and proceeded to travel along the length (parallel to) of the barriers. The truck traveled approximately 11 m (36 ft) before coming to a complete stop (Figure 15).
