MPC 19-399.3 | D.S. Shinstine, K. Ksaibati, and D. Trusty

Regional Implementation of Tribal Transportation Safety Program: Yankton Sioux Tribe Roadway Safety Improvement Program

> > October 2019

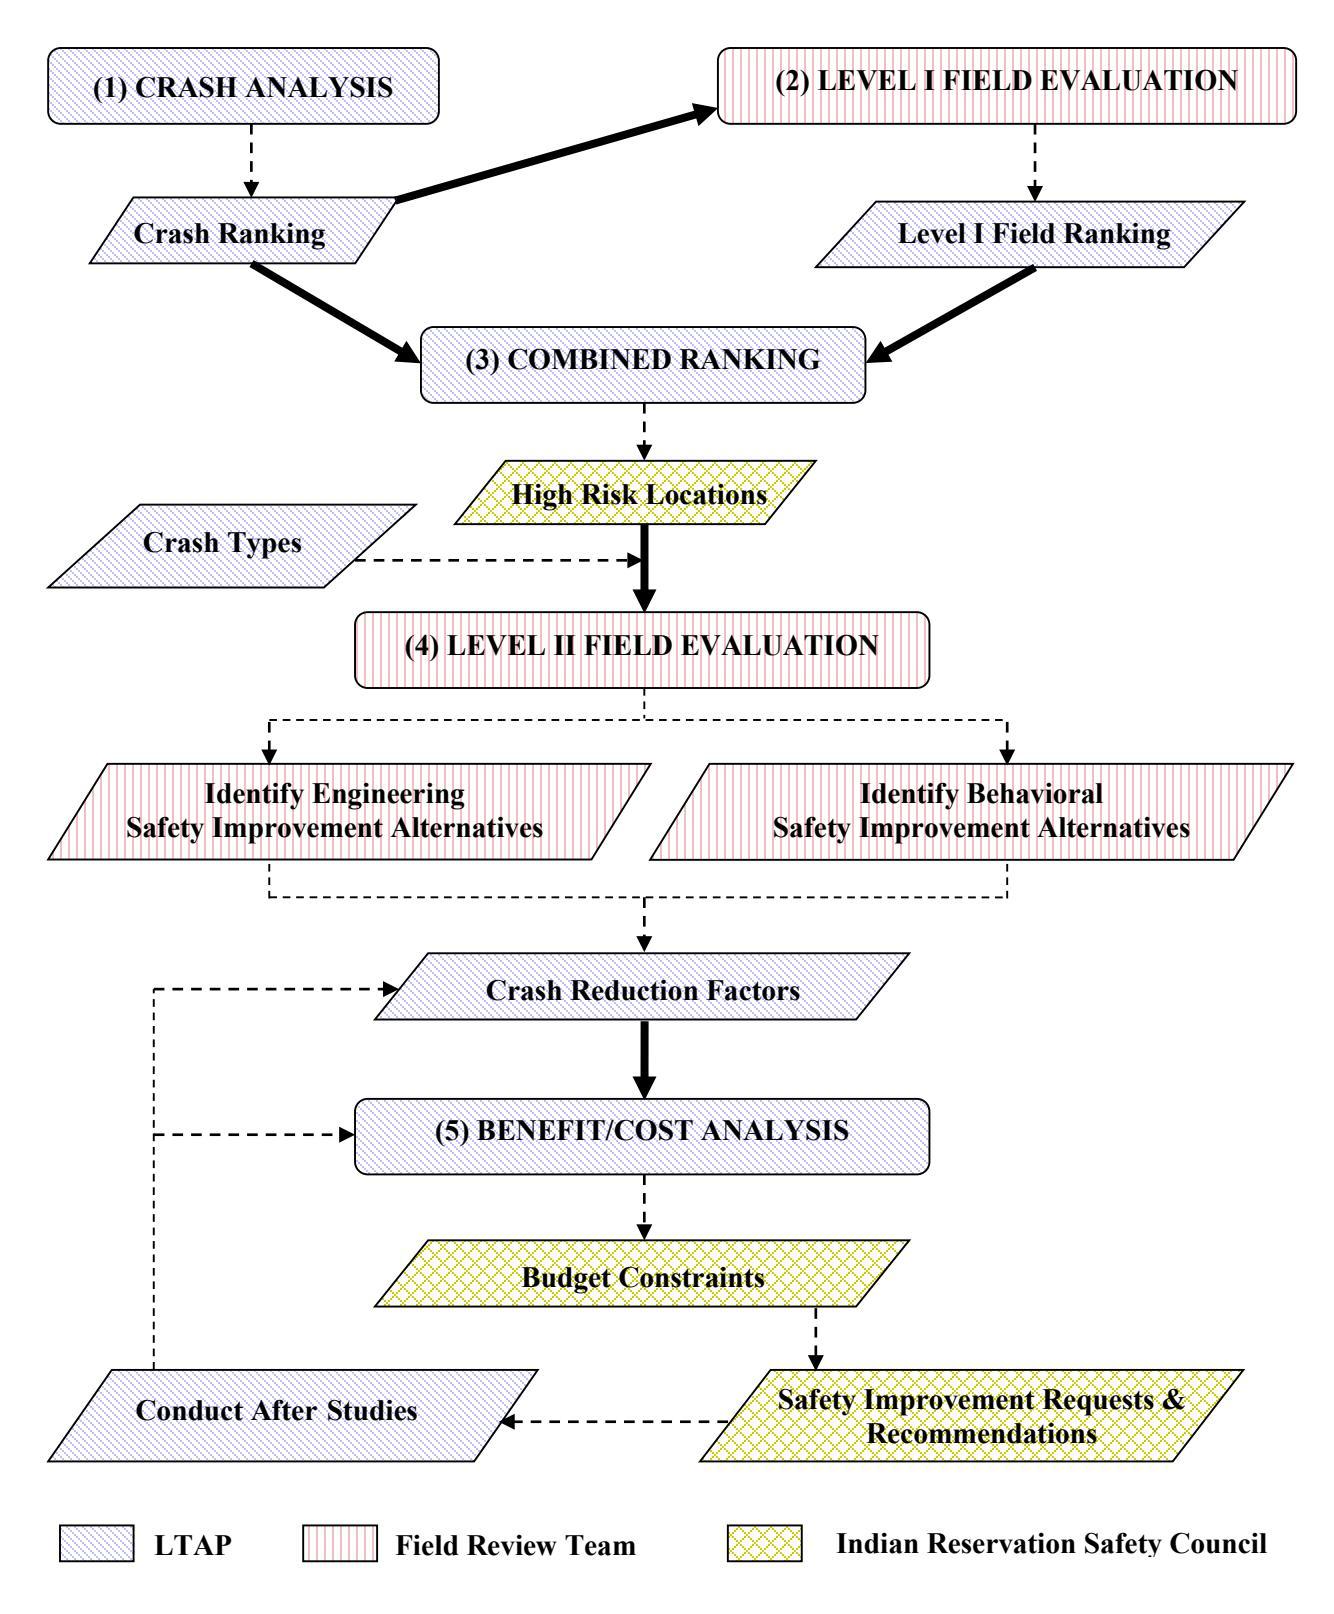
Figure 3.1 Five-Step Process for Indian Reservation Safety Improvement Program

This procedure is shown graphically in Figure 3.1. Crash data are analyzed and a ranking is established based on the high-crash locations. From this ranking, a list of roadways is proposed for field evaluation. From the field evaluation, a ranking of the conditions of the roadway is developed. The two rankings are combined to provide a list of proposed roadways considered for safety improvements. Another field evaluation is performed to identify safety improvements. Cost estimates are developed and a benefit-cost analysis is performed. The combination of historical crash data and field evaluations provides a substantive basis for identifying high-risk locations. The benefit-cost analysis gives the tribe a measure to prioritize the projects.

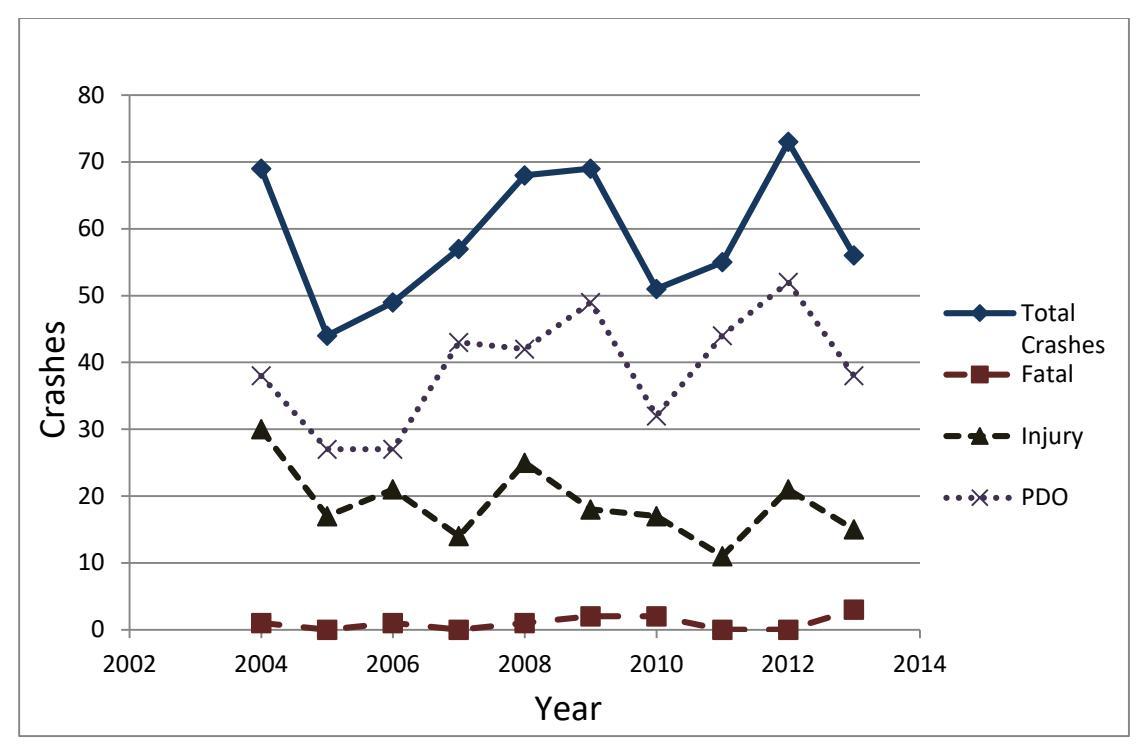
Figure 4.1 YST Crashes 2004-2013

There were 591 crashes recorded for YST from 2004 through 2013. Overall, the trend shows that crashes have increased over the 10-year period. At closer observation, property damage only (PDO) crashes have increased, injury crashes have decreased, and fatal crashes have remained relatively constant. The crash trends can be observed in Figure 4.1. Further study should be done to determine if the increase in PDO crashes is due to better reporting or if they are in fact increasing.

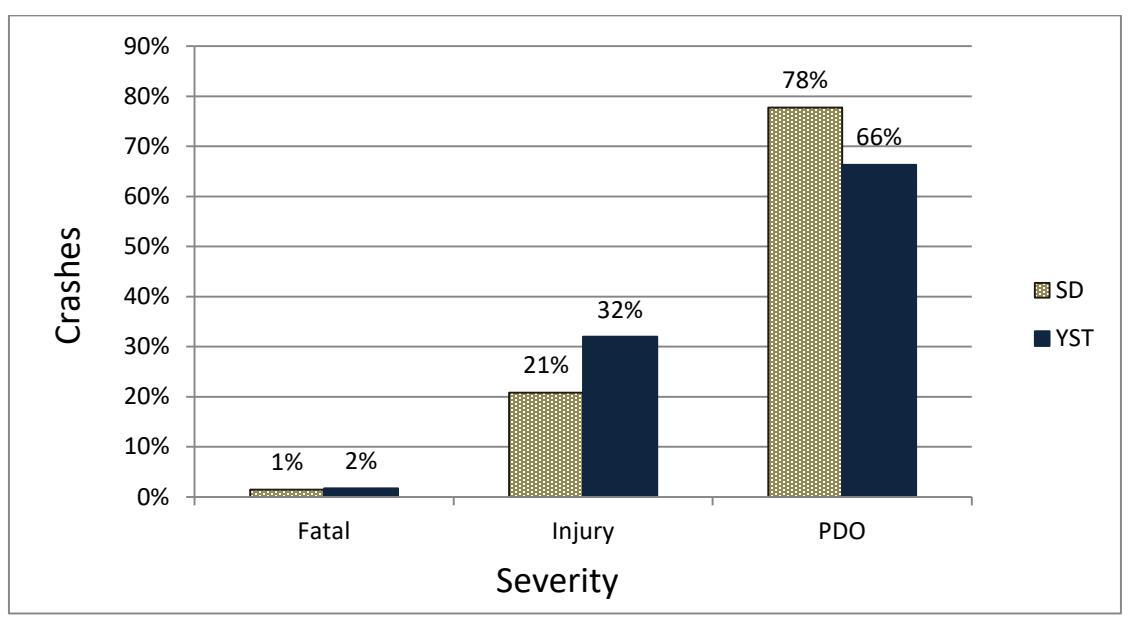
Figure 4.2 Crash Severity in SD and YST 2004-2013

Crash severity was divided into fatal, injury, and PDO. As seen in Figure 4.2, fatal crashes were slightly higher on YST at 2%, compared with South Dakota at 1%. Injury crashes on the reservation were more than 10% higher than statewide at 32% and 21%, respectively.

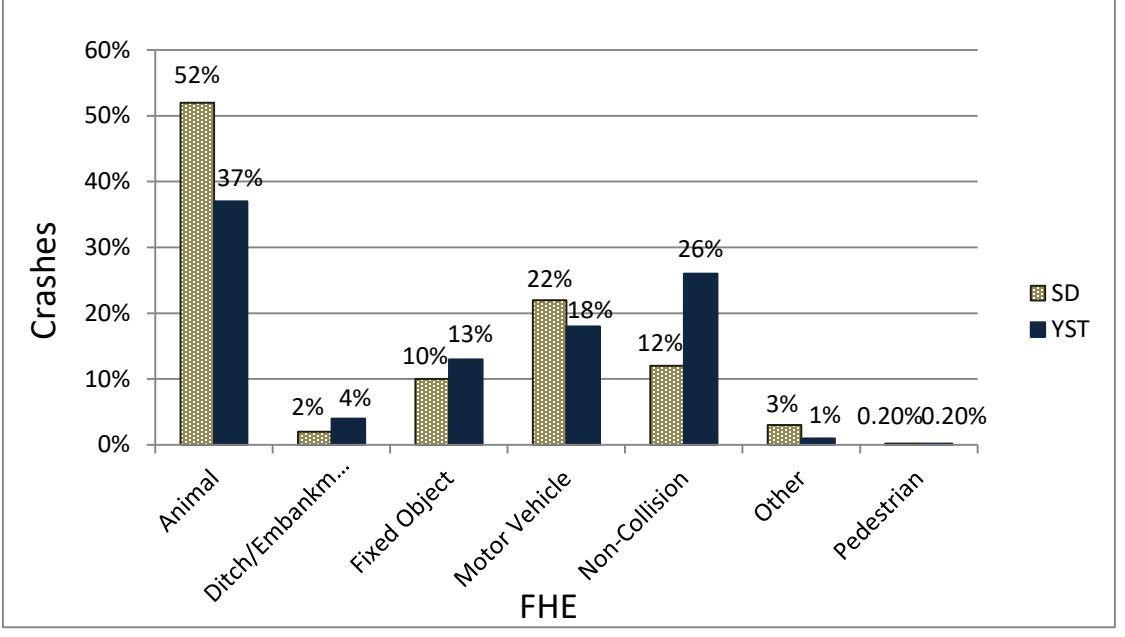
Figure 4.3 First Harmful Event for Crashes in SD and YST 2004-2013

The FHE revealed that animal crashes were lower than those across the state at 37%, compared with 52%. Non-collisions were much higher at 26% compared with 12% for the state. Non-collision crashes include rollover crashes. Motor vehicle crashes (crashes involving more than one vehicle) were lower, and fixed object crashes were higher. Crashes involving pedestrians were the same for YST and the state at 0.2% percent. The FHE results are located in Figure 4.3.

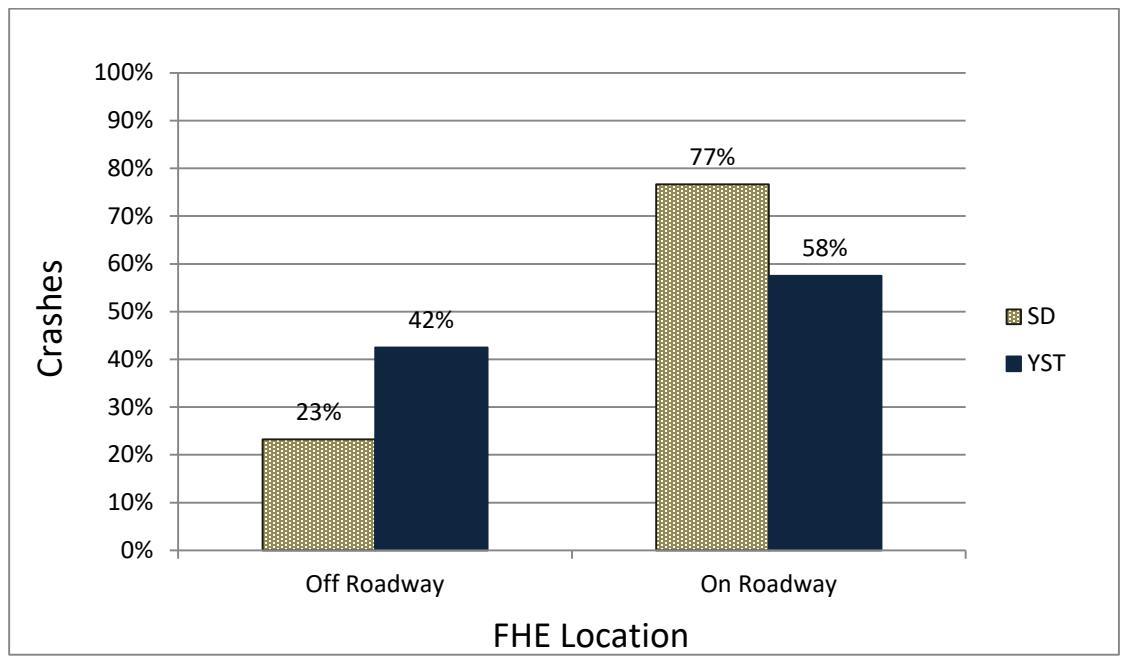
Figure 4.4 FHE Location for SD and YST 2004-2013

Almost two times as many crashes occurred off the roadway on YST as compared with the state at 42% and 23%, respectively. With 58% occurring on the roadway, on-road and off-road crashes are of equal concern. See Figure 4.4.

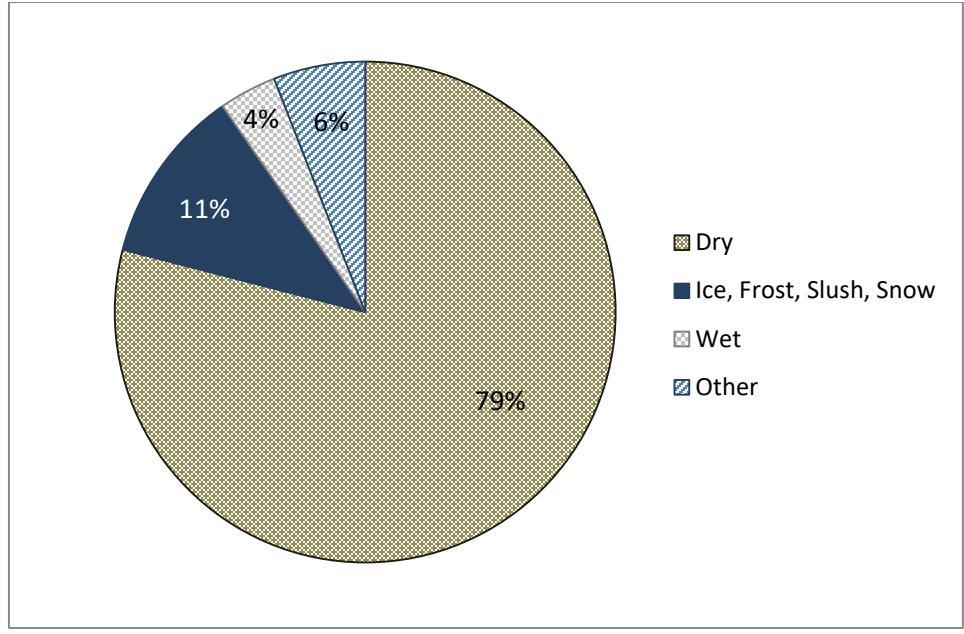
Figure 4.5 YST Road Conditions 2004-2013

Road conditions were reported as dry for 79% of the crashes, and as ice, snow, frost, or slush for 11%. Wet roads accounted for only 4% of all crashes. Other road conditions, such as sand, mud, dirt and gravel, accounted for 6% of all crashes. See Figure 4.5.

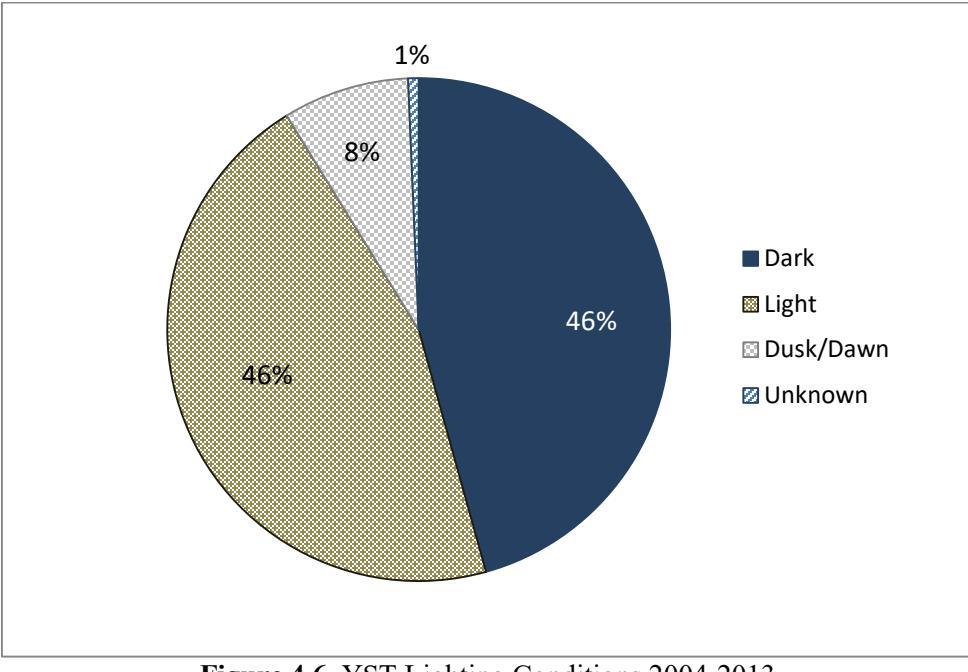
Figure 4.6 YST Lighting Conditions 2004-2013

Lighting conditions showed that crashes were evenly distributed between daylight and dark at 46% for both (Figure 4.6).

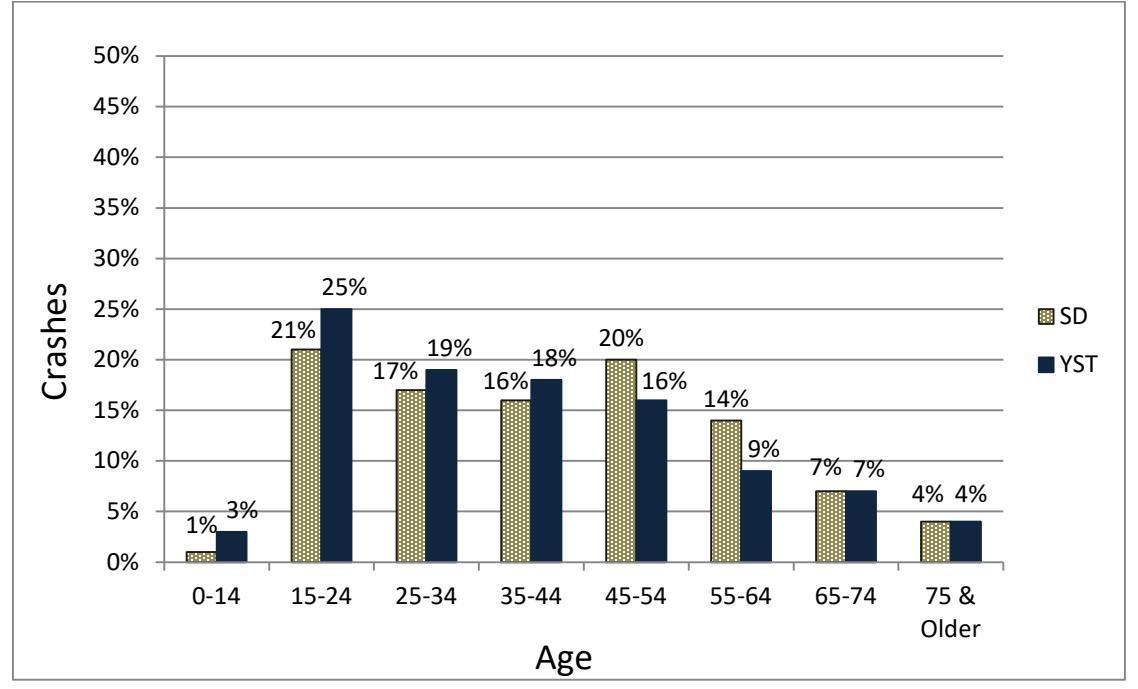
Figure 4.7 Driver Age for SD and YST 2004-2013

There was a slightly higher percentage of young drivers involved in crashes on YST compared with statewide. The analysis showed 25% were between the ages of 15 and 24, and 19% were between 25 and 34. For statewide, these values were 21% and 17%, respectively. For the 45 to 54 and 55 to 64 age groups, the statewide percentage of drivers was higher than YST. See Figure 4.7.

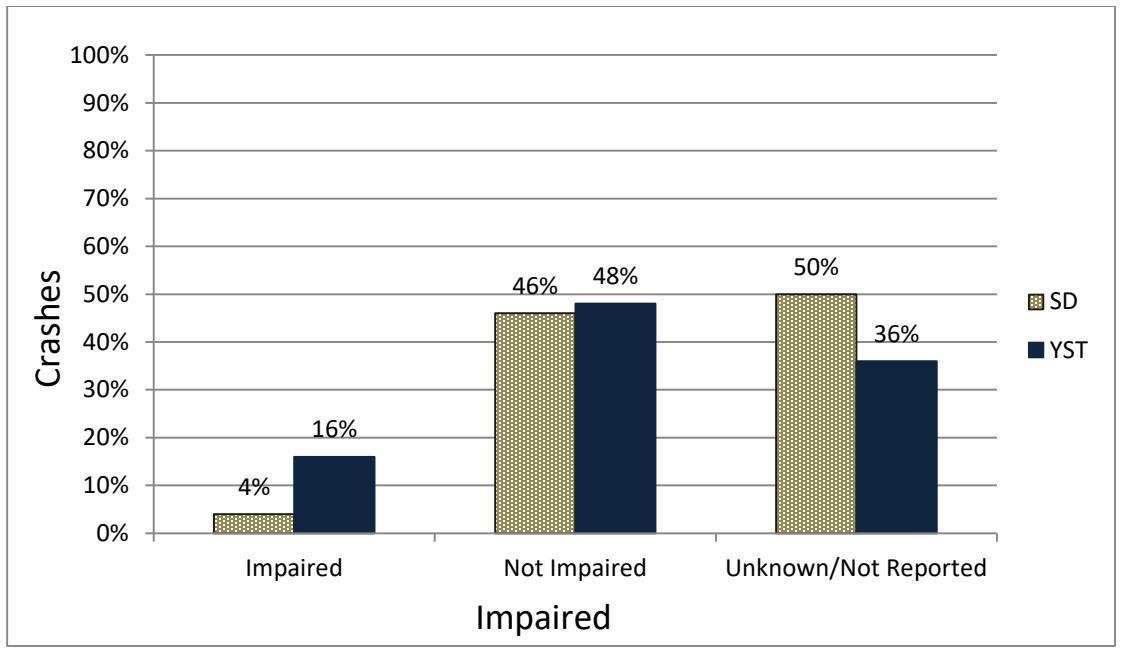
Figure 4.8 Crashes Involving Alcohol in SD and YST 2004-2013

Of all crashes reported, alcohol was involved with 16% statewide, showing only 4% impaired. However, it should be noted that the statewide also shows 50% as unknown or not reported impairment, as compared with YST at 36% unreported. See Figure 4.8.

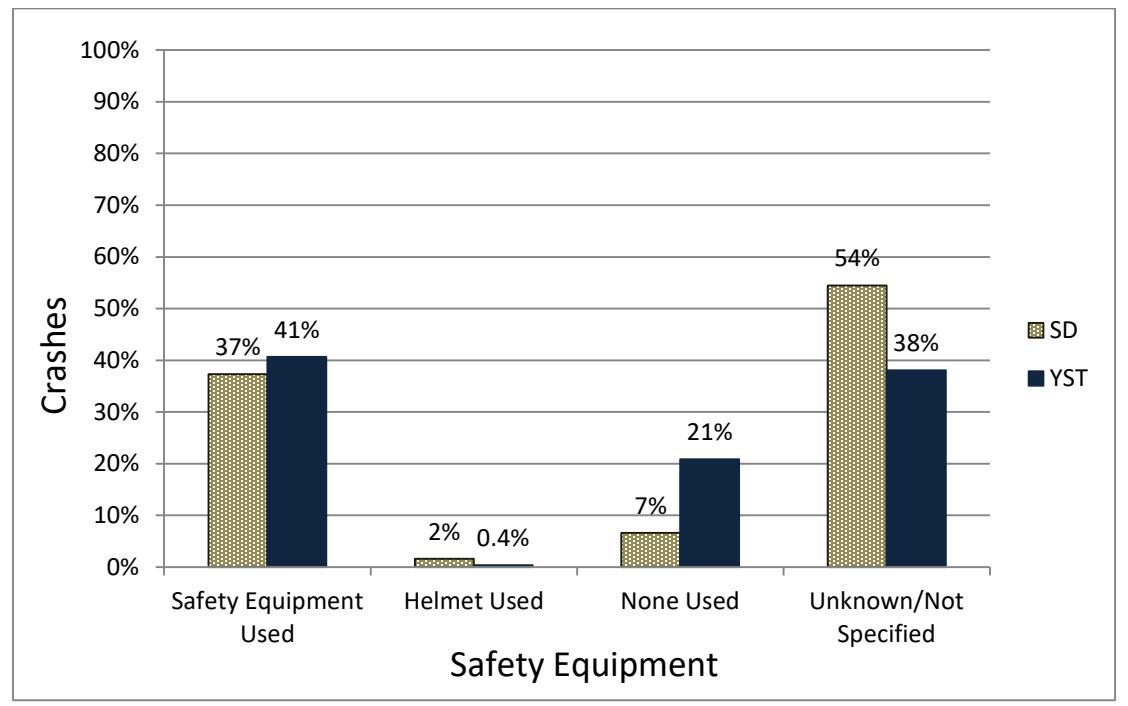
Figure 4.9 Safety Equipment Use in SD and YST 2004-2013

Safety equipment use is reported as slightly higher on the reservation at 41%, compared with 37% across the state. However, non-use of safety equipment was three times higher for YST compared with the state (Figure 4.9).

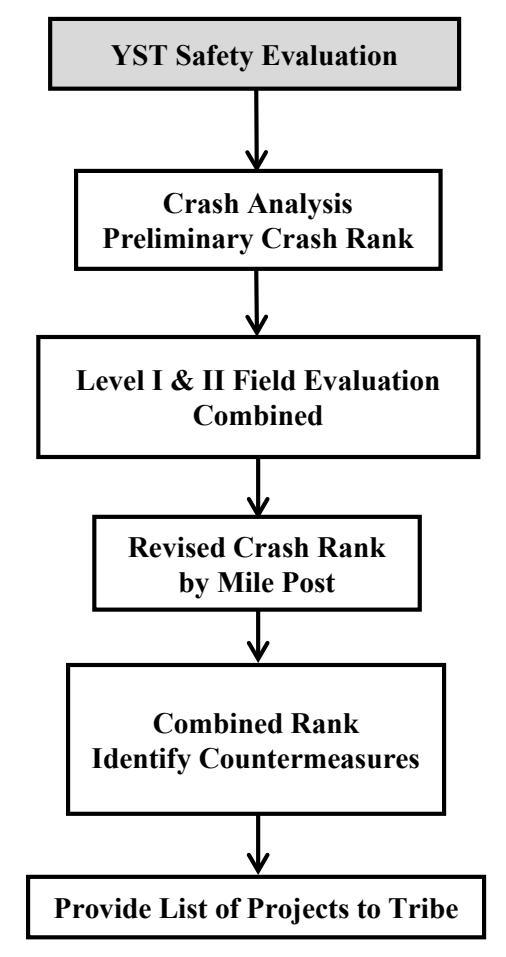
Figure 5.1 Applied Methodology

The methodology was slightly modified to fit the needs of YST. A preliminary crash ranking was first performed based on mapped locations. A revised crash ranking was performed once milepost locations were established during the field evaluations. In order to maximize resources, the Level I and Level II evaluations were performed simultaneously. See Figure 5.1.

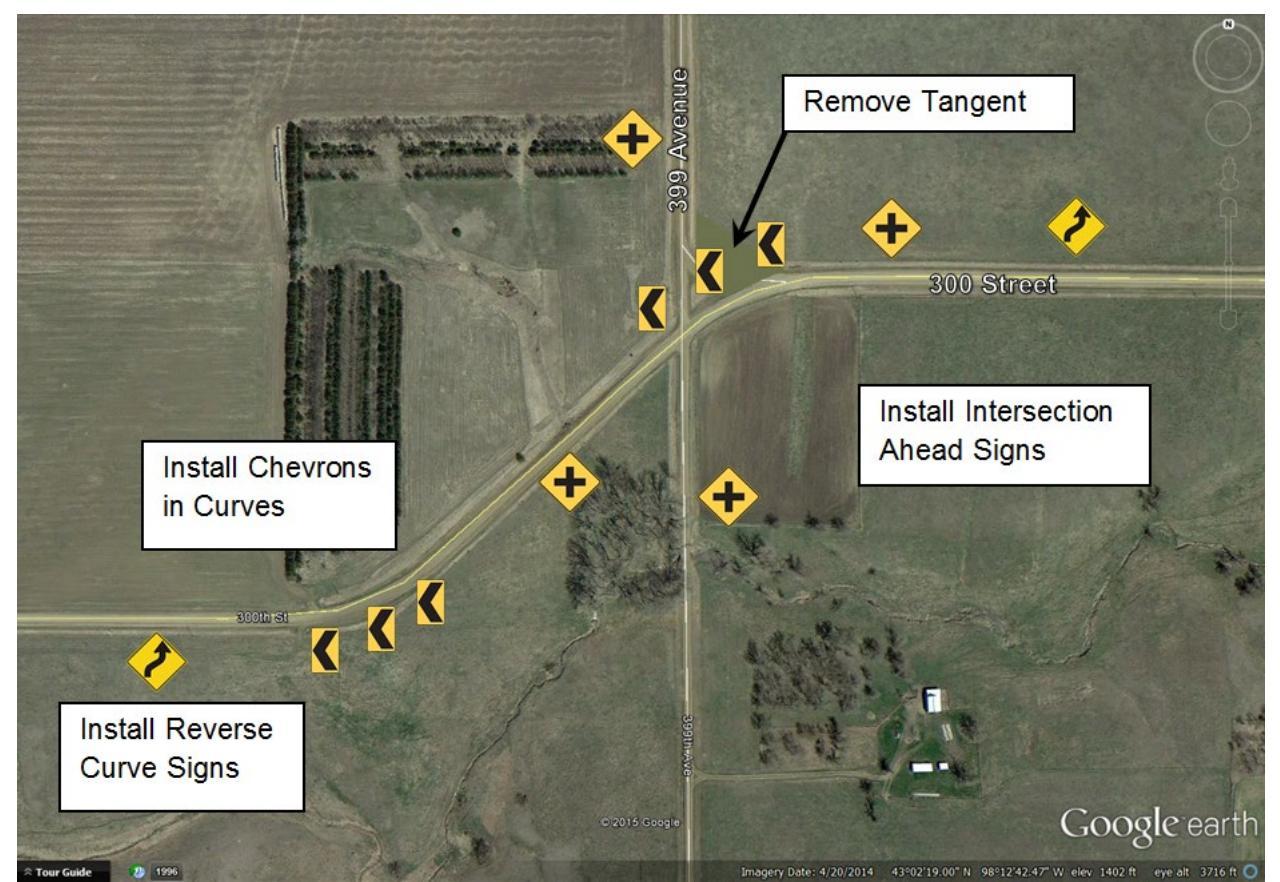
Figure 5.2 Proposed Improvements at 300th Street and 399th Avenue

On 300th Street, advanced intersection warning signs and two direction arrows at T intersections are recommended. The addition of advanced curve warning signs and chevrons in curves should be installed. The intersection of 300th Street and 399th Avenue is at a skewed angle and includes a tangent off of 300th Street. Because the alignment of 300th Street is along a horizontal curve, installation of curve warning signs with chevrons is recommended. In addition, the tangent off of 300th Street should be closed to reduce the number of conflicts created by the additional access. Intersection ahead signs should also be installed on both roadways. See Figure 5.2.

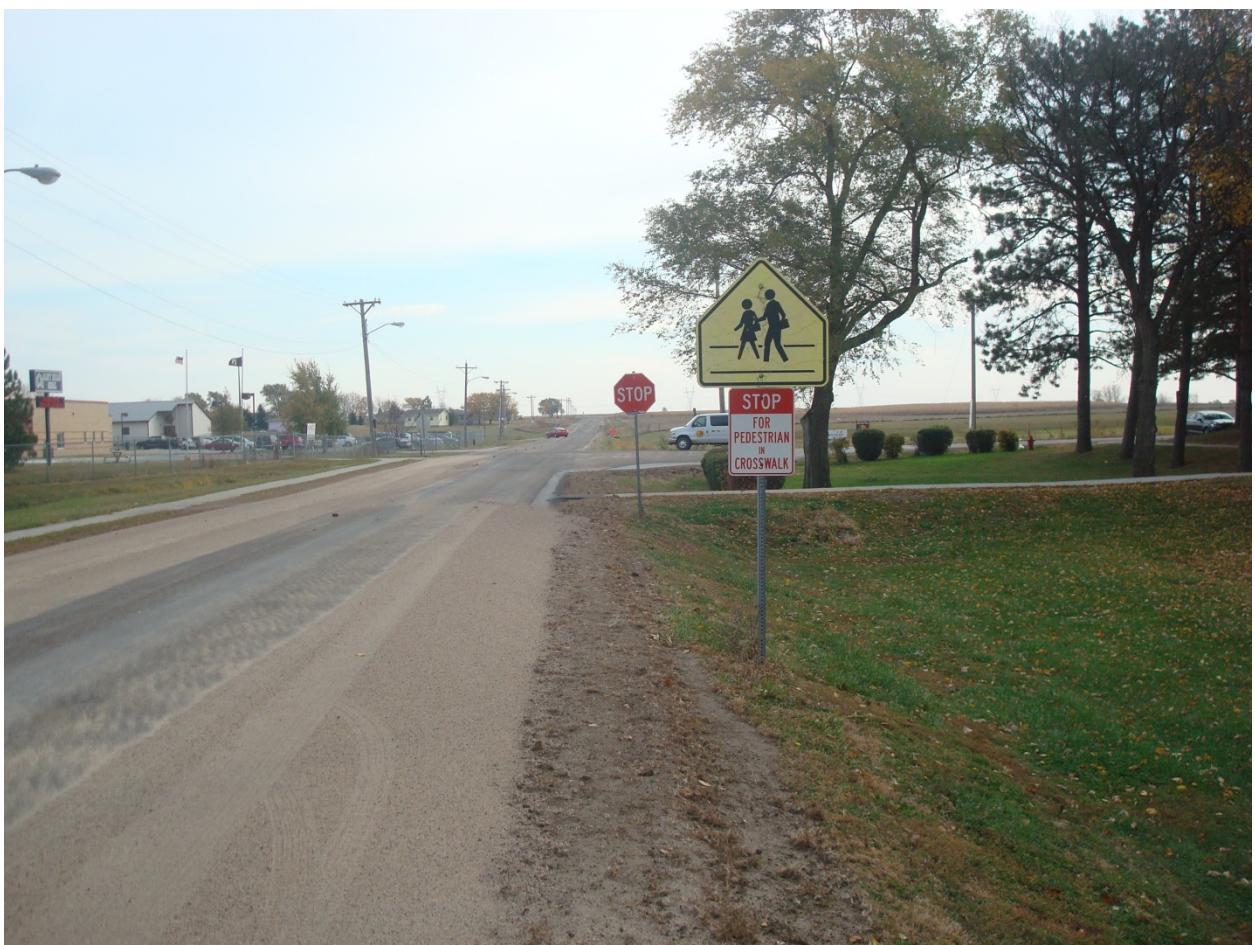
Figure 5.3 303rd Street in Marty near 388th Avenue Intersection

The intersection of 388th Avenue is within the school zone in Marty. The existing signage is not in compliance with the MUTCD and is confusing to the driver. A stop sign is located at the crosswalk, which is about 50 feet from the T intersection of 388th Avenue (see Figure 5.3)

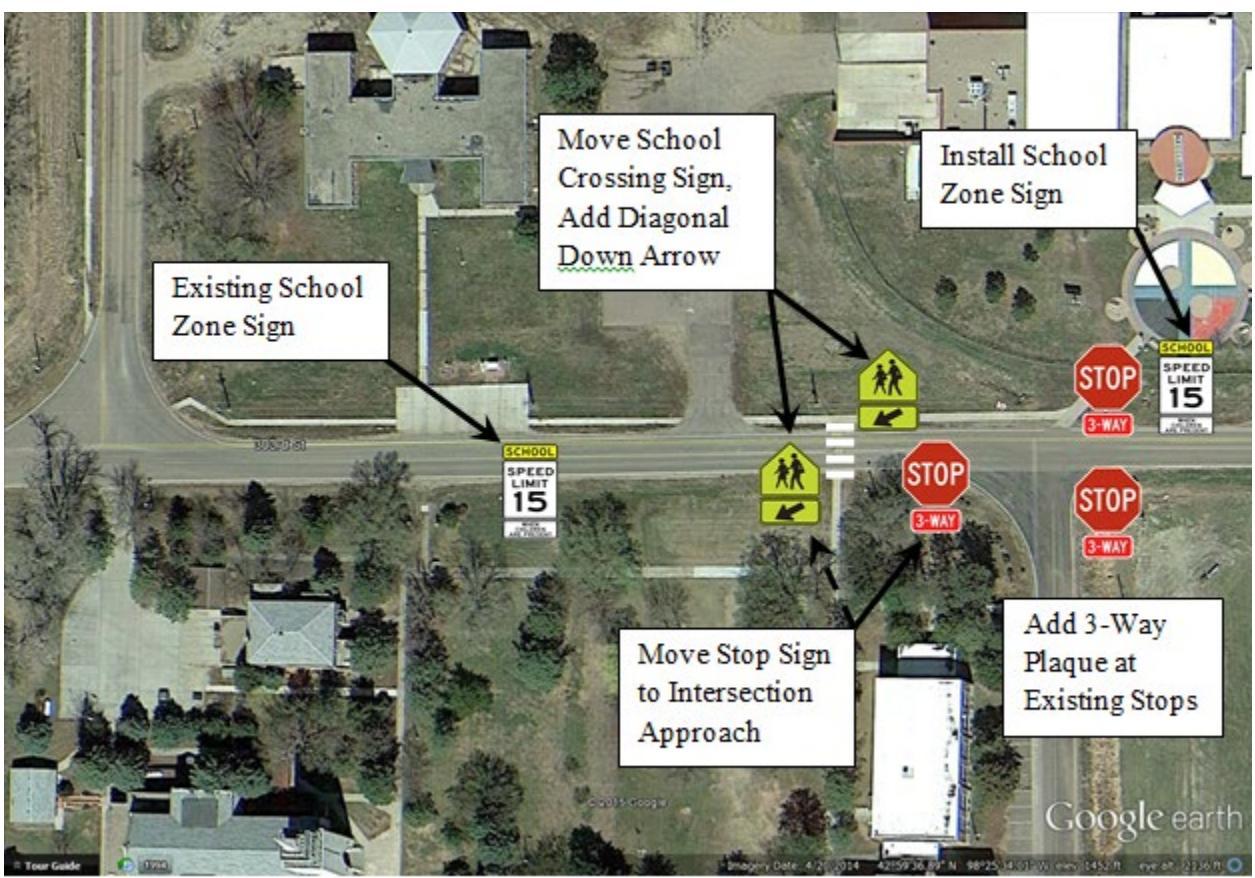
Figure 5.4 303rd Street School Zone Proposed Signage

In addition, upon entering Marty from the north on 388th Avenue, a 15 MPH regulatory speed limit sign is located 1,000 feet south of a 30 MPH speed limit sign. Drivers may have a hard time complying with such a low speed coming off a 55 MPH highway into town. A compliance speed study is recommended. The school zone begins just east of the north leg of 388th Avenue and is posted at 15 MPH with a school sign. The pedestrian crossing signs should be adjusted, locating them at the crosswalk with a diagonal down arrow. An additional school zone sign should be placed east of the school zone and just south of the 388th Avenue intersection if one does not exist in these locations. According to the MUTCD, the stop sign should be located at the approach of the intersection with 388th Avenue. A three-way stop plaque should be added to each stop sign. However, a stop sign warrant study is recommended for this intersection. It may reveal that only 388th Avenue northbound would require a stop sign. See Figure 5.4 for proposed signage.

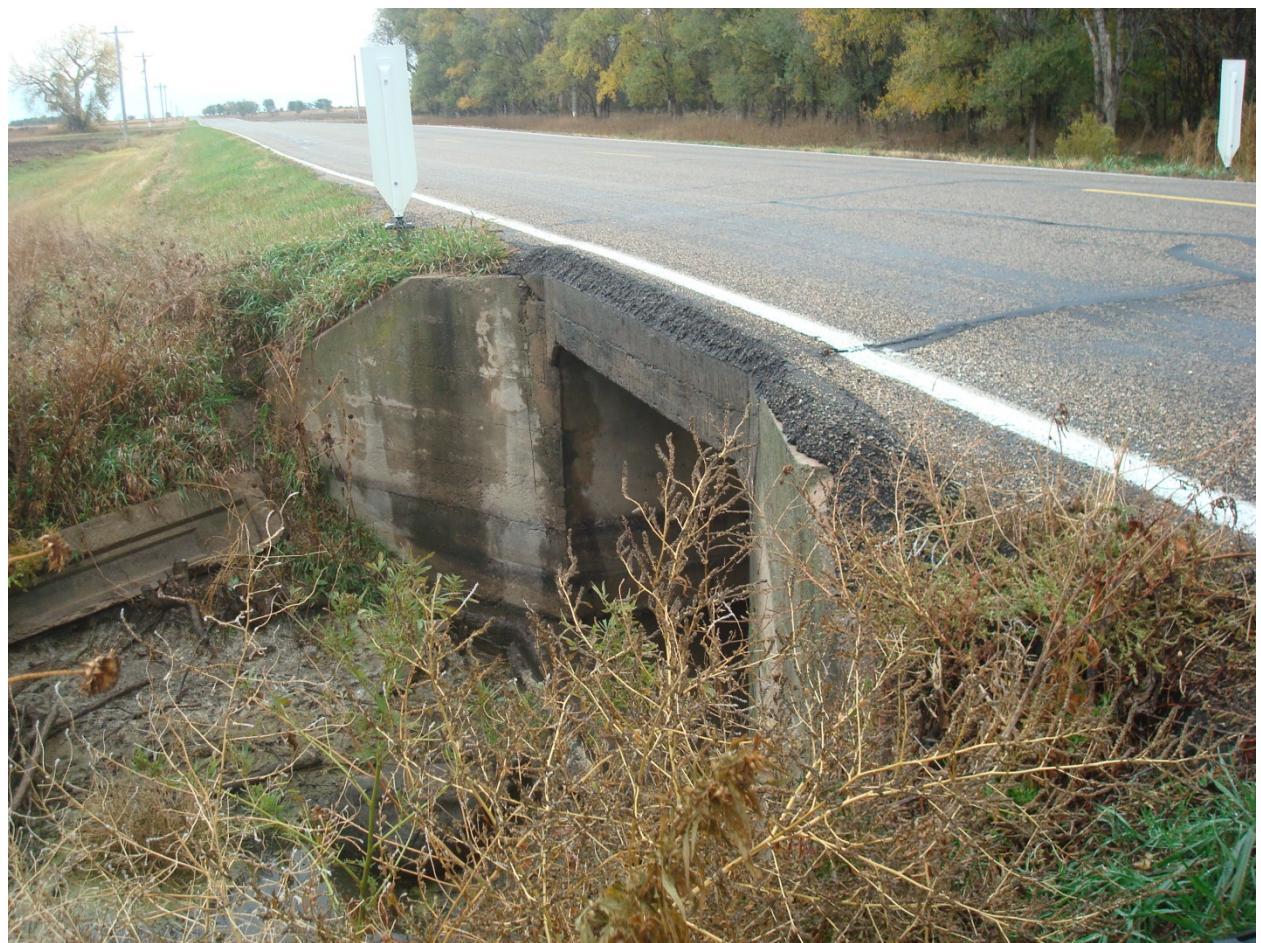
Figure 5.5 Culvert on 395th Avenue three Miles North of SD Hwy 46

About three miles north of South Dakota Highway 46 on 395th Avenue, a narrow culvert crossing exists with no shoulder or guardrail. It does have object markers, but the road drops off within inches of the edgeline (see Figure 5.5). This culvert should be widened and railings added to provide recovery for any vehicles crossing the edgeline.

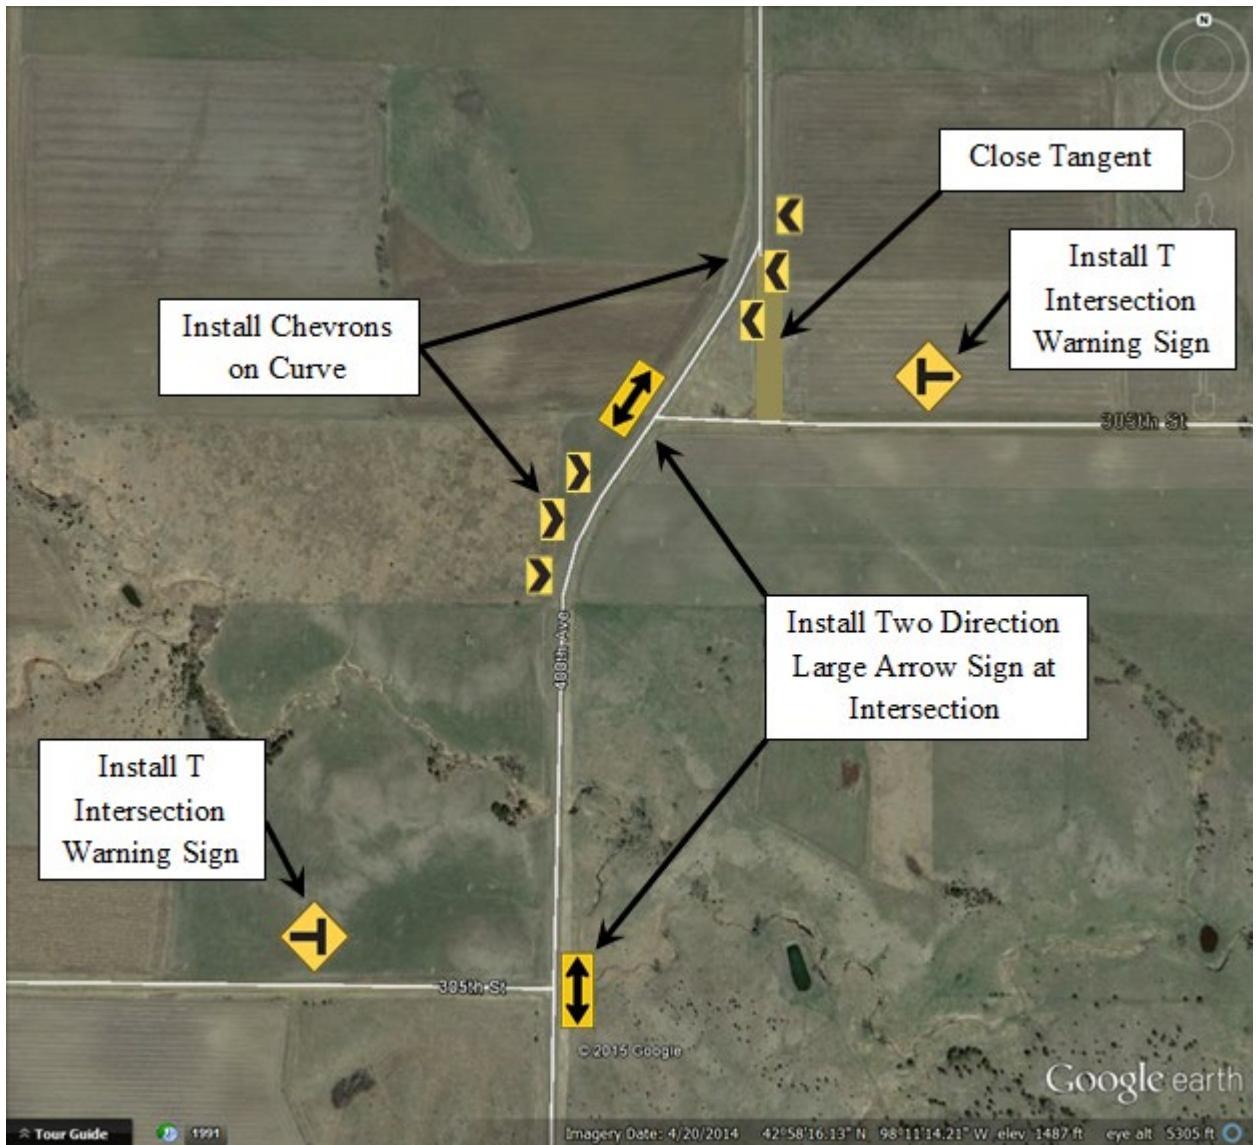
Figure 5.6 Proposed Improvements at 400th Avenue and 305th Street

The intersection of 400th Avenue and 305th Street has offset connections with a tangent access between the east leg of 305th Street and 400th Avenue. Intersection improvements are recommended to reduce the conflict points and provide advanced intersection warning signs. The tangent should be closed and require drivers to enter and exit 400th Avenue at the T intersection. Two direction arrows should be installed at the T intersections. See Figure 5.6 for proposed intersection improvements.
