# YOU SHOW US CONTEST 2012

*FHWA LTAP/TTAP*  
**BUILD A BETTER MOUSETRAP  
NATIONAL COMPETITION**  
National Entry Booklet 2012

# “YOU SHOW US” CONTEST

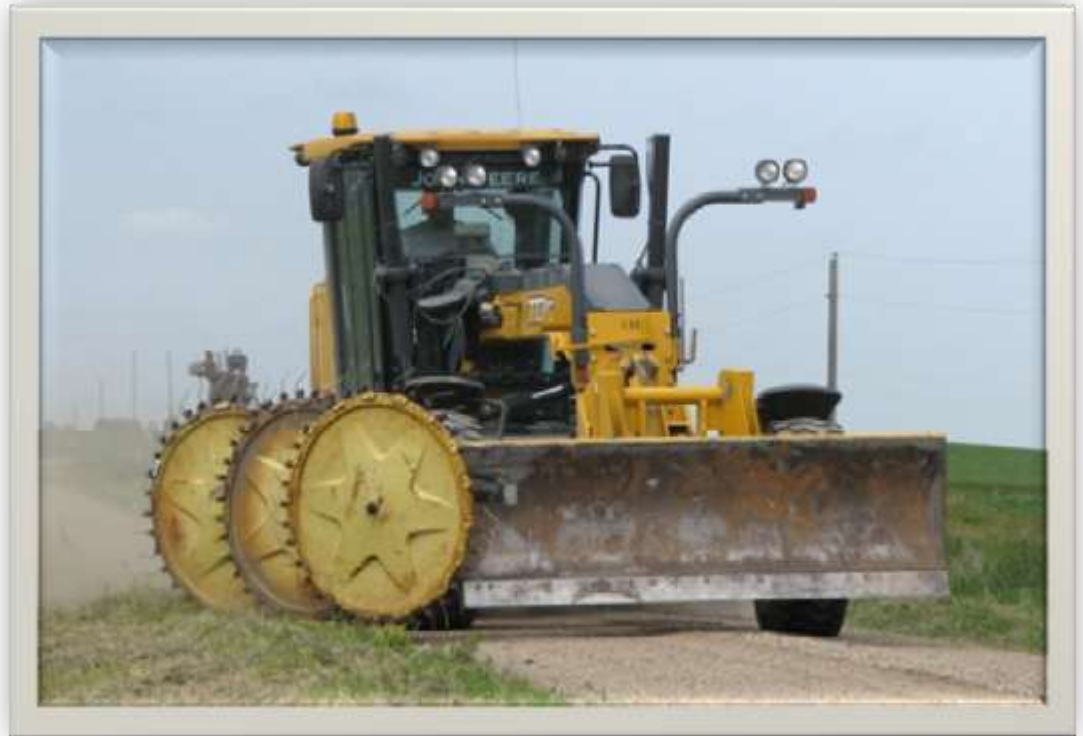
- Mowed grass from ditch blows onto roadway.
- When blading, grass mixes with gravel causing big mounds and ridges.
- 2- 3 feet of mowed grass ends up narrowing road width
- Hazard to the traveling public, potential for accidents

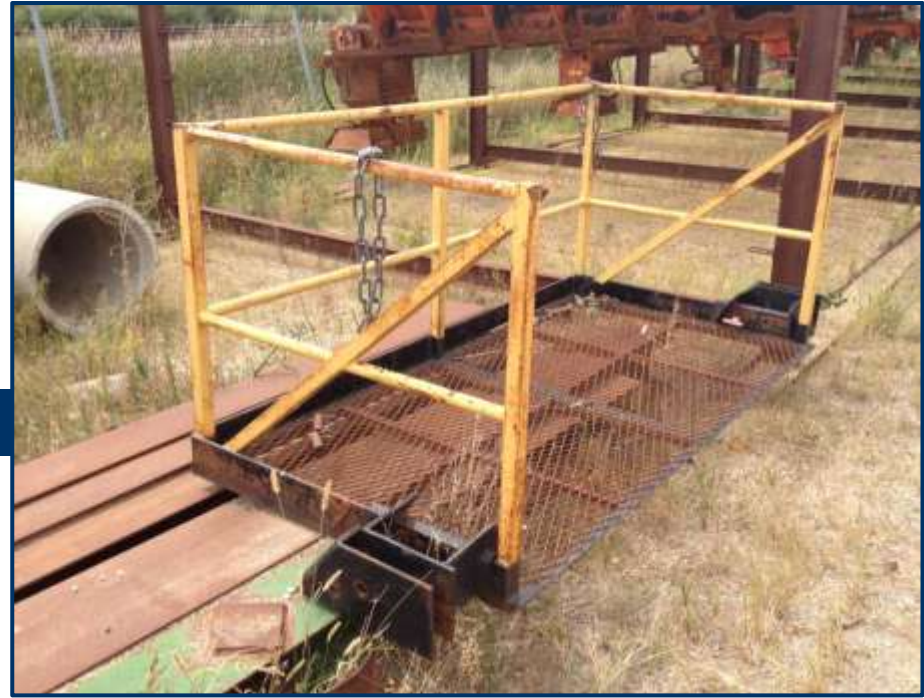
- Need to cut trees or limbs that overhang roads
- Crew members stood in loader bucket while cutting with chain saw. Safer operation needed since a man fell from bucket after cutting a large limb.
- Cost prohibitive to purchase a bucket truck
- Difficult to hire service in emergencies

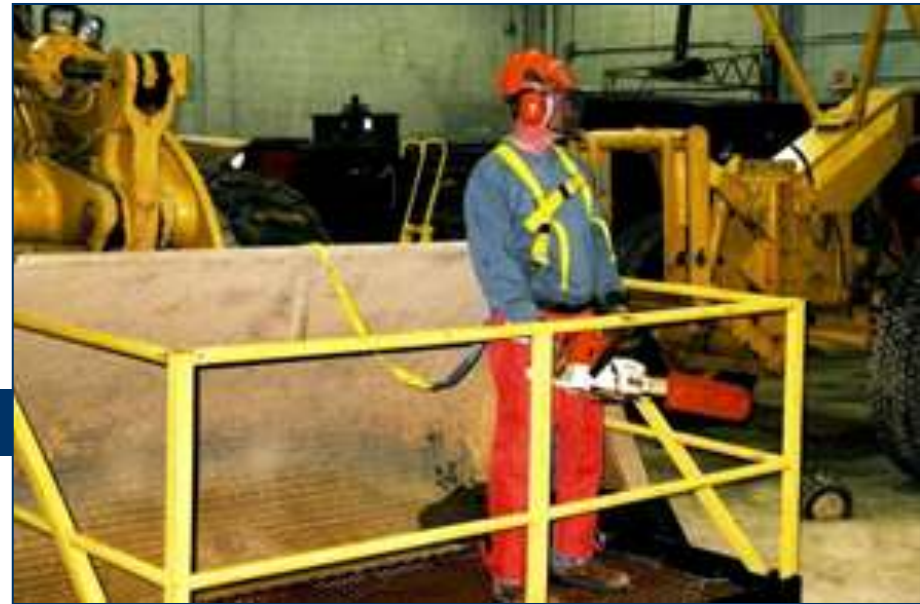
- A safety scaffold that mounts at front of loader bucket
- Railing surrounding front and sides of bucket
- Strong mesh floor for safety in preventing slips
- Safety harness and lanyard attached to a ring

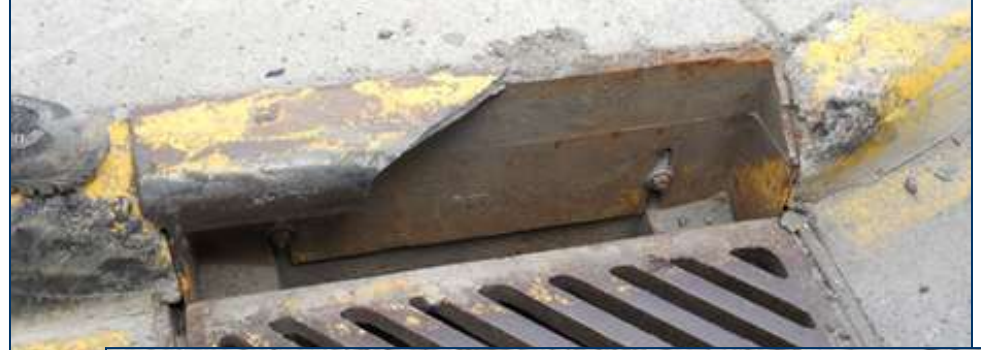
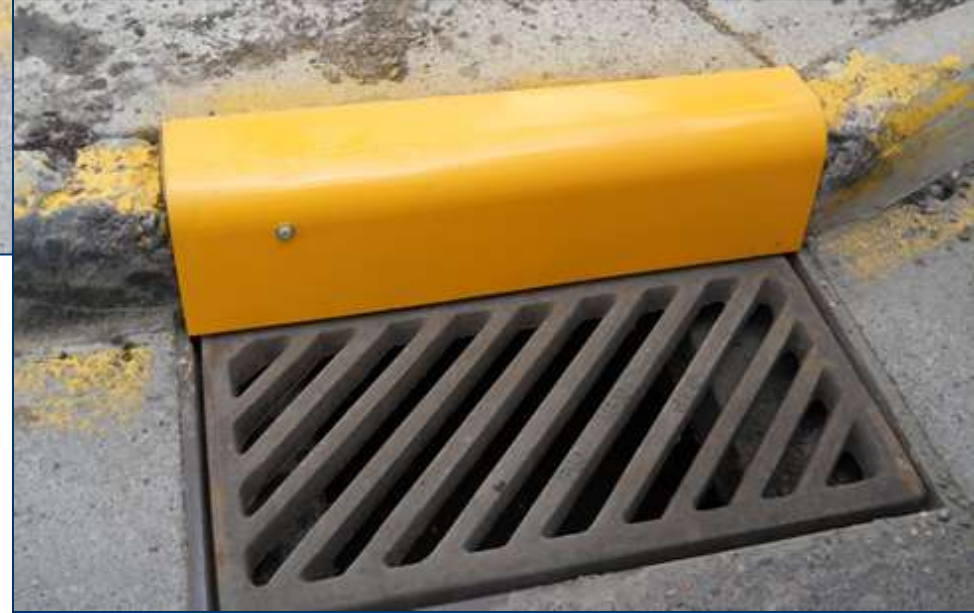
- Removal of concrete and infrastructure took approx 3 days in labor to replace entire backing structure
- A viable solution was to bolt a metal cap onto the remaining infrastructure of the damaged plate
