***FULL-SCALE LABORATORY TESTING OF A
TIMBER TRESTLE RAILROAD BRIDGE CHORD***

(Phase 1)

Richard M. Gutkowski, Professor

Colorado State University

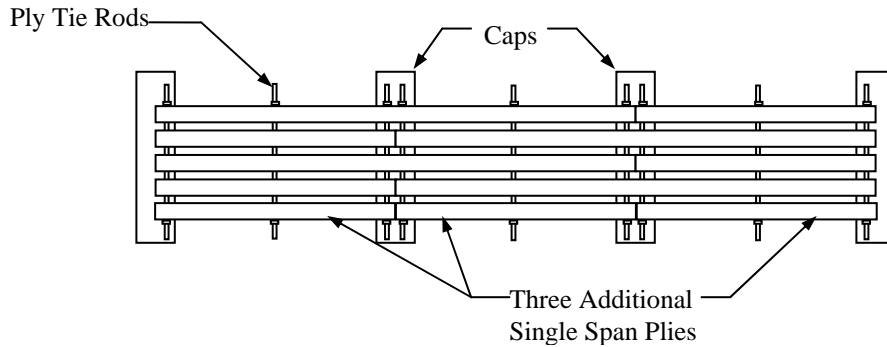
of each span, without adjusting the rail position (i.e. it was left "off-center") and the specimen was load tested again (see Figure 1.5).

Figure 1.5: 5-Ply Configuration for the 3-Span Bridge Chord

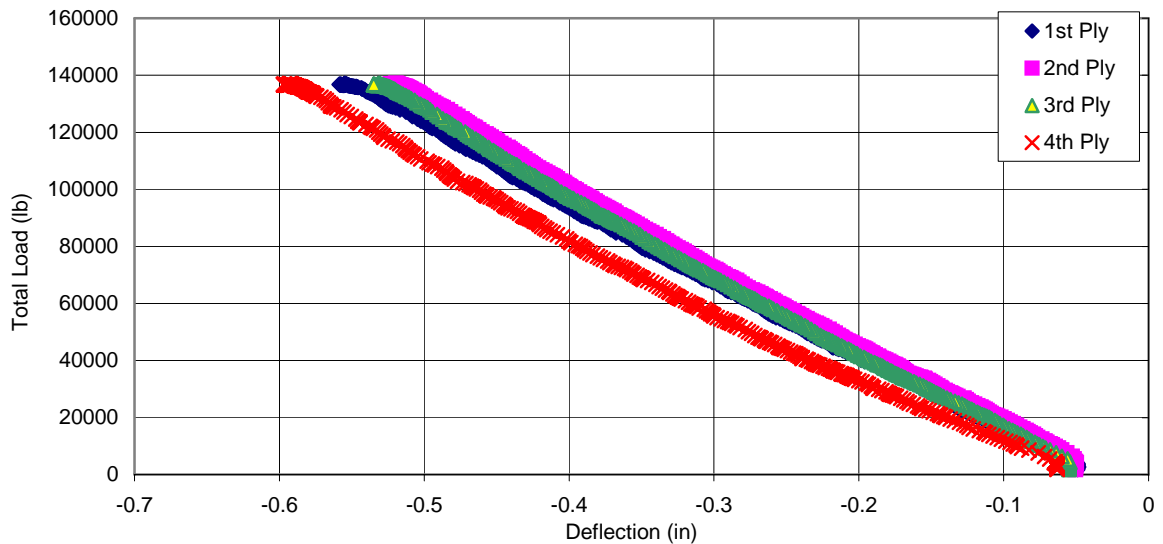
The corresponding responses under two-point loading are shown in Figures 1.31 (loaded span) and 1.32 (non-loaded span). All plies in the non-loaded span experienced a small downward motion at the maximum load level, 138,000 lbs. This suggests possible support displacement occurred at this higher total load. In the loaded span, at the highest load, all plies displacement downward and the range of maximum displacements was between .52" and .60". Again, ply 4 displaced noticeably more than the other plies.

Figure 1.31: Chord 2/4 - 2-Point Load, Mid Span Deflections of Each Ply in Span 2

Figure 1.32: Chord 2/4 - 2-Point Load, Mid Span Deflections of Each Ply in Span 1

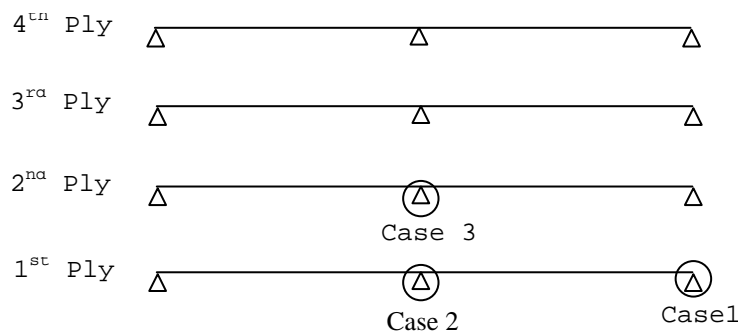
Chord 2/4 was retested after several adjustments of the bearing conditions. Figure 1.67 illustrates the three cases examined in this study and the reference number for the plies. Initially, all plies were shimmed with 3/4" thick plywood. In each of the three alterations, plywood was removed at one location. In Case 1, the plywood was removed from the end support of ply 1. In Case 2, plywood was removed from the interior support of ply 1. In Case 3, plywood was removed from the interior support of ply 2. These were individual events, not cumulative. The loading was a single point load in the right span. In each case ply tie rods were in place at mid-span.

Figure 1.67: Locations of Unsupported Plies – 2-Span Bridge Chord
