LOW-IMPACT, HIGH TOUGHNESS TRANSPORTATION BARRIERS

Paul R. Heyliger, Doug Allen, Michael Lebsack, and Thomas Wilson

Department of Civil and Environmental Engineering
Colorado State University
Fort Collins, CO

October 2012

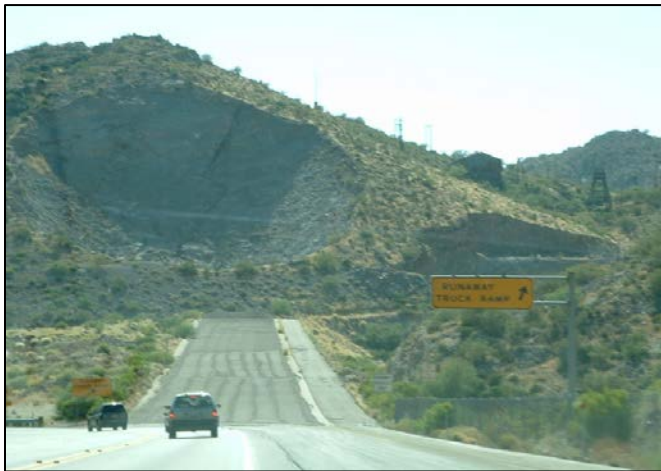
Figure 1.1 An example of a gravitational runaway truck ramp in Arizona.

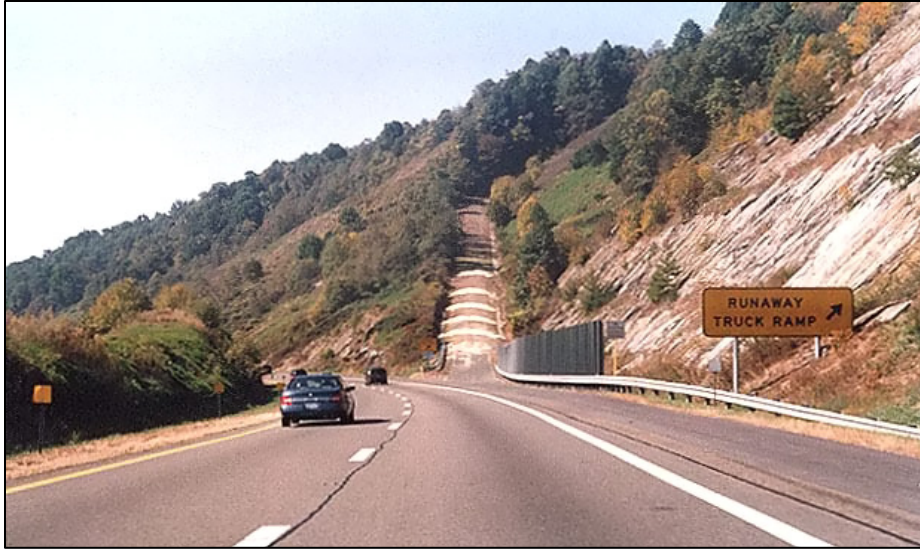
Figure 1.2 A gravitational ramp with sand piles in Virginia.

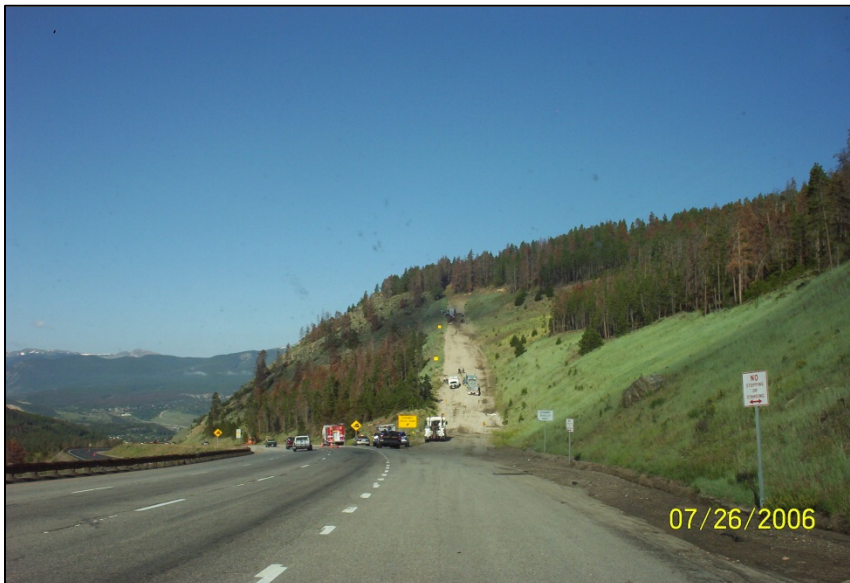
Figure 1.3 Perhaps the most-used runaway ramp in Colorado: the western side of the Eisenhower tunnel on I-70 just east of Silverthorne, showing a maintenance crew after an event. This ramp has over 20 reported events per year, with 106 reported 2001-2004.

Other solutions to emergency off ramps include gravity and sand pile escape ramps. Gravity escape ramps (Figures 1.3 and 1.4) utilize long roadways inclining upward that run parallel to the road. The concept behind the design is that gravitational potential energy will balance the kinetic energy. In fact, gravity ramps are often combined with arrestor beds to provide two means for slowing down vehicles.

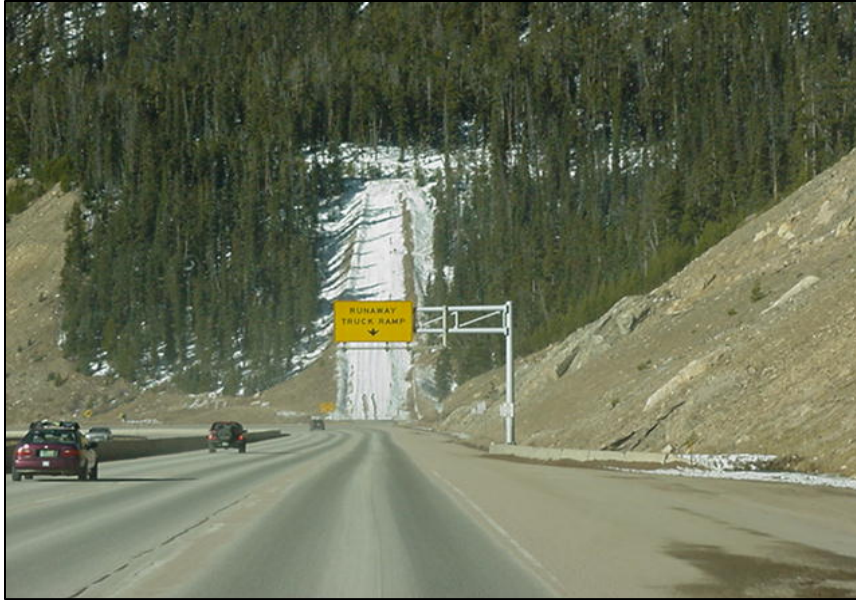
Figure 1.4 The same ramp as that of Figure 1.3 during the winter, with snow coverage.

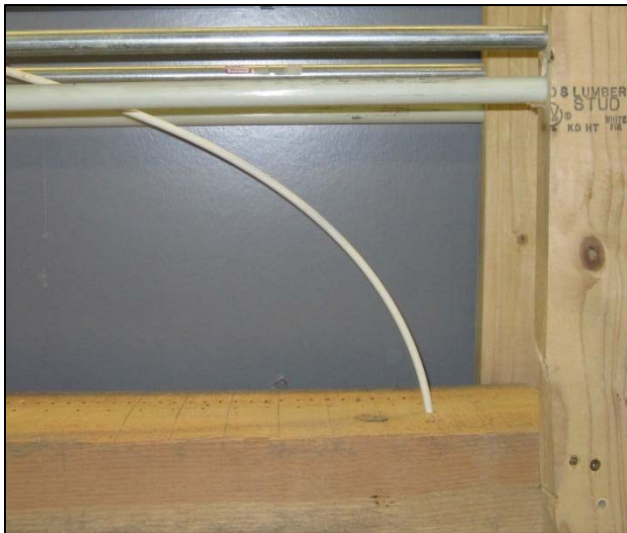
Figure 3.1 Static Deflection Test 1/4 in. Fiberglass Rod.

The deformation pattern in Figure 3.1 clearly shows the type of energy storage that is relied upon for the use of this sort of transportation barrier. All structures deform when they are loaded, but most structures have infinitesimal displacements that cannot be seen by the human eye. They are relatively stiff, and hence any loading will result in a shock to the system that is loading it. In this case, the rods are relatively soft. They immediately give way under loading but absorb energy as they do so. When they are linked together into an array of individual rods, the forces that slow down a vehicle are applied sequentially, resulting in a gradual slowing of the vehicle. If, for example, the rods were bonded into an individual unit with the same amount of material (but with inter-rod connectivity), the resultant moment of inertia would skyrocket and the impact would be similar to a car running into a pole. The rods would deform much less, but the damage to the vehicle and its occupants would be far more severe.

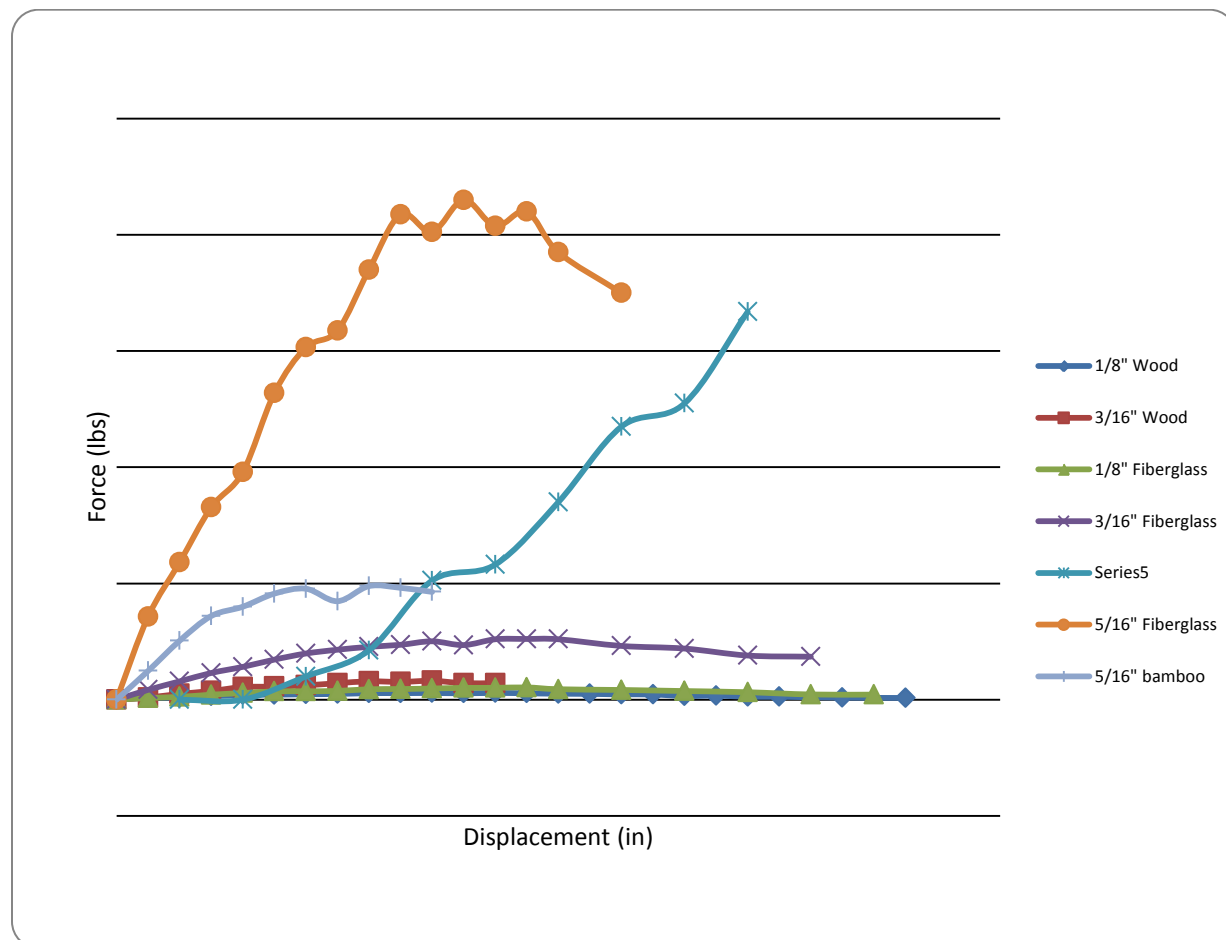
Figure 3.2 Static bending test data for various materials.

The results from the static deflection test showed the 1/4 in. diameter fiberglass rod was the optimal material for further testing. This is obvious from the results in Figure 3.2, with the level of energy absorbed for the same amount of displacement being dramatically larger for the fiberglass than the wood materials. Additionally, fiberglass is an economically feasible material and it proved to have superior performance in bending to that of wood and bamboo. The material is more uniform and was shown to have relatively small variability between specimens, creating an ideal candidate for this application. Fiberglass also has a significantly higher energy absorption envelope to minimize the number of rods necessary for energy absorption. A modulus of elasticity of between 2,800,000-5,500,000 psi was provided for the specimens by the manufacturer, McMaster's. The force-deflection curve for the 1/4 in. fiberglass rods can be seen in Figure 3.3.

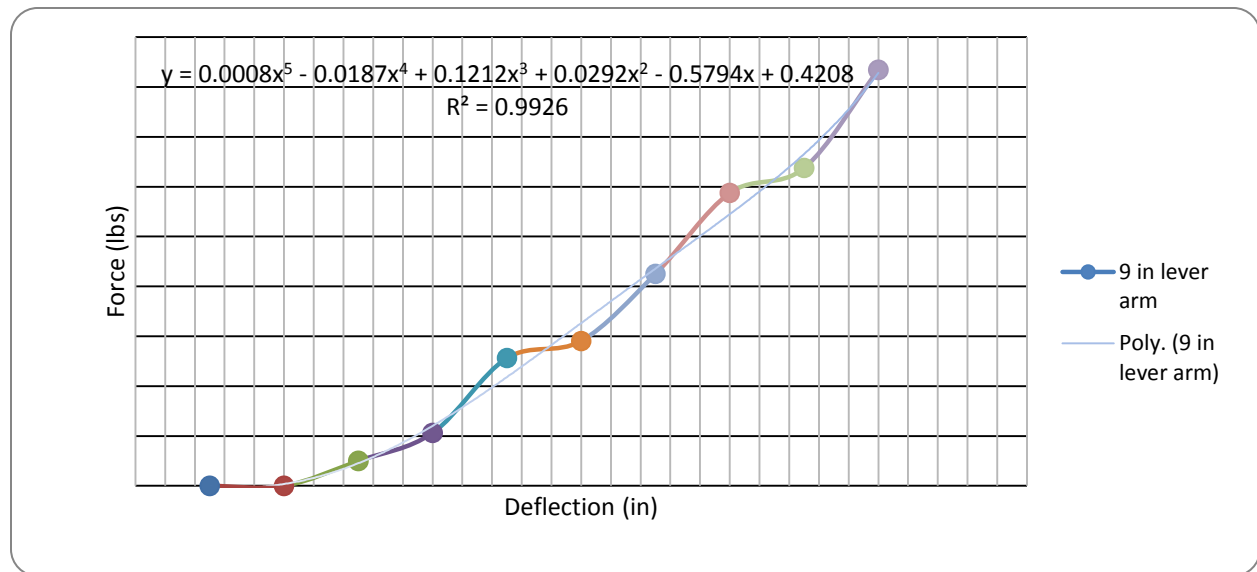
Figure 3.3 Bending test 1/4 in. fiberglass rod. The area under the curve is the energy stored during the deformation.

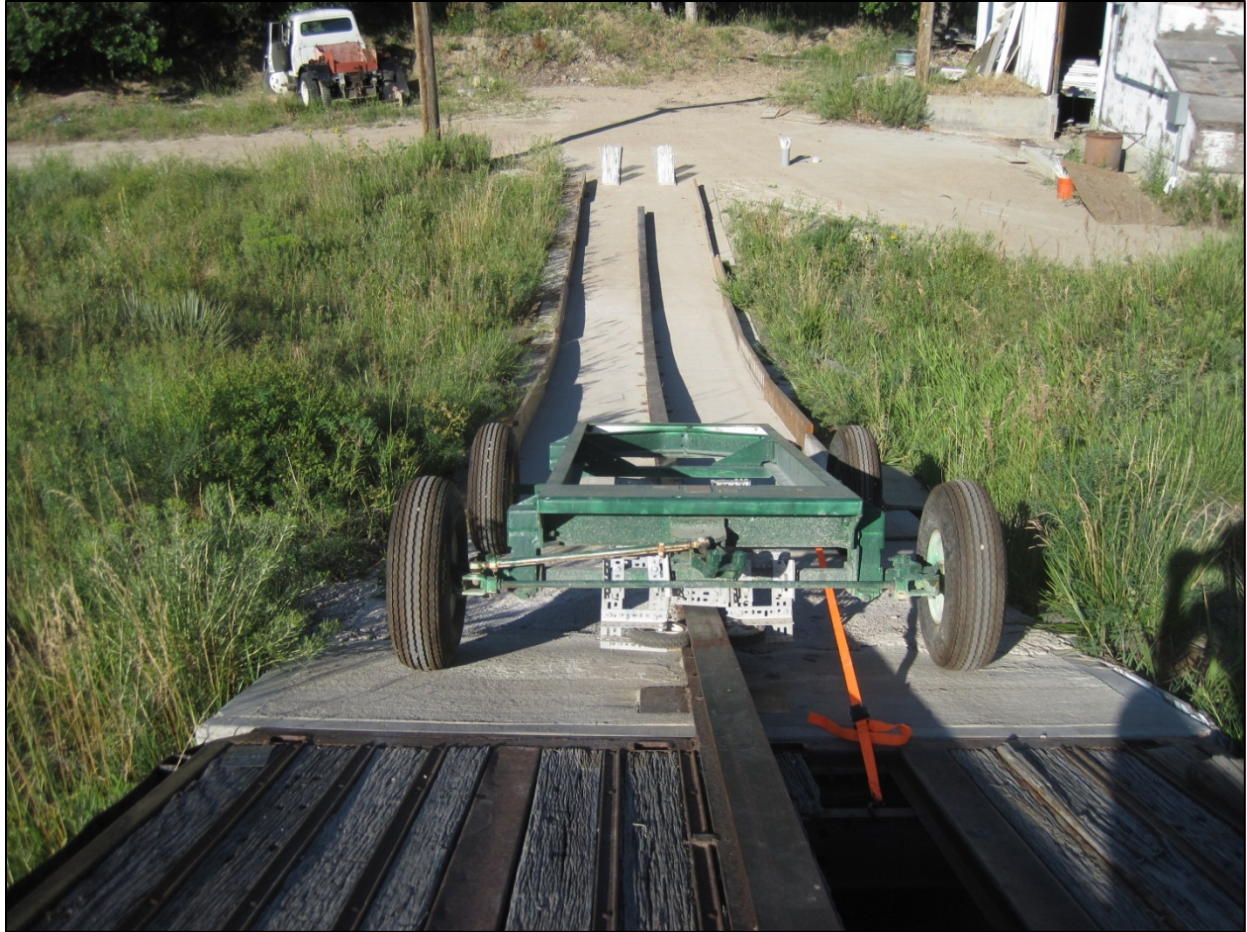
Figure 3.4 CSU vehicle testing ramp. The change in elevation allows a vehicle speed of up to 25 mph to be achieved with little effort, providing a reasonable amount of kinetic energy that needs to be absorbed by the flexible ramp system. The two white blocks at the bottom of the ramp (after the center rail, which guides the vehicle, ends) are in fact the array of fiberglass rods.

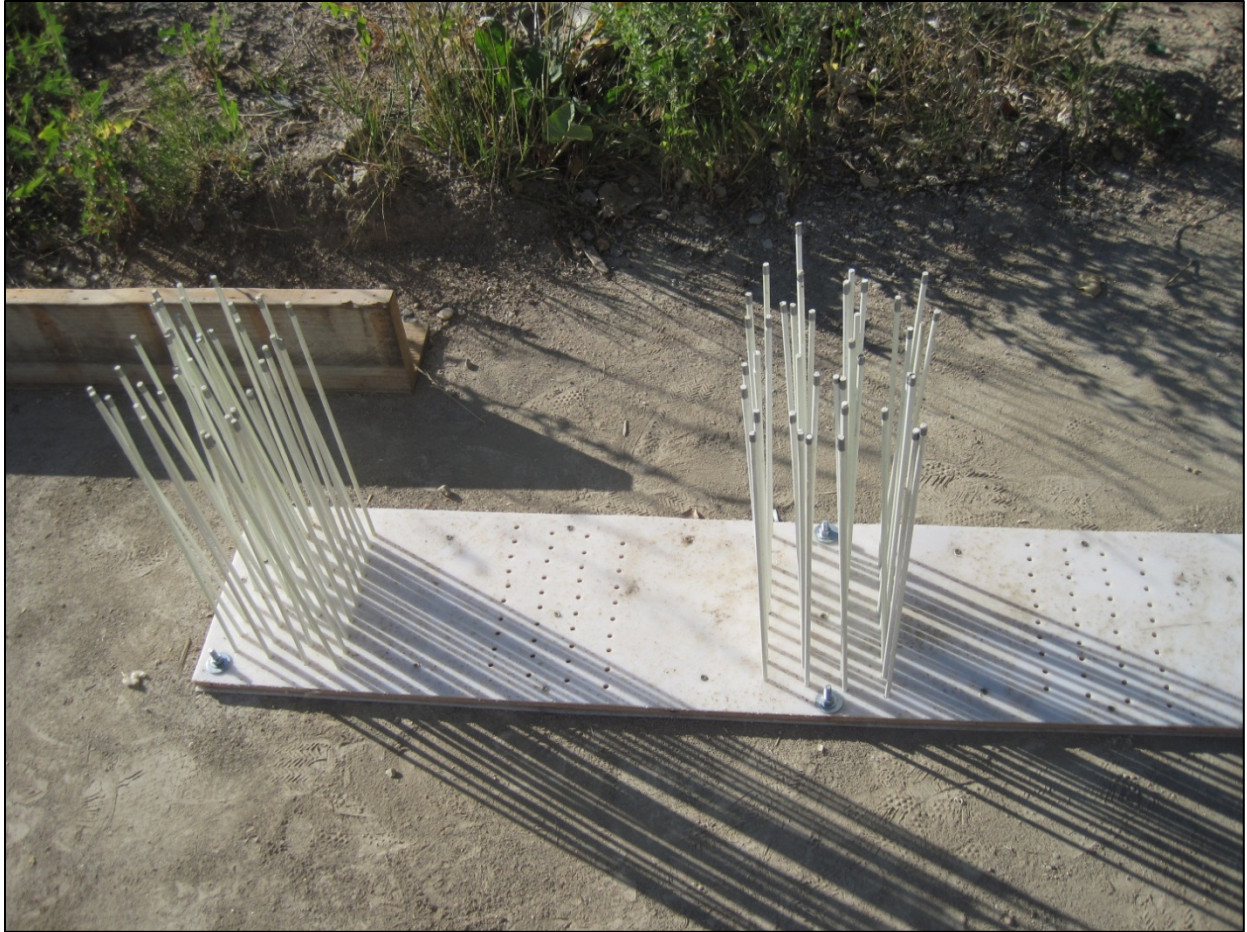
Figure 3.5 Rod and mount setup.

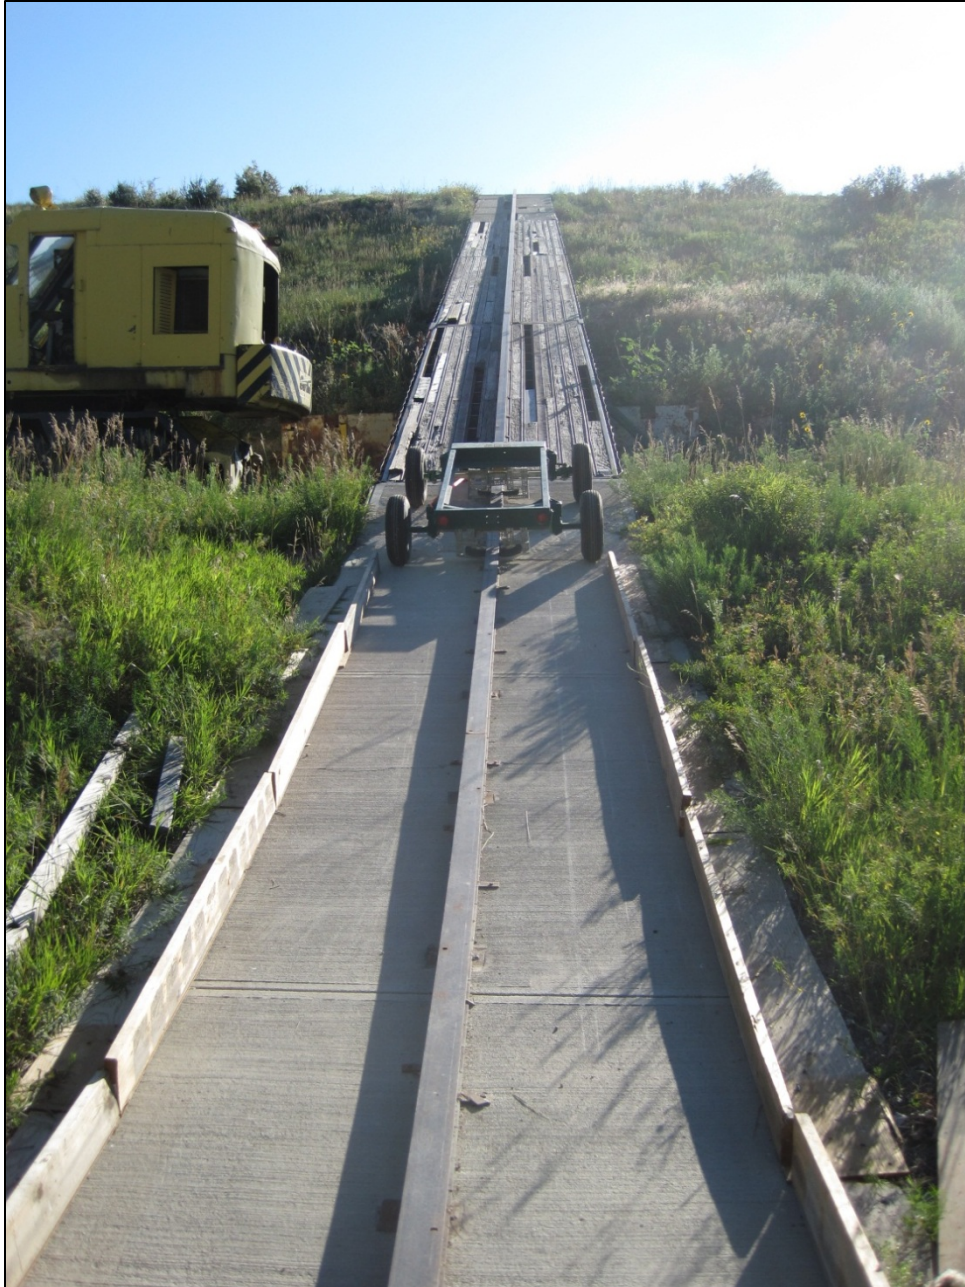
Figure 3.6 CSU vehicle test ramp from below.

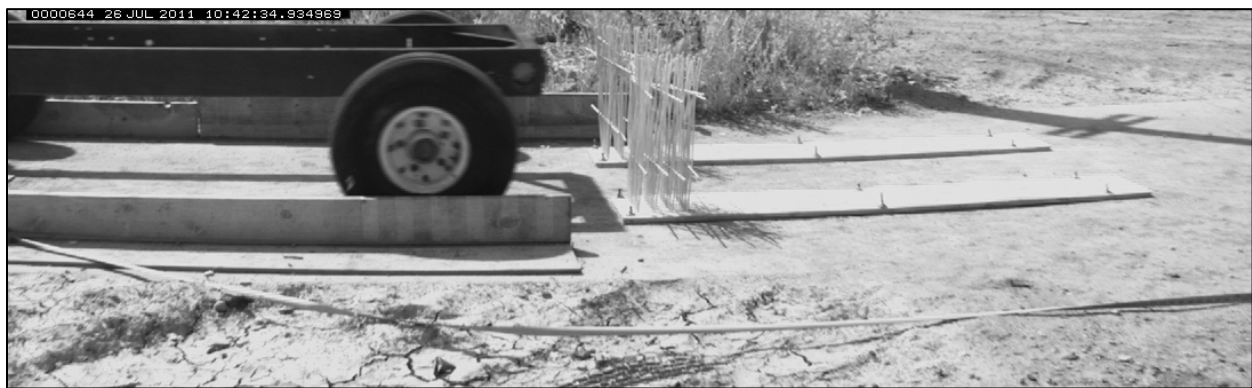
Figure 4.1 Horizontal bracing.

Our calculations also predicted 91 rods would stop the cart traveling at 7.0 mph, but in Test 4 the cart was traveling even faster at 7.6 mph, and just 80 rods were able to stop the cart. At a speed of 8.0 mph, 119 rods should have been necessary to stop the cart, yet at 8.1 mph as little as 96 rods were able to stop the cart. Test 5 used 80 rods placed vertically, with 16 more rods oriented horizontally (two per row of 10 rods) and performed very well. In Test 6, the predicted 119 rods (all vertical) stopped the rods as well. A picture of the horizontally oriented rods can be seen in Figure 4.1.

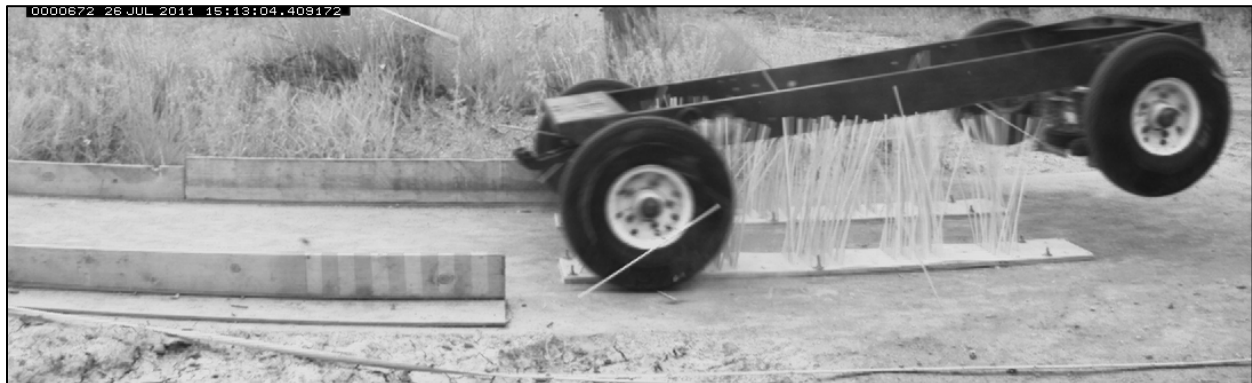
Figure 4.2 Cart lift due to tightly spaced clusters.

It should be noted that the number of rods used in testing doesn't provide the entire picture or completely represent the challenges associated with regular use. The layout and spacing of the rods have a significant impact on the performance of the barrier. The high-speed camera footage revealed that the cart would lift off the ground due to the vertical force exerted upon it by the rods. When the cart lifted, it would often jump over a number of rods as can be seen in Figure 4.2. As shown in Figure 4.3, the use of clusters spaced apart was effective and kept the cart low to the ground. Consequentially, the spacing of the rods was altered so as to prevent any rods from being jumped. Our high-speed footage also revealed that grouping the rods into clusters had a positive impact on the performance of the barrier. One preliminary test was performed in which individual rows of rods spaced 14 inches apart was compared with rows of rods spaced just two inches apart. Each layout used 40 rods. The test with the rods bunched together was able to stop the cart, while the test with the rods spread out at 14-inch intervals failed miserably at the same speed. When the rods are closer together, they interact with one another and act as a more rigid unit while still maintaining their flexibility.

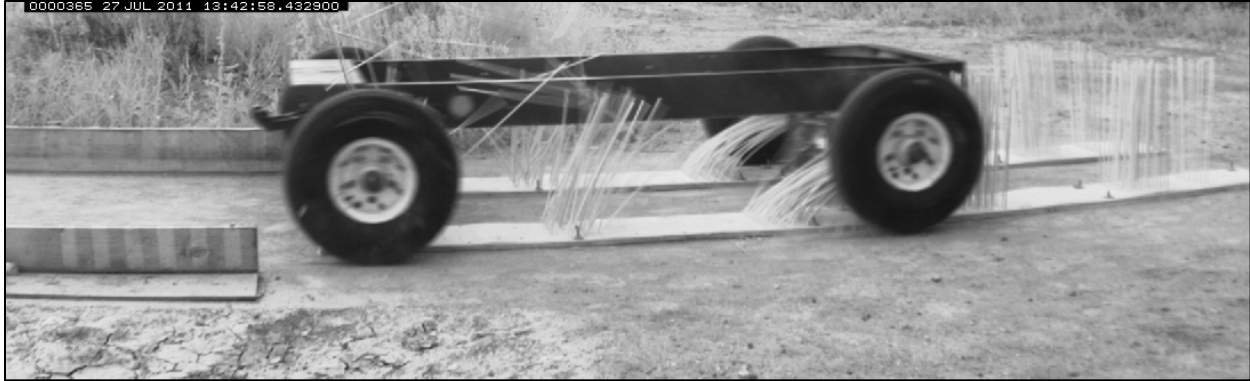
Figure 4.3 Clusters spaced apart with no lift.

A similar result can be seen from Test 5 in which two rods were woven in between every row of ten rods. With the horizontally woven rods acting to band the ten rods in each row together, the barrier exhibited a more rigid behavior while still remaining flexible.

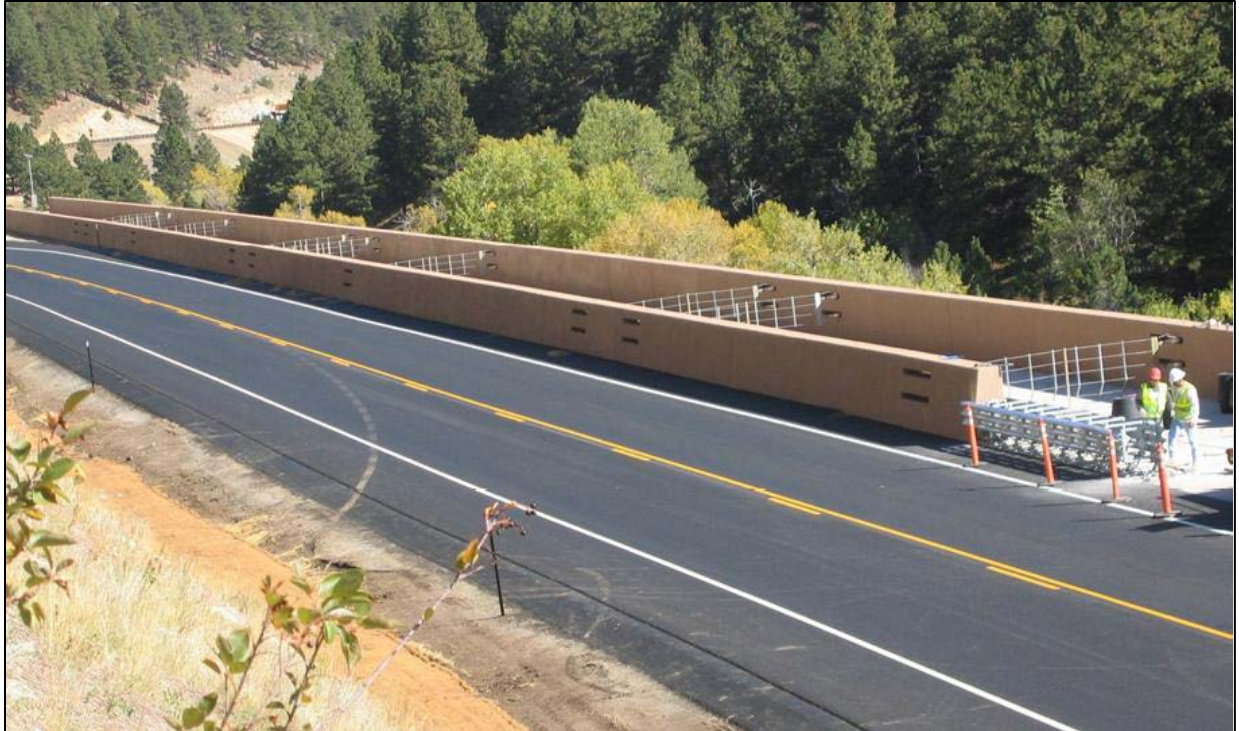
Figure 4.4 The novel ramp design on Wyoming Highway 14, in the eastbound lane just outside of Buffalo. The older ramp was on the other side of the highway, requiring the driver to cross oncoming traffic. The metal mesh webs are designed to absorb energy to a point and then break away.

The ramp design is shown in Figure 4.4, and pictures of the ramp and the vehicle after an actual incident are shown in Figures 4.5 and 4.6. By far the most significant advantage is its lack of reliance on an uphill grade. This system can be placed anywhere. It also has the advantage of allowing a gradual slowing of the vehicle. It works extremely well. The downside of this system is the replacement cost after use. Although no figures exist in the public domain, they are expected to be significant.

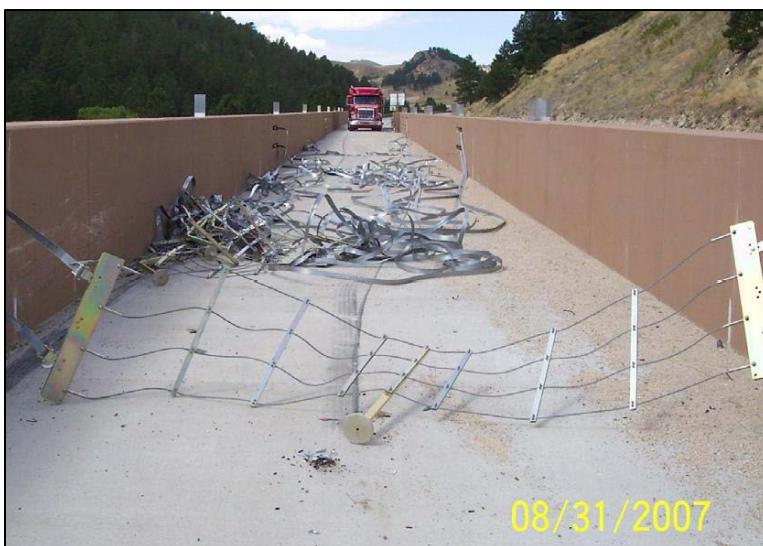
Figure 4.5 The crumbled wire gates following a successful ramp event.

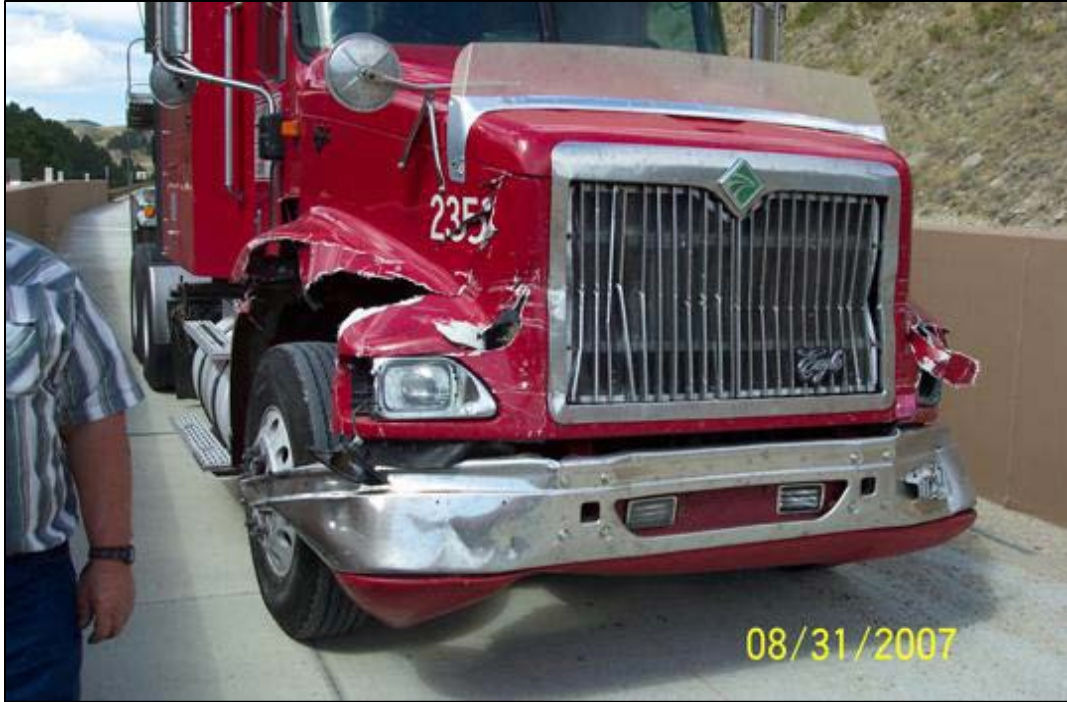
Figure 4.6 The front of the truck after stopping, showing the relatively minimal damage to the vehicle.

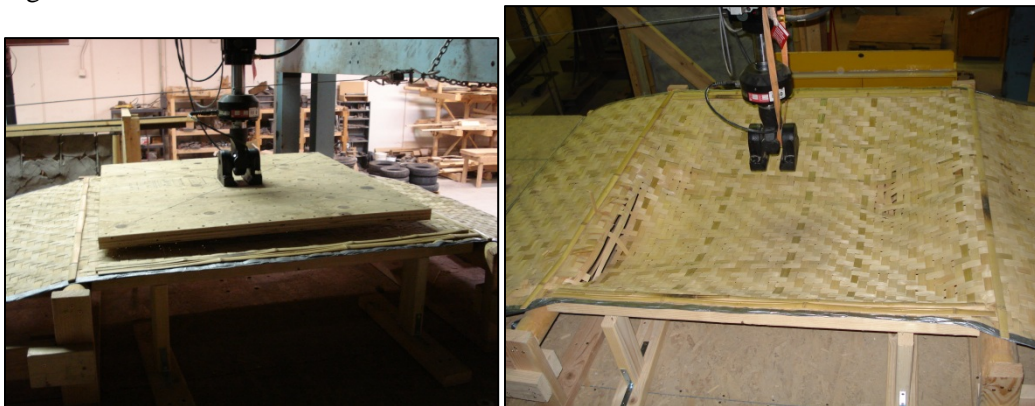
Figure 4.7 The puncture shear testing of a woven bamboo mat.

As an alternative to the types of metal meshes used in the Wyoming ramp design, we also considered alternative testing materials during the preliminary phases of this study that had the key features of being widely available and low cost. After preliminary testing of several other materials, the main material candidate chosen for secondary testing was a woven bamboo mat. This type of material is shown in Figure 4.7.

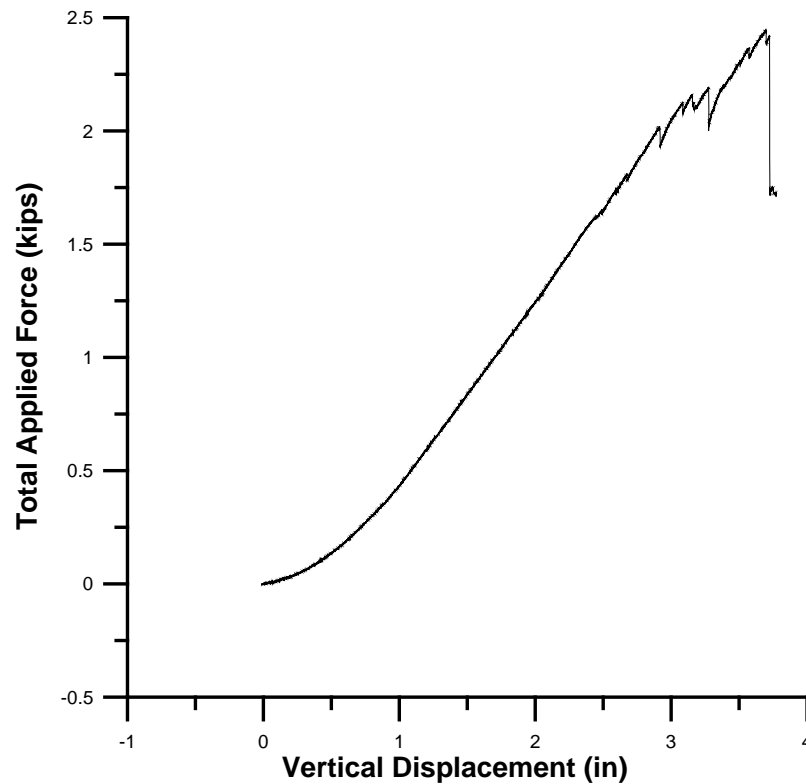
Figure 4.8 The static deflection test for the bamboo mat.

The advantages of using this material is that it is extremely inexpensive (a roll of several dozen feet was purchased for testing for less than \$100) and widely available through southeast Asian sources. Preliminary testing was completed to derive initial estimates for the amount of energy absorbed during static loading. A sample of the results is shown in Figure 4.8.

The results of this testing are mixed. Although the material is extremely tough, at least relatively, this mat would only stop a cart weighing 475 pounds (i.e., our test cart) moving at about 5 mph and is destroyed during testing. The rod array system is far more durable, can be re-used, and for an equivalent amount of funding (i.e., \$100 to purchase fiberglass rods) can stop the same cart moving at 25 mph. Although these tests were very preliminary and somewhat limited, these results directed our efforts in the direction of the rod array, and further testing of the web-mesh system was not explored.
