Fatigue Testing of Wood-Concrete Composite Beams

Dr. Jenő Balogh

May 2013

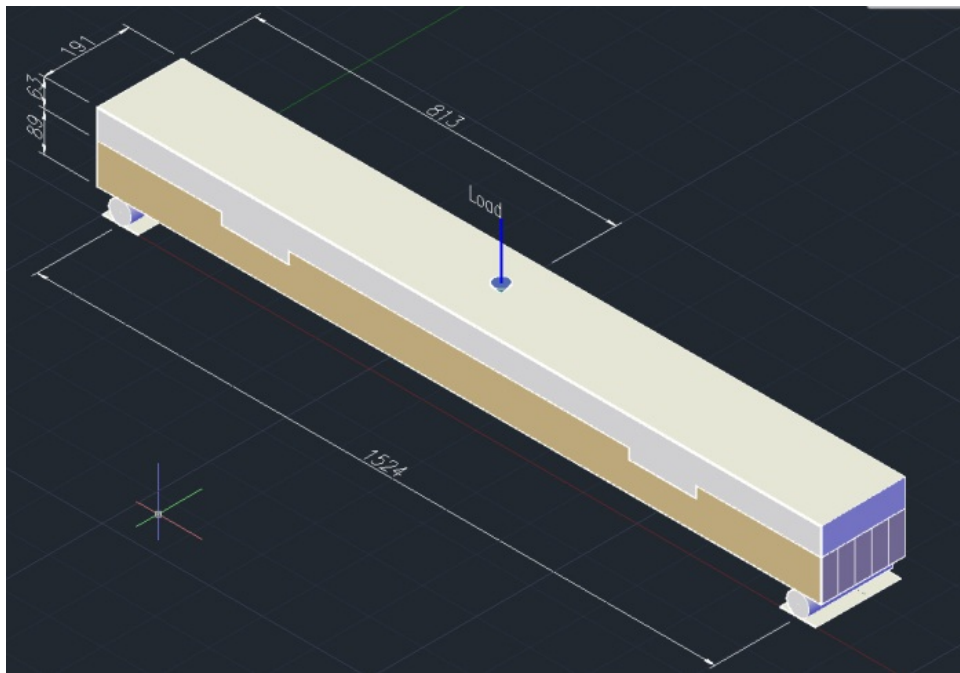
Figure 2.1 Specimen configuration [mm]

Fourteen 1626 mm (64 in) long wood-concrete composite beam specimens were built. The width of the specimens was 191 mm (7.5 in) and each had a 89 mm (3.5 in) thick wood layer consisting of five 2 in x4 in boards with nominal size of 38 mm x 89 mm (1.5 in x 3.5 in), as shown in Figure 2.1 and Figure 2.2, and a 63 mm (2.5 in) concrete layer. The wood and concrete layers were interconnected by embedded anchor screws, of 12 mm (0.5 in) diameter and 100 mm (4 in) long with an embedding depth of 50 mm (2 in), at the notch locations, as shown in Figure 2.3. The notches were cut into the wood 25 mm deep (1 in) and were 150 mm (6 in) long over the entire width of the specimen. The wood boards were attached to each other by 4 in deck screws 150 mm (6 in) apart. The wood layer was coated with a sealer paint (shown as white in the picture) to reduce the moisture entering the wood during the casting of the concrete layer. The paint was applied to the end of the wood boards as well.

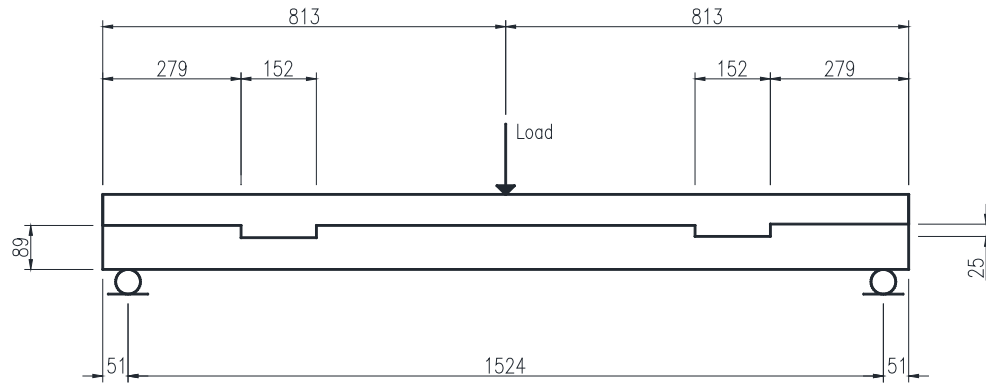
Figure 2.2 Specimen geometry [mm]

The specimens were configured as simply supported with a span of 1524 mm (60 in). Loading was applied at the mid-span (three-point loading) using an MTS hydraulic loading and digital data acquisition system, as shown in Figure 2.4. Each support was configured as a roller to avoid horizontal forces straining the actuator. This setting resulted in a symmetric configuration (see Figure 2.2).

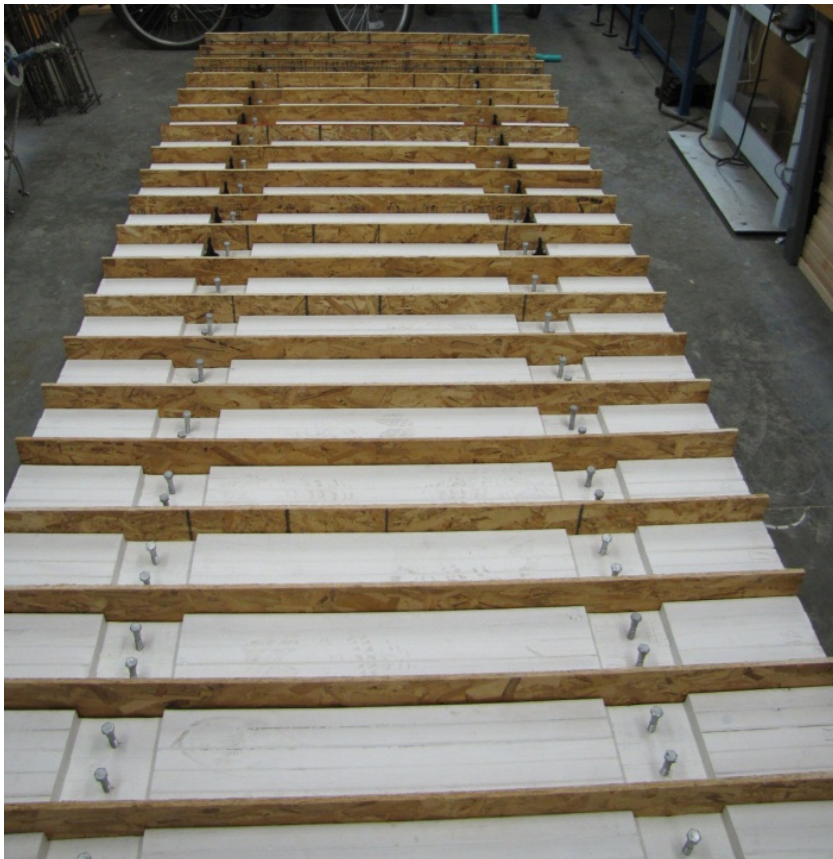
Figure 2.3 Specimens under construction with exposed notch detail

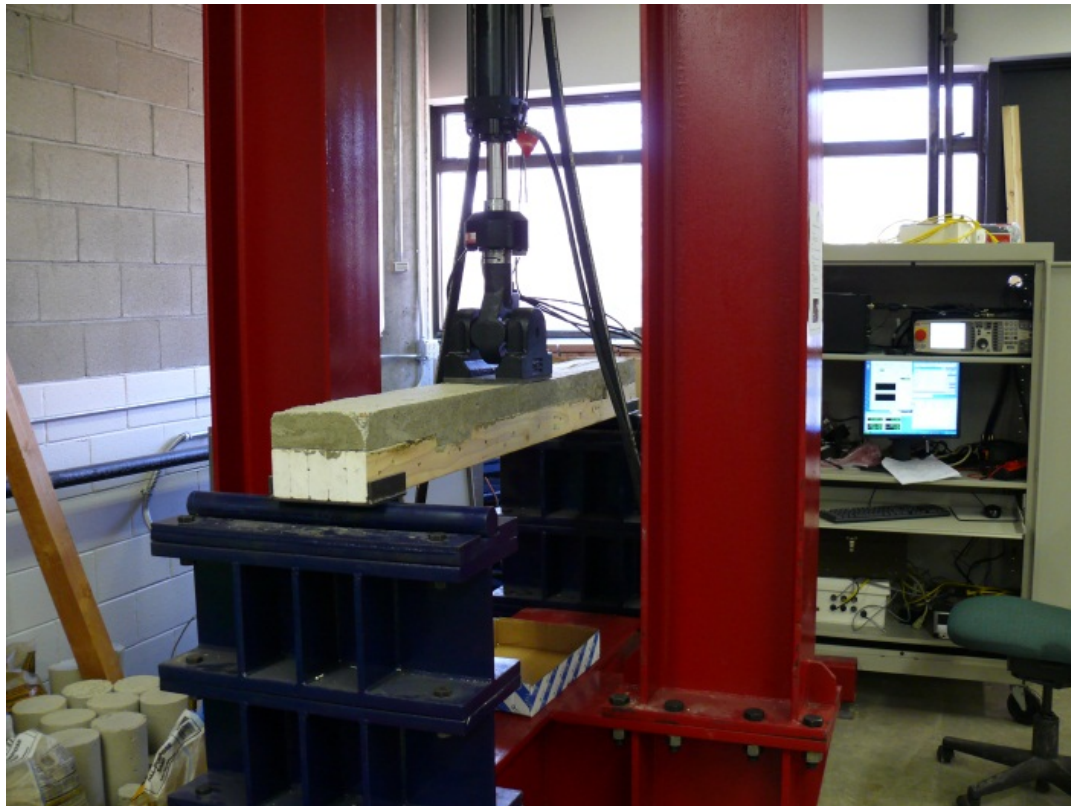
Figure 2.4 Typical test setup

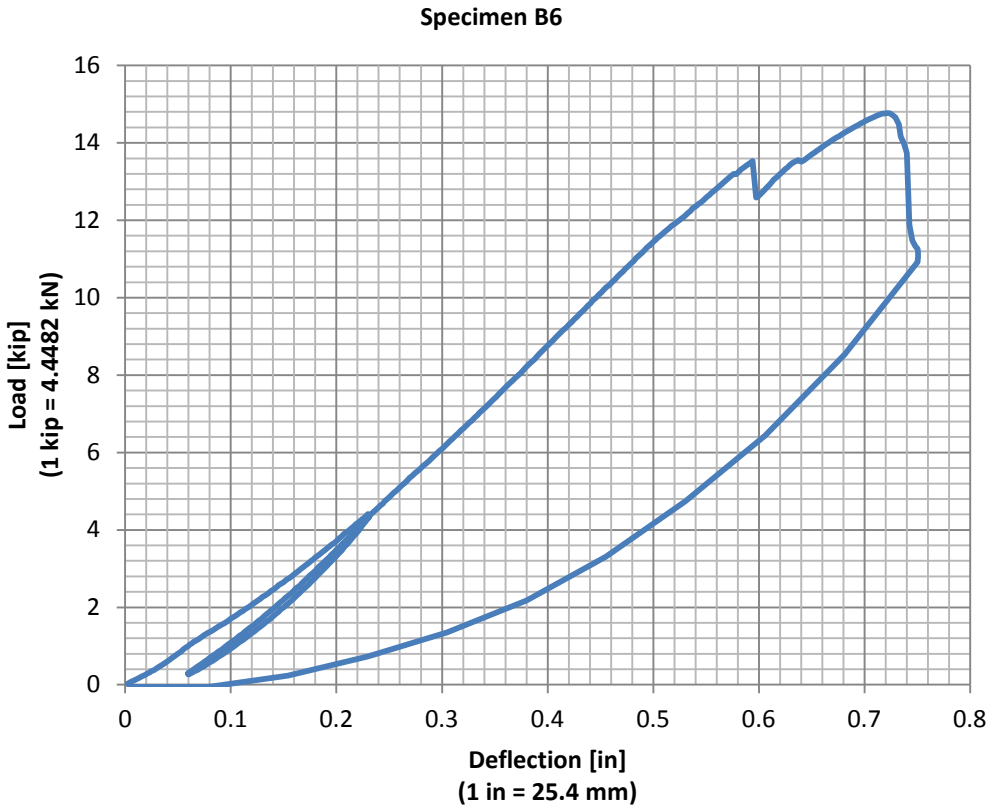
Figure 3.1 Typical load-deflection curve (Specimen B6)

In order to determine the average static failure load, five specimens were tested using a procedure suggested by EN 26891, a European standard describing principles for determining strength and deformation characteristics of mechanical joints in timber structures. A 44.5 kN (10 kip) reference maximum load was assumed (which was found to be about a 21% under-estimation, which resulted in a slightly lower actual loading speed compared with the value suggested in EN 26891) during the conversion of the mostly load controlled curve provided by EN 26891 to a displacement controlled one. A typical load-deflection characteristic recorded is shown in Figure 3.1 (depicting the behavior of specimen B6).

The static test results are summarized in Table 3.1. The total failure load is the maximum load resisted by the specimen, and the initial failure load corresponds to the first failure (indicated by a drop in the load-deflection curve) noticed during the ramp loading to failure.

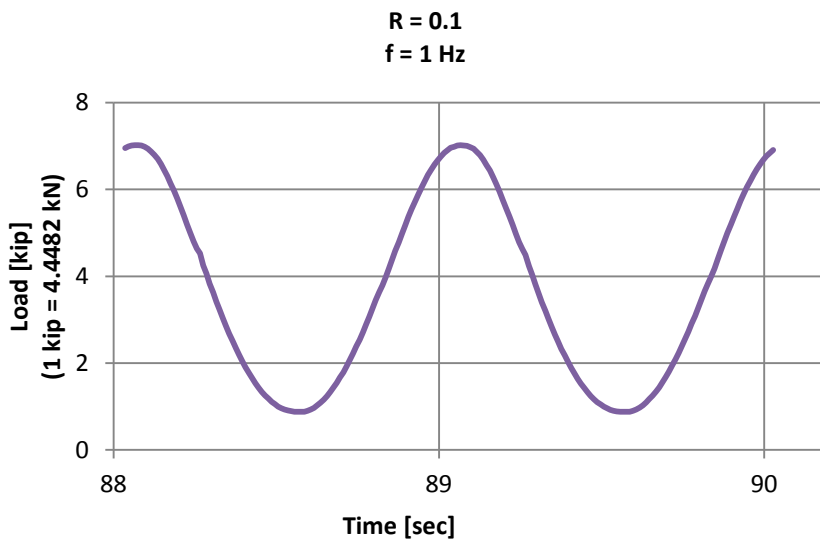
Figure 3.2 Typical pulsating load (Specimen F10)

The load was cycled sinusoidally, at a frequency of 1 Hz, maintaining a maximum load, P_{max} , to minimum load, P_{min} , ratio of $R=P_{min}/P_{max}=0.1$, as shown in Figure 3.2.

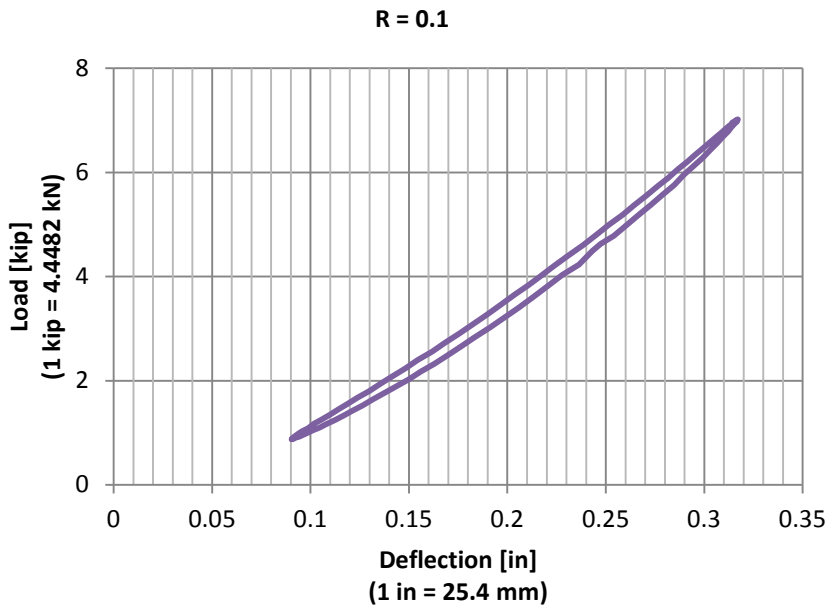
Figure 3.3 Typical behavior for a load cycle (Specimen F10)

Typical cyclic behavior of the test specimens observed corresponding to the loading shown in Figure 3.2 is depicted in Figure 3.3.

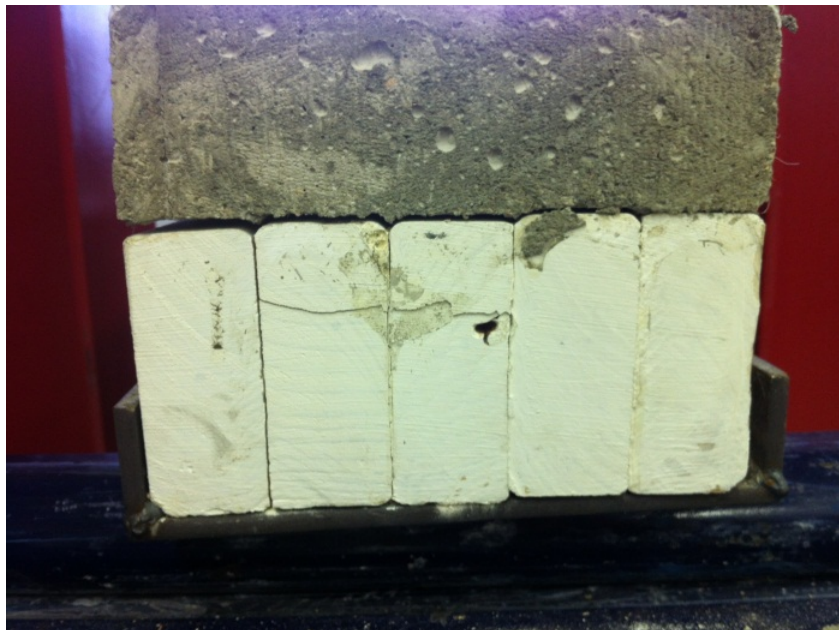
Figure 3.4 Typical block-shear failure (Specimen F11)

A typical observed block-shear failure mode is presented in Figure 3.4, visible on the second and third boards from the left.

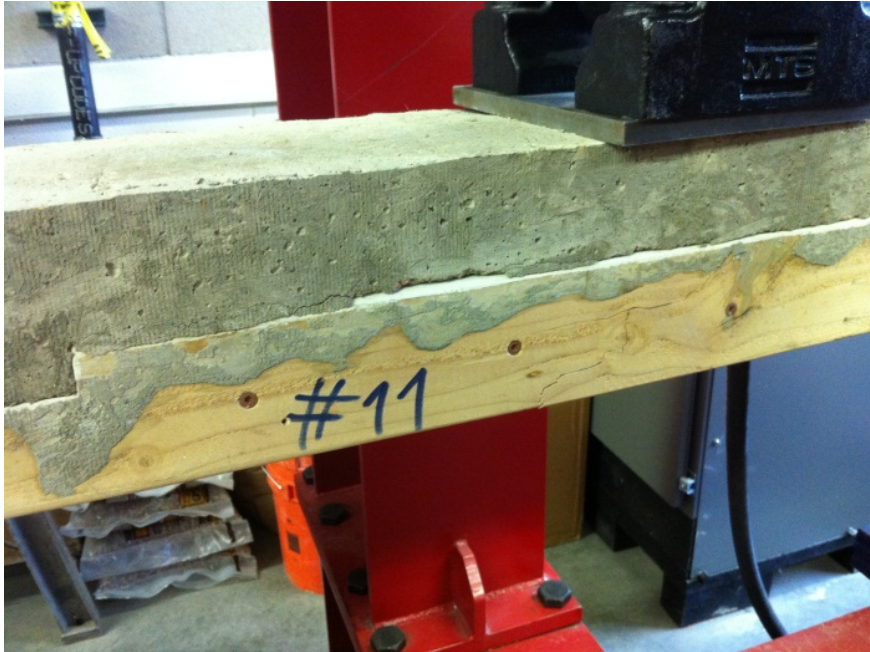
Figure 3.5 Typical tension failure (Specimen F11)

Typical observed tension failure (of the wood in bending) mode is presented in Figure 3.5. In all instances, block-shear of the wood at the notch occurred first.

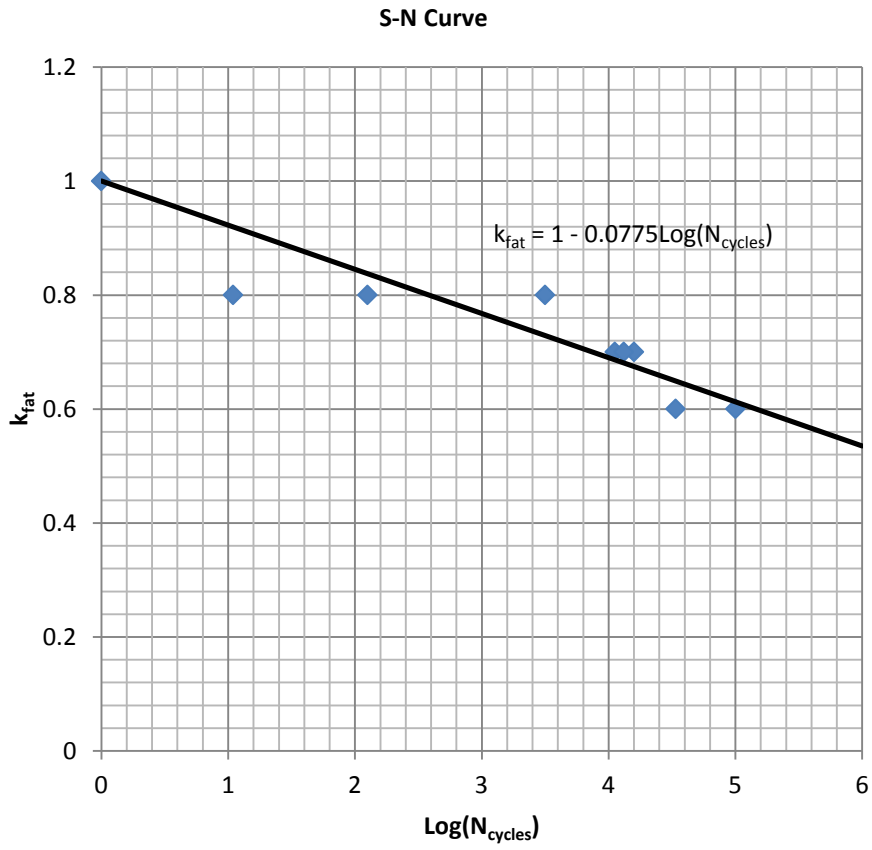
Figure 3.6 Mean S-N Line Approximation

Based on the fatigue test results, the mean S-N line is approximated in Figure 3.6, on a logarithmic scale.

Points on the S-N curve were determined for three levels of the maximum load as a function of the average static failure load. Typical observed failure modes were block-shear of the wood at the notch in some cases followed by tension failure of the wood at mid-span. The obtained S-N mean line allows for comparison with the Annex A of Eurocode 5: Design of Timber Structures EN 1995-2:2004, which describes verification of fatigue strength in timber bridges. Assuming the coefficient $b = 1.3$ (corresponding to wood in shear from Table A.1 of the Annex A) the coefficient a is found to be $a = 9.68$, which is more conservative than the value provided for the coefficient $a = 6.7$ in the Annex A for wood in shear.
