MPC 19-389 | S. Rimal, B. Kidd, M. Tazarv, J. Seo, and N. Wehbe

Methodology for Load Rating Double-Tee Bridges

Department of Civil and Environmental Engineering
South Dakota State University
Brookings, South Dakota

July 2019

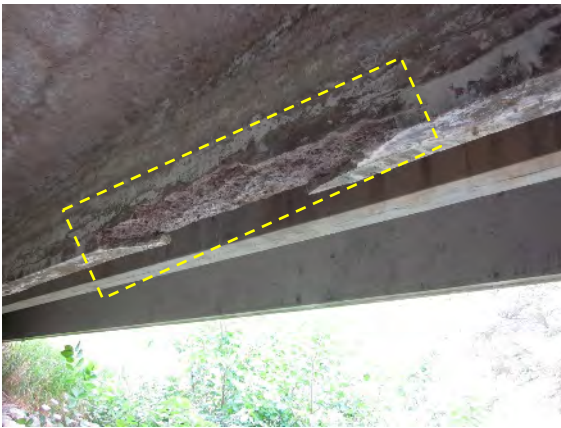
(a) Stem Cover Deterioration

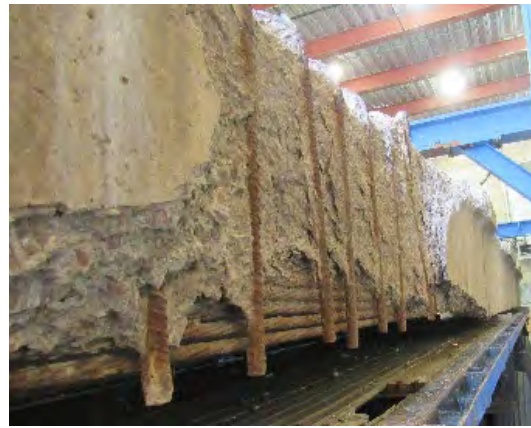
(b) Stem Reinforcement Exposure

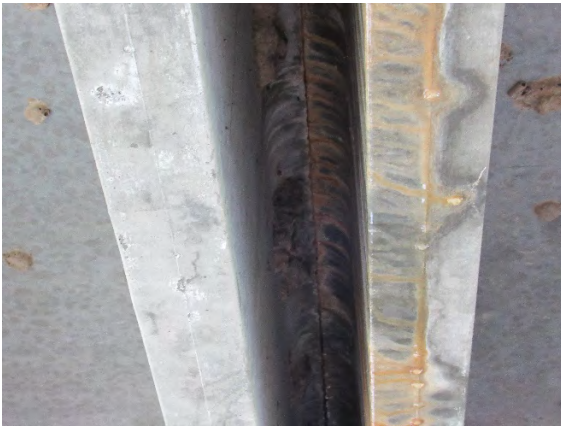
(c) Girder-to-Girder Damage

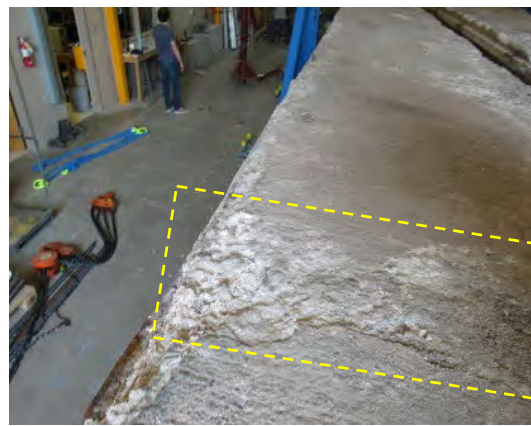
(d) Flange Cover Deterioration

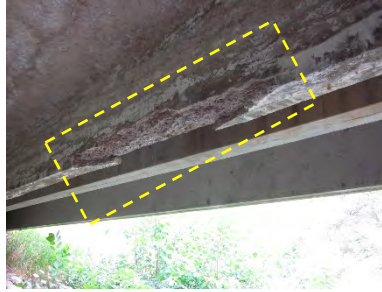
(b) Stem Cover Deterioration (CS-3)

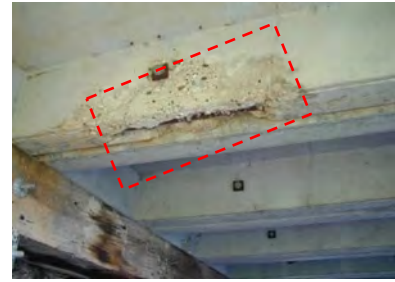
(c) Stem Cover Deterioration (CS-4)

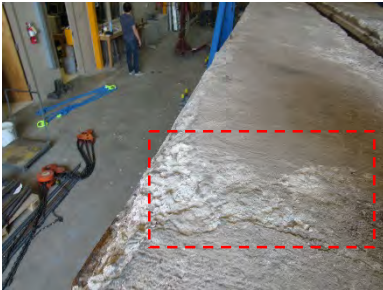
(d) Flange Cover Deterioration (CS-2)

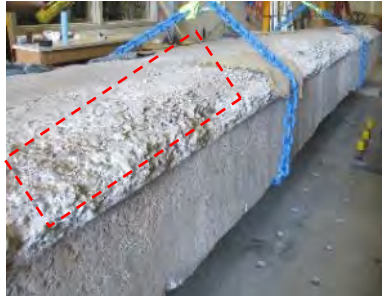
(e) Flange Cover Deterioration (CS-3)

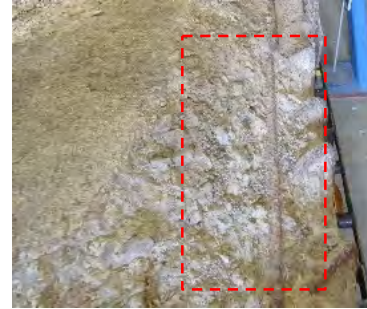
(f) Flange Cover Deterioration (CS-4)

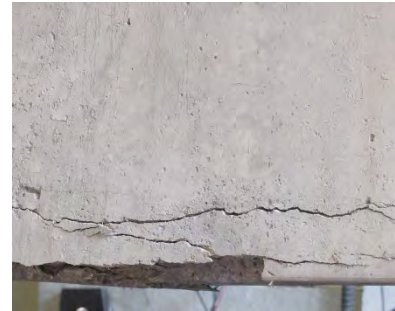
(i) Stem Cracking (CS-4)

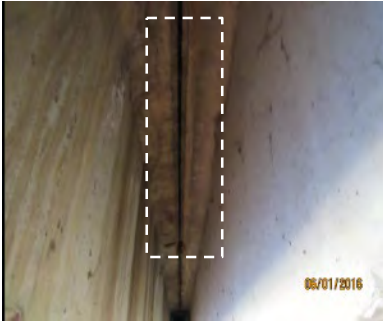
(m) Flange Girder to Girder Longitudinal Joint Deterioration (CS-2)

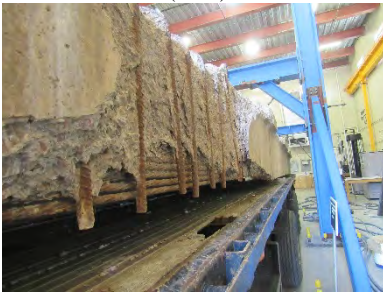
(p) Stem Exposure of Strand (CS-2)

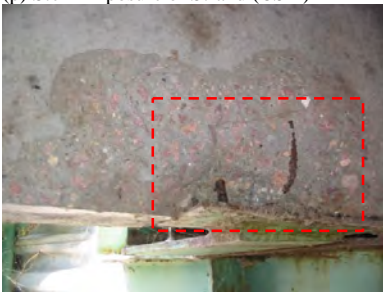
(s) Stem Exposure of Transverse Rebar (CS-1)/Stem Cover Deterioration CS (4)

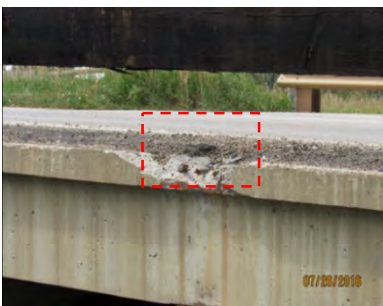
(v) Flange Exposure of Rebar (CS-1) & Flange Cover Deterioration (CS-4)

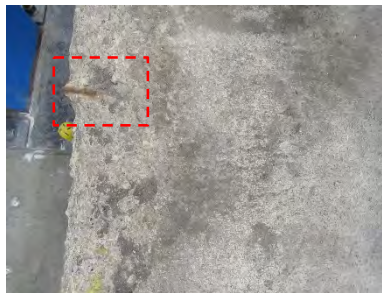
(w) Flange Exposure of Rebar (CS-2)

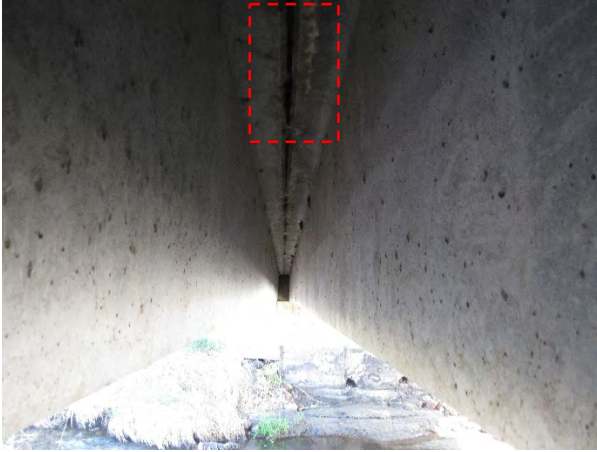
(a) Efflorescence in Joint

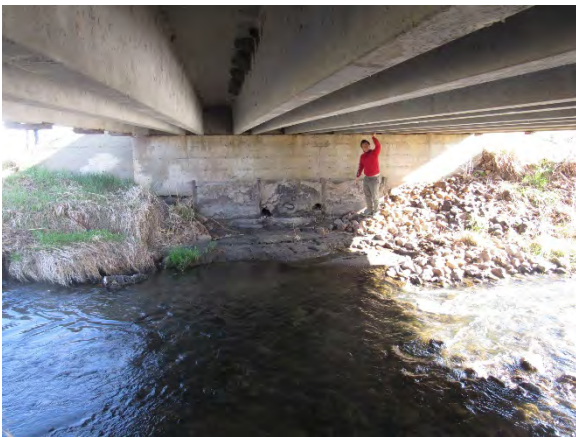
(e) Underneath of Bridge

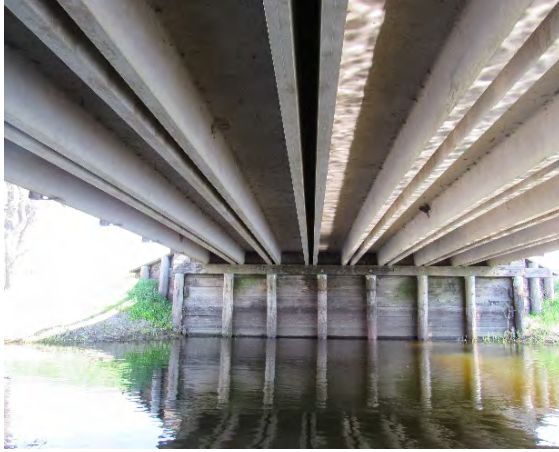
(a) Underneath of Bridge

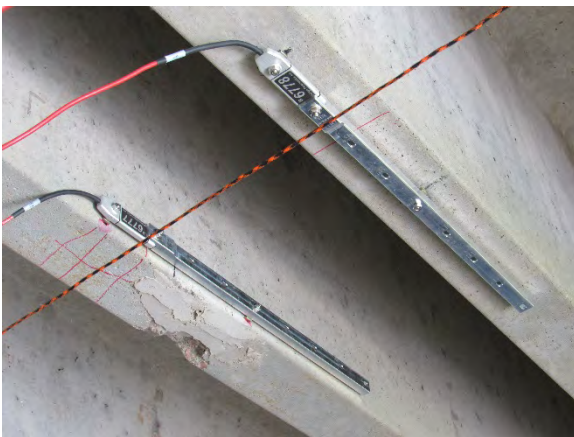
(c) Strain Gauges on Stem Side due to Damage

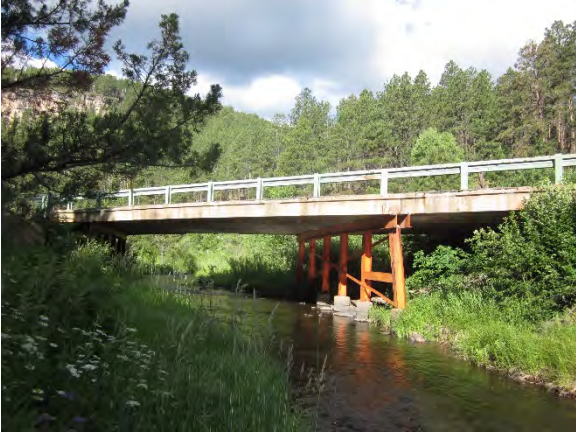
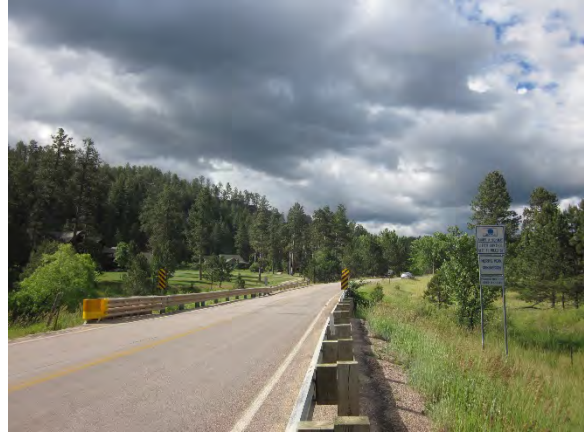
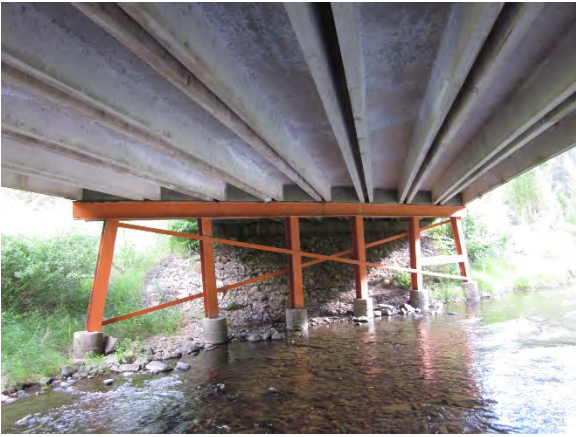
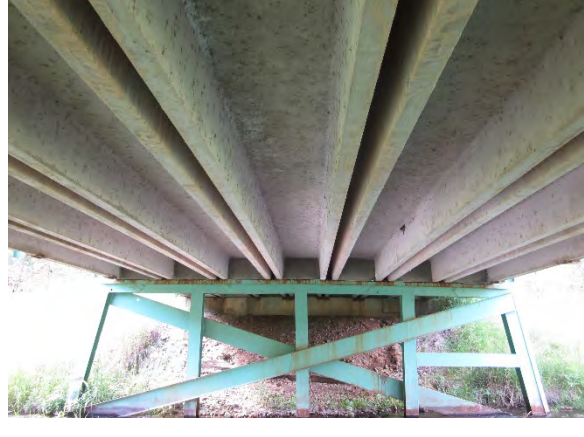
Figure 6.1 Double-Tee Girder Bridges Inspected for Strength Testing

Two double-tee bridges (Fig. 6.1) close to Rapid City, SD, for which replacement funds became available, were inspected to select girders for lab test. Girders of the Nemo Road Bridge (ID 52-313-265, built in 1972) had more apparent damage compared to those of Norris Peak Road Bridge (ID 52-319-268, built in 1972). Therefore, one 30-ft (9.14-m) long double-tee girder and one 50-ft (15.24-m) long double-tee girder (Fig. 6.2), each 23-in. (584-mm) deep, were selected and extracted from this bridge (Fig. 6.3). The variation in the girder length was to investigate different failure modes. A short and damaged girder may fail in shear even though it was designed for a flexural failure. The two salvaged girders were delivered to the Lohr Structures Laboratory at South Dakota State University (SDSU).

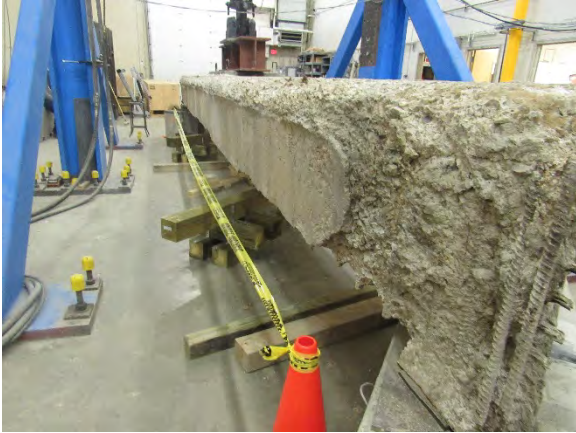
Girder Depth, in. (mm)	Girder Length, ft (m)	As-received Girder Damage Type and Condition State
23 (584)	30 (9.14)	Spalling of stem concrete cover (with a condition state of severe, Fig. 6.4a), exposure of stem transverse reinforcement (with a condition state of severe, Fig. 6.4a & c), and leakage of girder-to-girder joints (with a condition state of poor).
23 (584)	50 (15.24)	Deterioration of concrete cover (with condition state of severe, Fig. 6.4b), exposure of transverse rebar (with a condition state of severe, 8.4f), exposure of longitudinal prestressing (with a condition state of severe, Fig. 6.4f), and leakage of girder-to-girder joints (with a condition state of poor).

(a) Stem Cover Deterioration for 30-ft (9.14-m) Girder

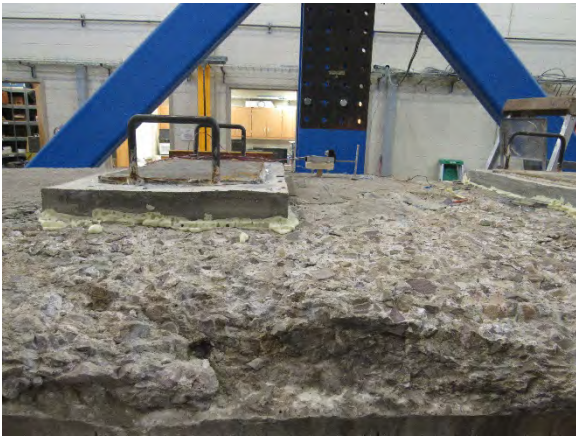
(c) Flange Cover Deterioration of 30-ft (9.14-m) Girder

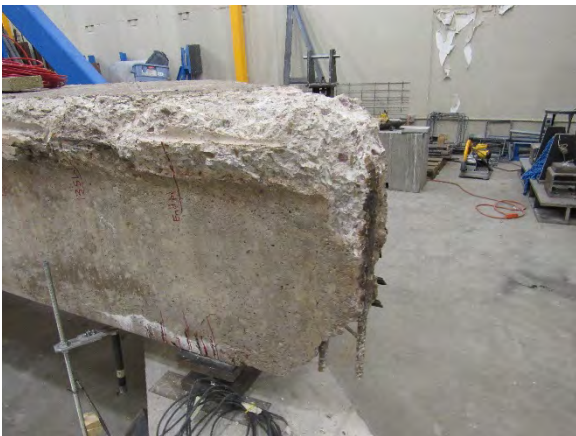
(e) Reinforcement Exposure of 30-ft (9.14-m) Girder

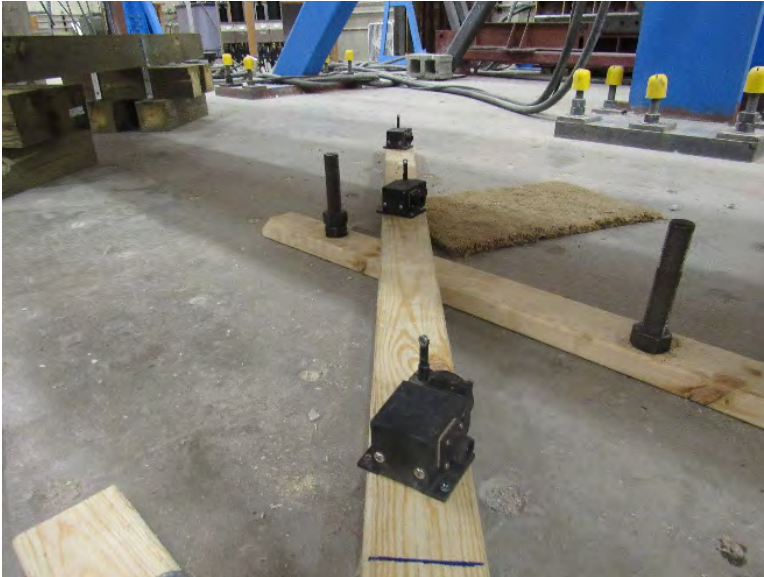
Figure 6.21 String Pot Installation at Midspan of 30-ft (9.14-m) Long Girder

Three string pots were installed at the girder midspan, two at each stem and one at the flange, to measure girder deflections (Fig. 6.20a & Fig. 6.21). It was noticed that the middle string pot (SP-2) was not working properly. Therefore, its data was excluded in the post-processing.

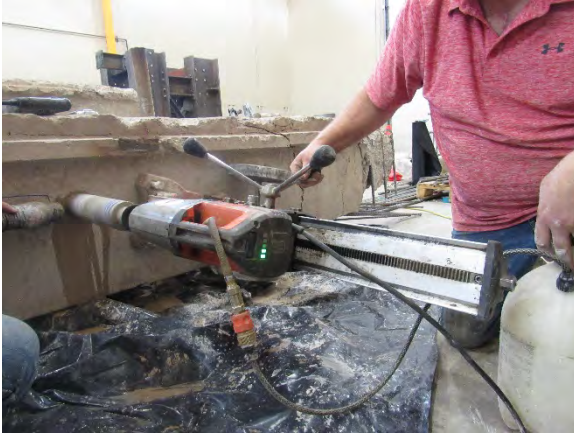
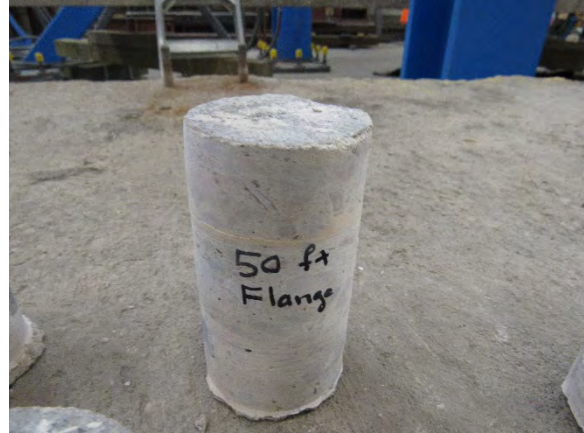
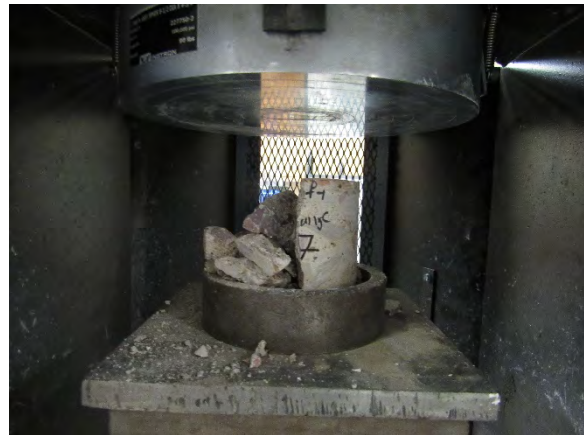
Figure 6.22 Concrete Coring and Testing for Salvaged Girders

Figure 6.22 shows a sample core, which was obtained following ASTM C42 (2003), and the test setup, which was in accordance to ASTM C39 (2012). Table 6.4 presents a summary of the results. The concrete compressive strength for the 50-ft (15.24-m) long girder stem and flange was 3.15 ksi (21.7 MPa) and

Unfortunately, concrete in the 30-ft (9.14-m) long girder was severely deteriorated, so no samples could be obtained (all samples crushed during coring). The only core sample that was extracted from this girder had a short height that was not acceptable by ASTM C42 (2003). Due to a lack of test data, the compressive strength of the 30-ft (9.14-m) long girder is assumed to be the same as that in the 50-ft (15.24-m) long girder.

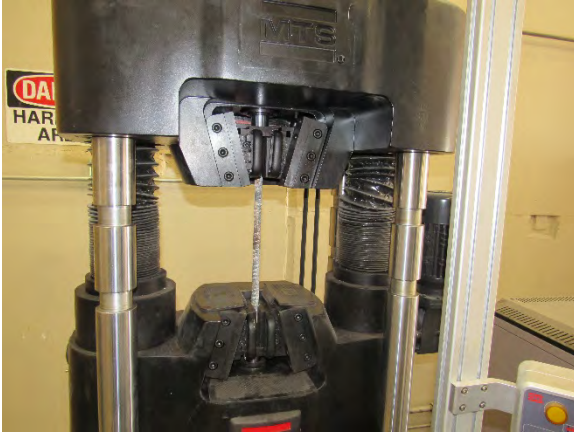
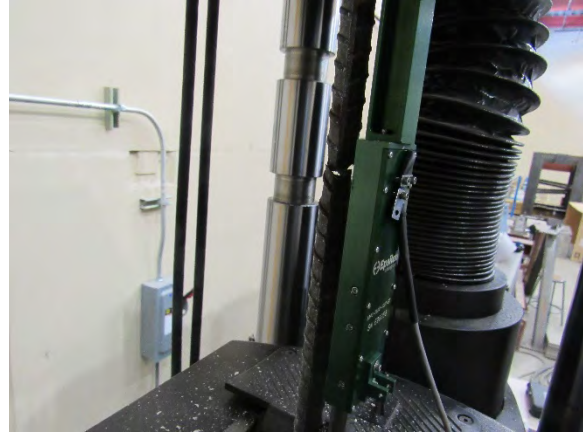
Figure 6.23 Tensile Testing of Steel Bars Extracted from Salvaged Girders

According to shop drawings of typical double-tee girders, transverse and longitudinal reinforcing steel bars used in the salvaged girders should conform to the requirements of ASTM A615 Grade 60. After girder testing, the reinforcement pattern was inspected, and sample bars were collected for tensile testing. The transverse reinforcement of the test girders was one size larger than that found in the shop drawing (No. 5 (16-mm) bars instead of No. 4 (13-mm) bars).

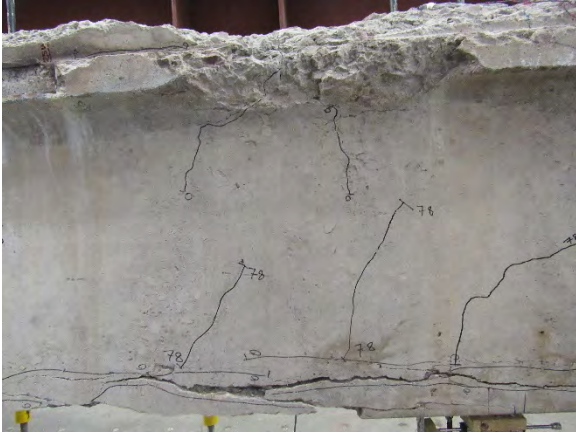
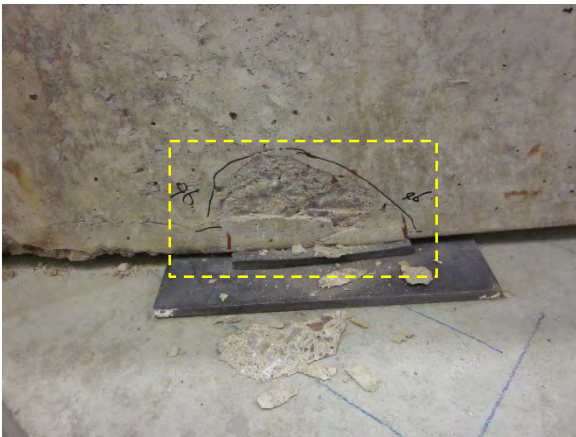
The 45-year old girder had several damages prior to testing (Fig. 6.4). As was mentioned in Sec. 6.1, this girder was cracked at the midspan during unloading from the delivery truck. The first flexural crack was observed at the midspan at a 24.9-kip (110.7-kN) load as shown in Fig. 6.26 (marked as Run No. 78). New flexural cracks developed at the midspan at higher loads (Fig. 6.26b) and the concrete spalled at the north support (Fig. 6.26c). Finally, the girder failed at the midspan in a brittle manner (Fig. 6.26d). It was concluded from the analytical study (Sec. 6.7) that the girder failure was due to failure of the flange concrete.

(a) First Flexural Crack at Midspan

(c) Concrete Spalling at Support

Figure 6.26 Observed Damage of 50-ft (15.24-m) Long Girder during Strength Testing

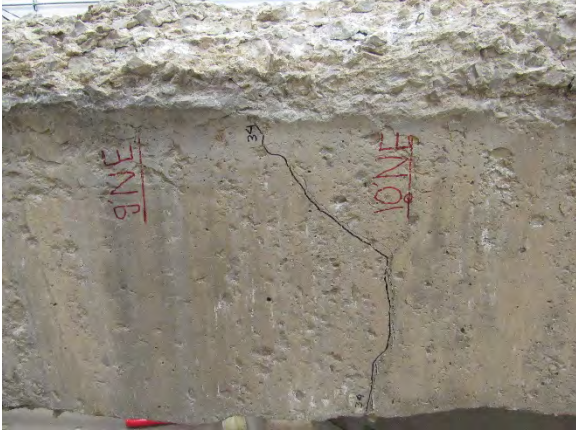
The 45-year old girder had several damages prior to testing (Fig. 6.4). The north end of the girder had more prior-to-testing apparent damage than the south end. That is probably why the first crack occurred near the north end (Fig. 6.32a, marked as Run No. 34), 10 ft (3.05 m) away from the midspan at an actuator load of 15.3 kips (68.06 kN). The first flexural crack was observed at a distance of 5 ft (1.5 m) from the midspan at a 22.41-kip (99.68-kN) load as shown in Fig. 6.32b (marked as Run No. 47). The width of cracks extended, and new cracks formed, at higher loads (Fig. 6.32c & d). Finally, the girder failed in flexure at the midspan (a major flexural crack as marked in Fig. 6.32e), which was a ductile failure.

(a) First Shear Crack at North End

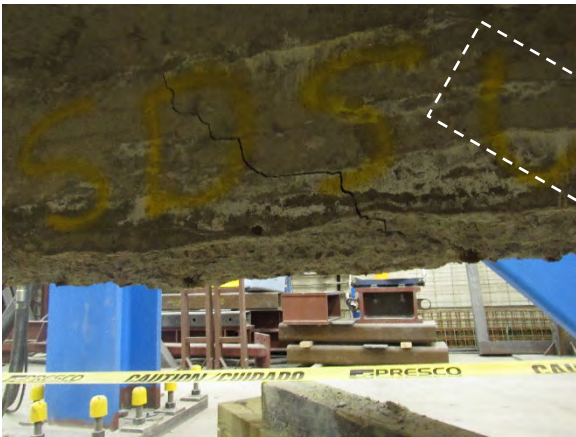
(e) A Major Flexural Crack at Midspan– Stem inside View

The 30-ft (9.14-m) long girder failed in a ductile manner at the midspan with a load of 37.37 kips (166.23 kN). Table 6.8 also presents the calculated capacities of this girder including all damages. The calculated shear and moment capacities for this girder at the failure section were 64.7 kips (287.8 kN) and 223.58 kip.ft (303.5 kN.m), respectively. The equivalent calculated load carrying capacities (a point load at the midspan, $P_{calculated}$) were respectively 129.4 kips (575.6 kN) and 35.89 kips (159.65 kN), which is 3.9% higher than measured load. Therefore, the 30-ft (9.14-m) long girder failed by the flexural failure of the section, which is a ductile failure.

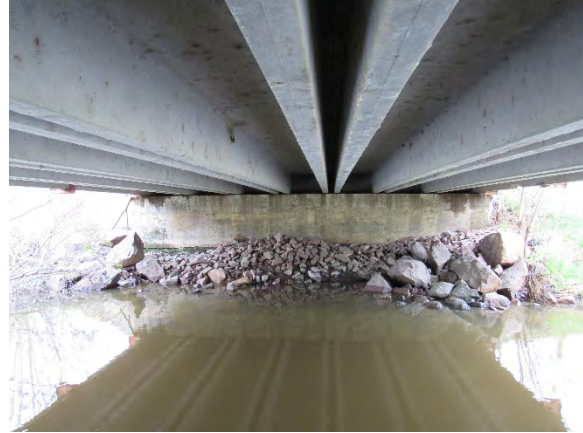
(b) Underneath of bridge

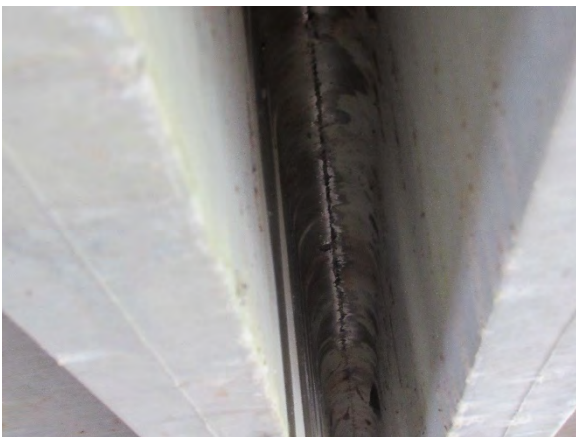
(c) Efflorescence in joint

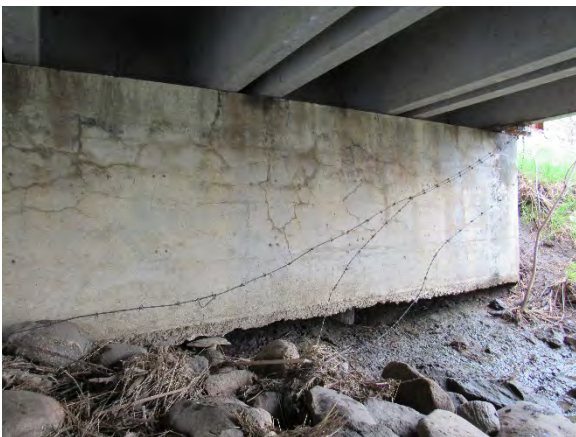
(e) Scouring from bottom of abutment

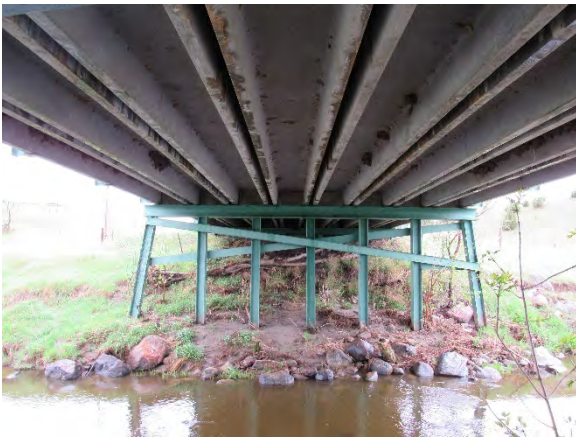
(c) Underneath of bridge

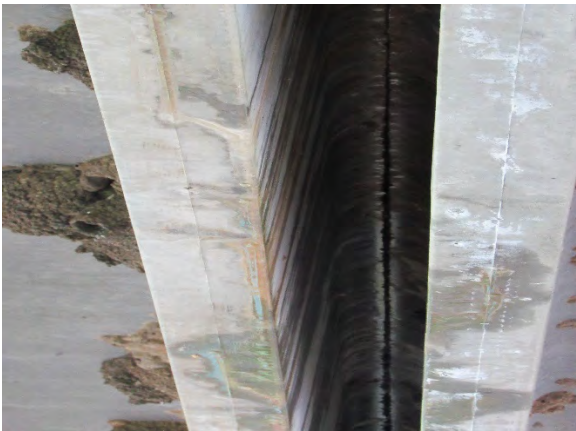
(e) Efflorescence

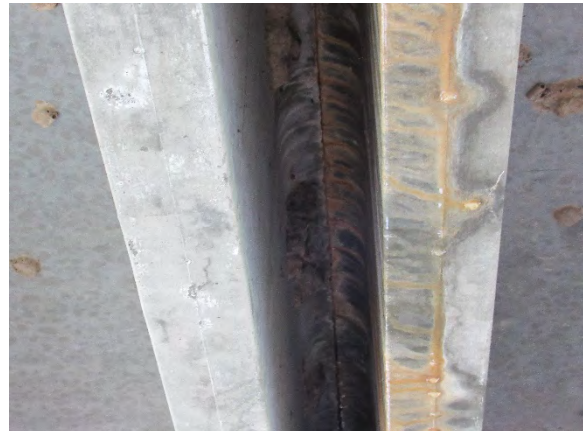
(f) Sign of corrosion

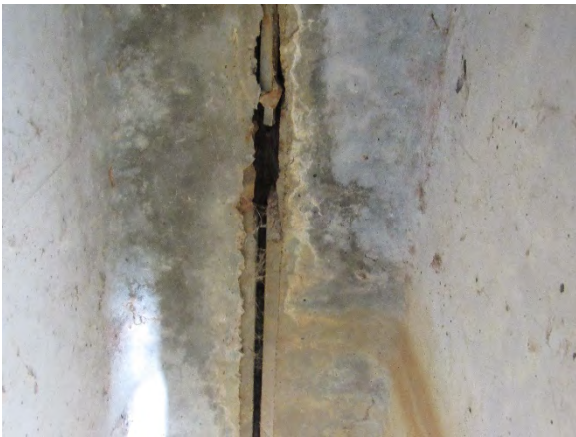
(c) Joint deterioration

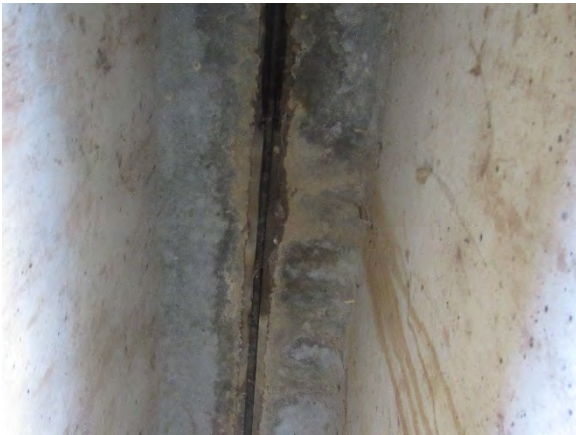
(e) Leakage from joint

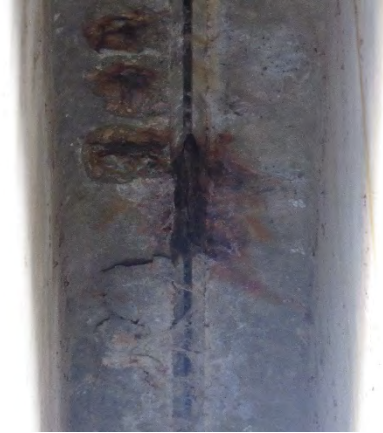
(b) Corrosion in joint

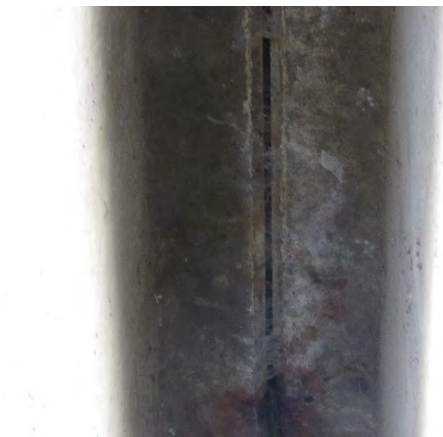
(c) Efflorescence in joint

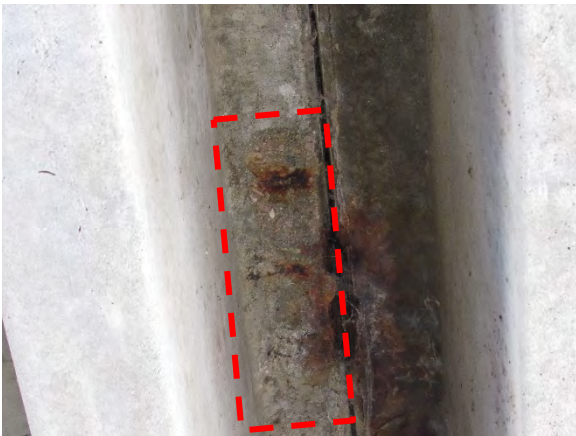
(e) Deterioration in Joint

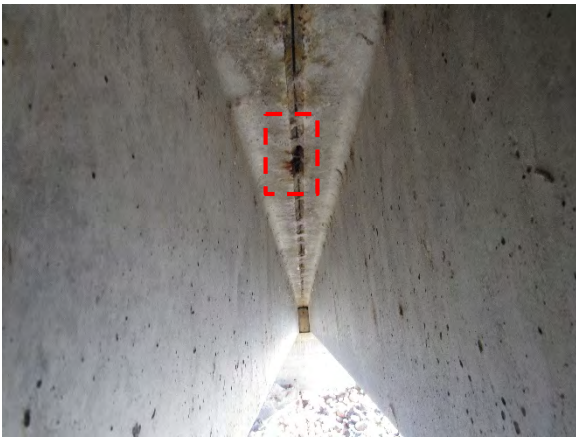
(c) Corrosion in the joint

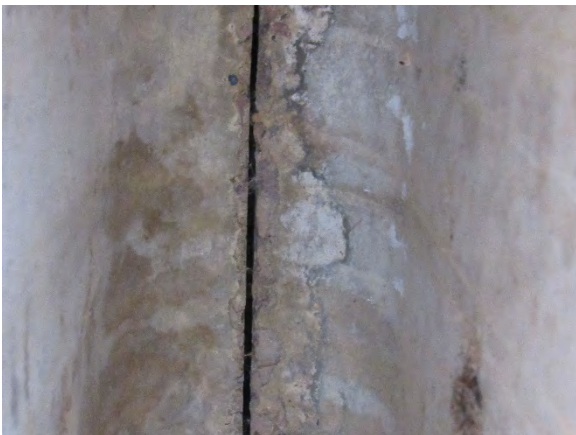
(e) Efflorescence at joint

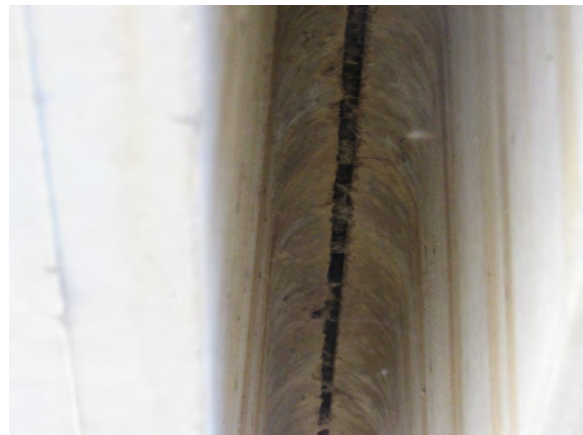
(f) Wide gap in joint

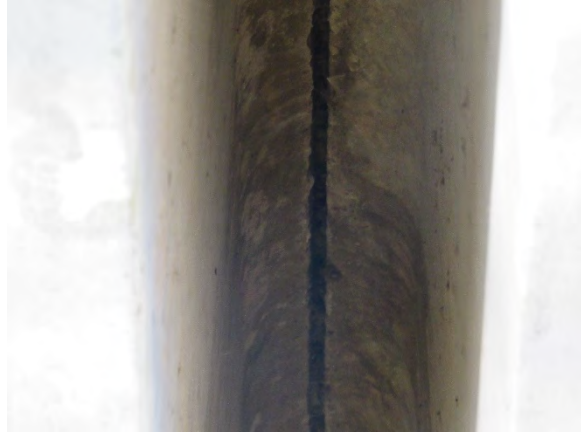
(b) Gap of joint

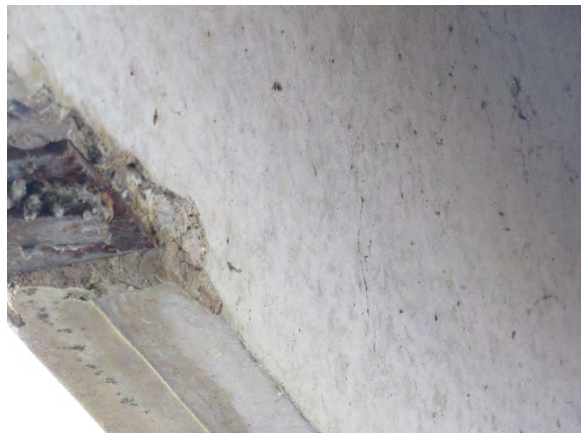
(f) Deterioration at bottom of stem

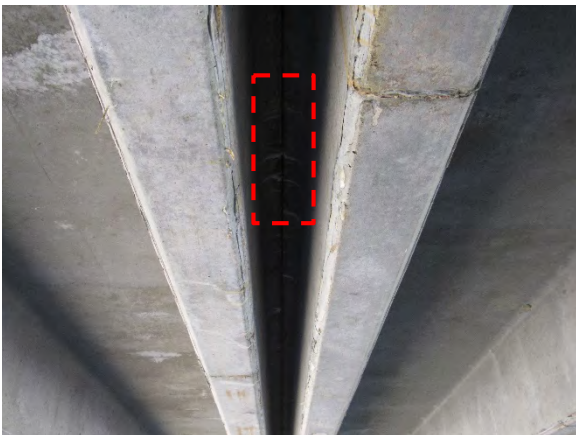
(e) Efflorescence at joint

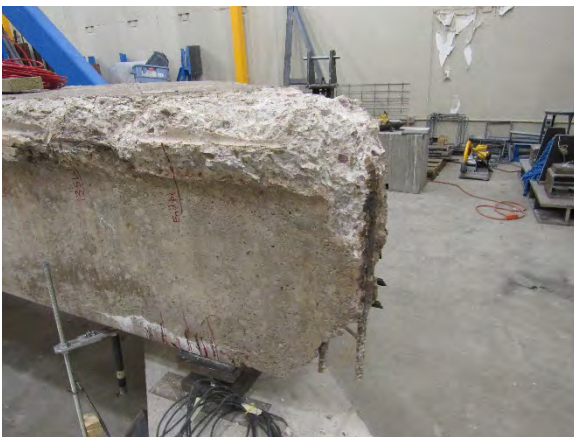
(c) Reinforcement Exposure

Girder Depth, in. (mm)	Girder Length, ft (m)	Damage Type and Condition State
23 (584)	30 (9.14)	Spalling of stem concrete cover (CS-4), exposure of stem transverse reinforcement (CS-3), flange cover deterioration (CS-4), exposure of flange rebar (CS-2) and cracking at stem and flange joint (CS-1).

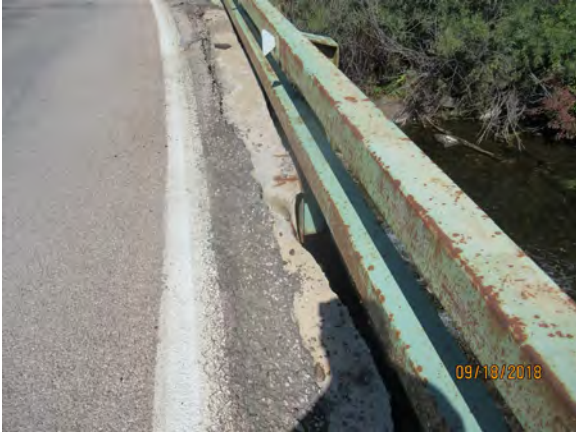
(a) Deterioration of Concrete on Top of East Deck Unit

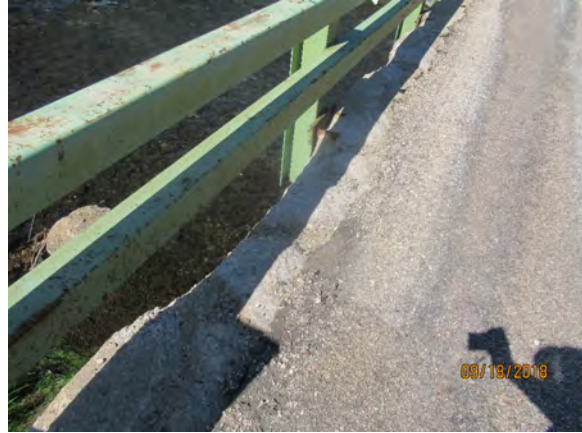
(b) Deterioration of Concrete on Top of West Deck Unit

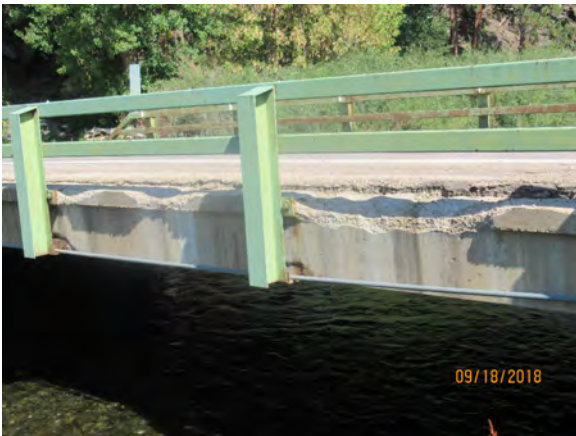
(c) Deterioration of West Side of West Deck Unit

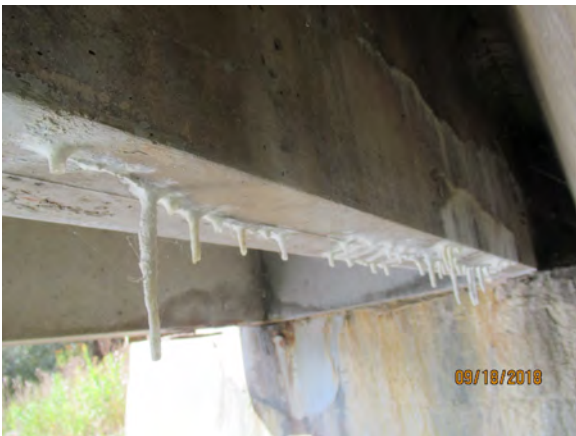
(d) Longitudinal Cracking and Severe Efflorescence-
North End of Deck Unit 1

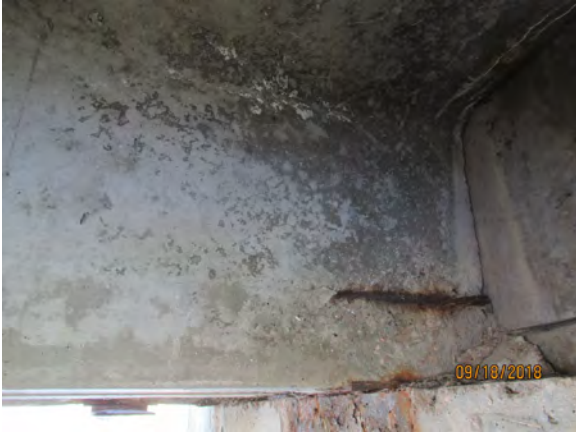
(f) Spall with Prestressing Strand Exposed – South End of East Stem of Deck Unit 6

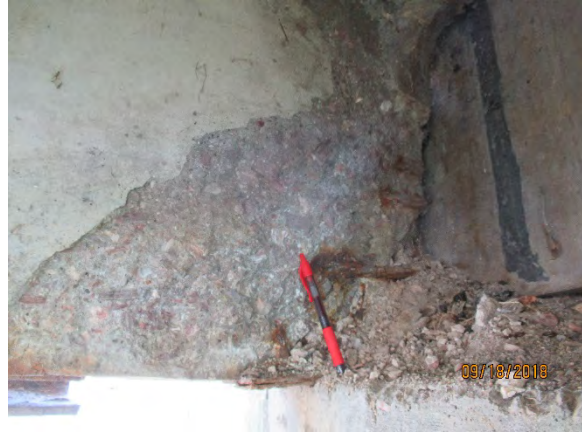
(g) Spall with Prestressing Strand Exposed – South End of East Stem of Deck Unit 7

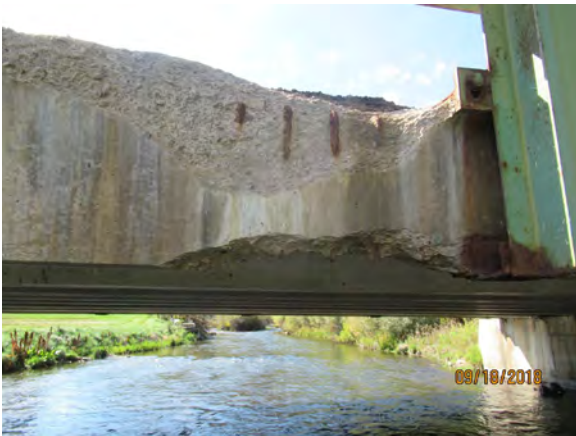
(h) Spall with Exposed Rebar Near Post 4 – Deck Unit 7

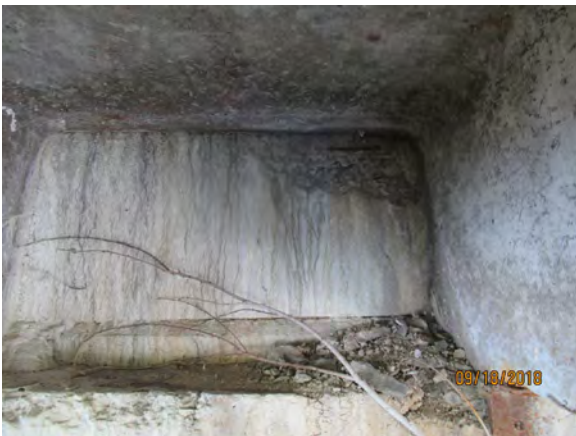
(k) Spall in North Backwall with Exposed Rebar Beneath Deck Unit 7
